ENGINE — STARTER AND TAI DUCT SYSTEM — INTRODUCTION OF NEW MORE DURABLE BEARING LINK ASSEMBLIES

Turbojet Engine Service Bulletin No. V2500-ENG-80-0022 Revision No. 1 dated October 29, 2014.

V2522-A5, V2524-A5, V2527-A5, V2527E-A5, V2527M-A5, V2530-A5, V2533-A5

V2500 Series 80-0022

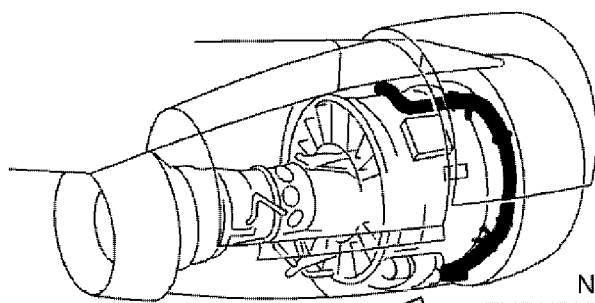
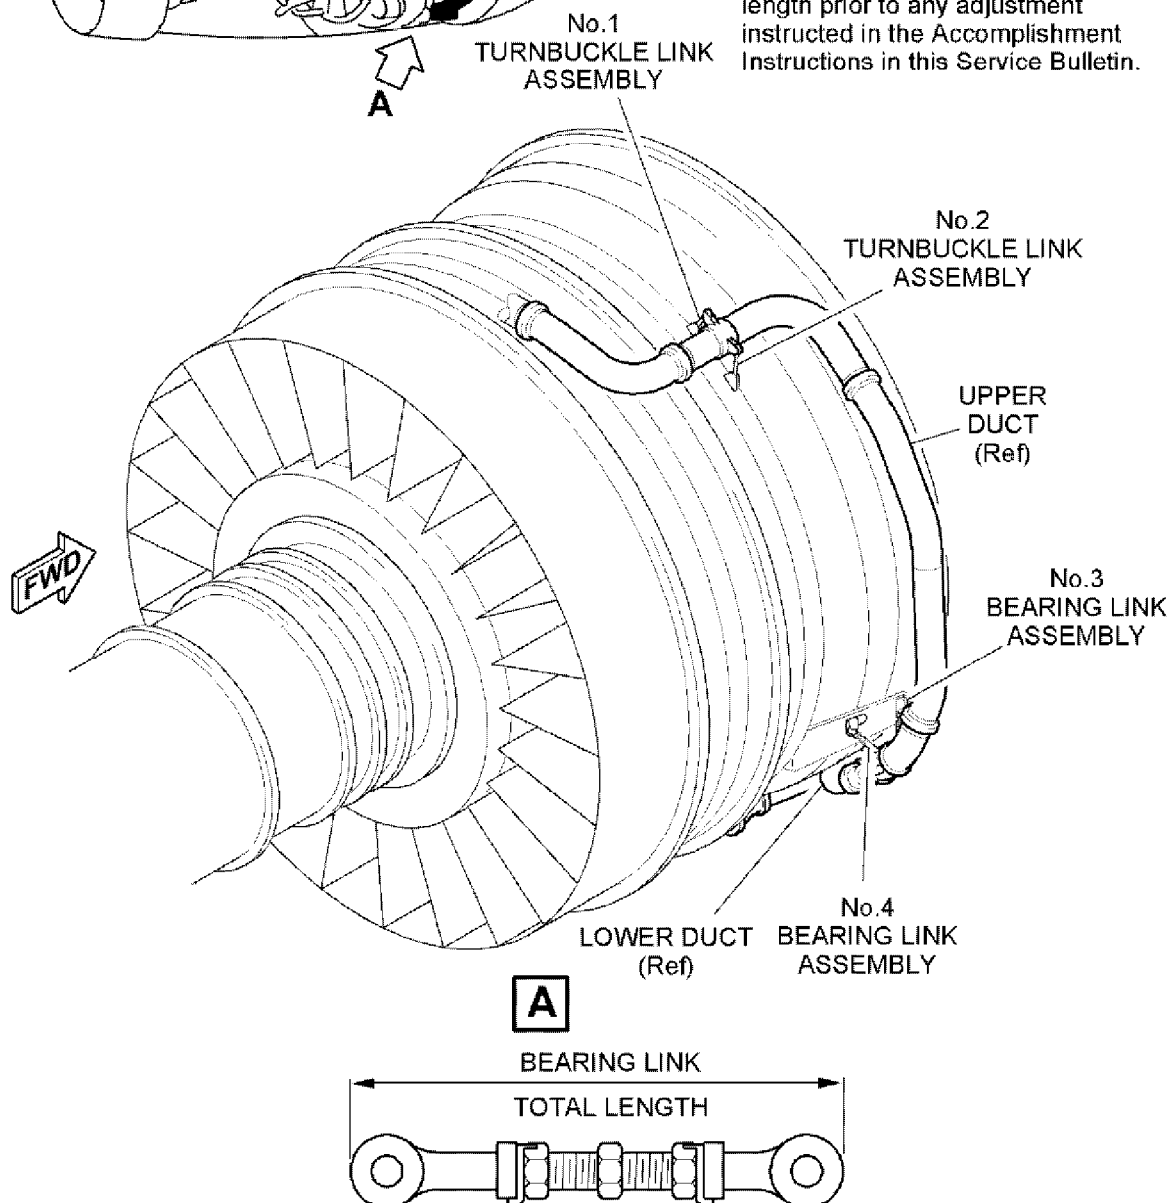
REPLACEMENT OF STARTER DUCT BEARING LINK ASSEMBLIES
FIGURE 1

1. Issue: There have been reports from operators of too much wear on the Starter Duct and Thermal Anti-Icing (TAI) link rod bearings.
2. Evidence: Operators have observed the issue in service.
3. Substantiation: This service bulletin gives instructions to install turnbuckle type linkages that have been tested in controlled service use conditions. The service use trial found that there was less vibration which increased the life of the link bearings.
4. Objective: This service bulletin gives the instructions to replace specified bearing links with turnbuckle type links, to reduce wear of the link bearings.
5. Effects of Bulletin on:
 - Operation: Not affected.
 - Maintenance: Affected.
 - Overhaul: Not Affected.
 - Repair Scheme: Not affected.
 - Interchangeability: Fully intermixable and interchangeable.
 - Fits and Clearances: Not affected.
6. Supplemental Information
 - None.

PART A — Replacement of the bearing link assemblies on the Air Starter — LH or RH Engine (Refer to Figure 1)

- (1) Adjust the central connecting rod nut at position one to make the overall length of the turnbuckle link an approximate nominal length of 4.65 in (118.00 mm).
- (2) Adjust the central connecting rod nut at position two to make the overall length of the turnbuckle link an approximate nominal length of 5.55 in (141.00 mm).
- (3) Make further adjustments to the turnbuckle link at position one to set the link to a length that just permits you to put in the bolts at the end of the turnbuckle link. Tighten the turnbuckle link bolts in accordance with the Aircraft Maintenance Manual, TASK 80-13-49-400-010.
- (4) Make further adjustments to the turnbuckle link at position two to set the link to a length that just permits you to put in the bolts at the end of the turnbuckle link. Tighten the turnbuckle link bolts in accordance with the Aircraft Maintenance Manual, TASK 80-13-49-400-010.

- (5) Torque the central adjustment nut on the connecting rod at position one to 25 lbf in (2.8 Nm). Apply the torque so that it will reduce the length of the turnbuckle link. Refer to the Aircraft Maintenance Manual, TASK 70-23-11-911-013.

- (9) Visually inspect the bearing link assemblies at positions three and four for wear. If serviceable, undo the lock nuts to permit the adjustment of the bearing links.

- (10) Adjust the length of the bearing link at position three to the nominal length of 3.04 in (77.4 mm) as shown.

- (11) Adjust the length of the bearing link at position four to the nominal length of 4.59 in (116.5 mm) as shown.
- (12) Make further adjustment to the bearing link at position three to set the link to a length that just permits you to put in the bolts at the end of the bearing link.
- (13) Make further adjustment to the bearing link at position four to set the link to a length that just permits you to put in the bolts at the end of the bearing link.
- (14) Shorten the length of the bearing link at position three by the application of a half turn (180 degrees) in a clockwise direction.

- (15) Shorten the length of the bearing link at position four by the application of a full turn (360 degrees) in a clockwise direction.
- (16) Install the bearing links at positions three and four. Tighten the lock nuts at each end of the bearing links and bend the washer tabs to make sure the lock nuts are tight.

LINK ASSEMBLY	TOTAL LENGTH*
No.1	4.65 in. (118,00 mm)
No.2	5.55 in. (141,00 mm)
No.3	3.04 in. (77,30 mm)
No.4	4.59 in. (116,50 mm)
