NACELLE - ELECTRICAL POWER -SUPPORT BRACKET, IDG POWER CABLE-REWORK OF - CATEGORY CODE
6. - MOD.NAC-24-0001

V2500-NAC-24-0001

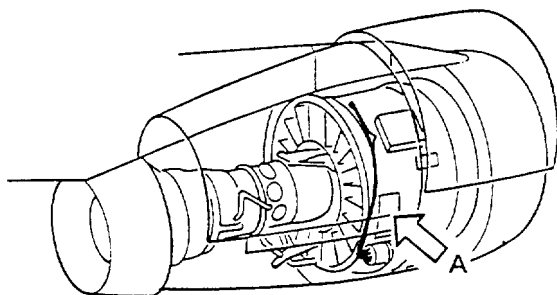
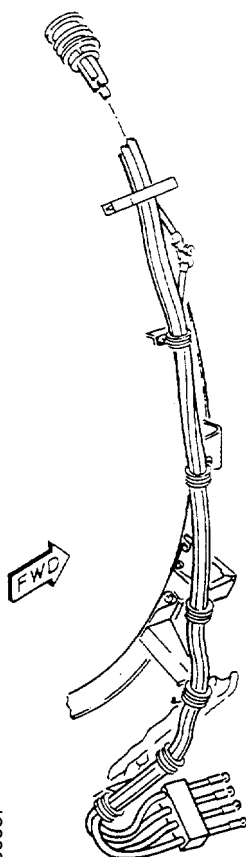
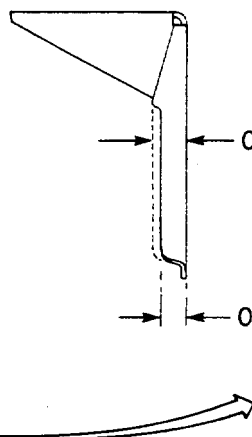
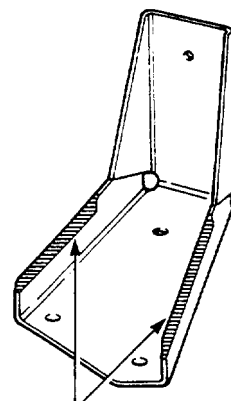
Rework of I.D.G. cable support bracket
Fig.1

The clearance between a support bracket for the IDG powercable and an adjacent tube has been found to be minimal on some units in production.

(a) The existing bracket is modified to the new configuration by trimming two parallel edges (See Figure 1.)

- (1) Cut off 0.1 inch from the two edges of the 740-5465-501 bracket as shown (Refer to Figure 1).
- (2) Use a file and round the sharp edges. Remove any burrs.
- (3) Re identify the bracket to new part number 740-5465-503 with a vibro-etch engraver.

REMOVE HATCHED AREAS

RE-IDENTIFY
BRACKET 740-5465-503
