NACELLE - ELECTRICAL POWER - SUPPORT BRACKET, IDG POWER CABLE - REWORK OF - CATEGORY 6. ACCOMPLISH WHEN THE NACELLE SUBASSEMBLY (I.E. ACCESSORIES, COMPONENTS) IS DISASSEMBLED SUFFICIENTLY TO AFFORD ACCESS TO THE AFFECTED PART AND TO ALL AFFECTED SPARE PARTS. - MOD.NAC-24-0003

V2500-NAC-24-0003

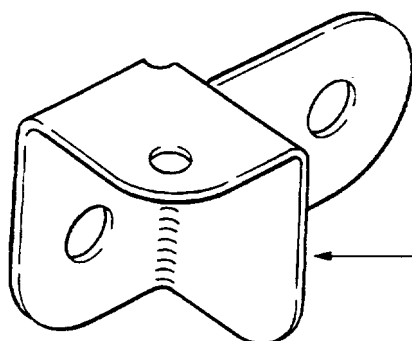
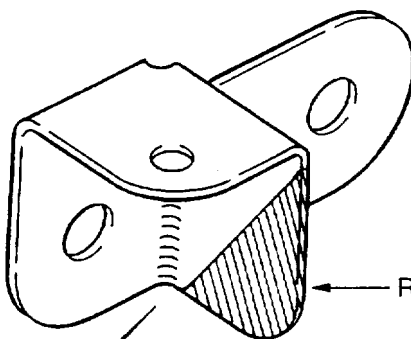
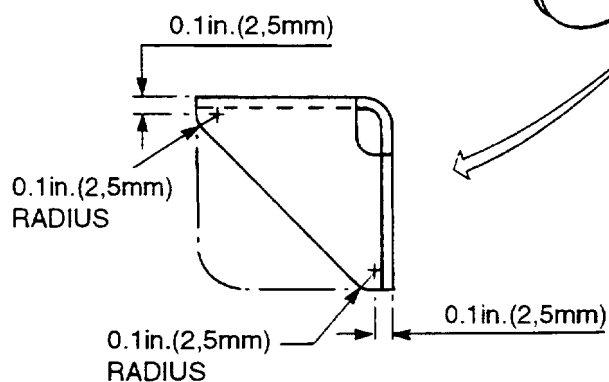
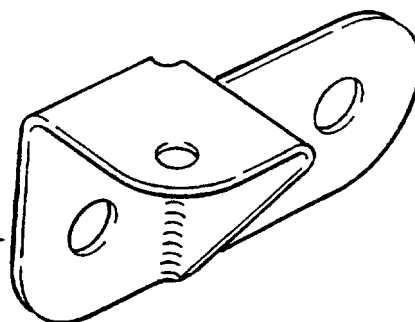
Rework of I.D.G. Cable Support Bracket
Fig.1

Relocation of a fan case bolt caused contact with a support bracket for the IDG power cables.

BRACKET 740-5965-501

REMOVE HATCHED AREA

- (a) The existing bracket is modified to the new configuration by trimming one corner. These rework instructions are provided for spares stock (See Figure 1).

- (1) Cut off a corner piece from the 740-5965-501 bracket shown as a hatched area (Refer to Figure 1).
- (2) Use a file to shape the radii 0.1 inch (2.5 mm). Remove any burrs.
- (3) Reidentify the bracket to new part number 740-5965-503 with a vibro-etch engraver. Refer to the IAE/V2500 Standard Practices/ Processes Manual, Chapter 70-09-00.

REWORK DETAILS

RE-IDENTIFY BRACKET
740-5965-503
