**International
Aero Engines**

SERVICE BULLETIN

**NACELLE - ELECTRICAL POWER - COVER ASSEMBLY, VSCF POWER FEEDER HARNESS
-REPLACEMENT OF**

V2500-NAC-24-0008

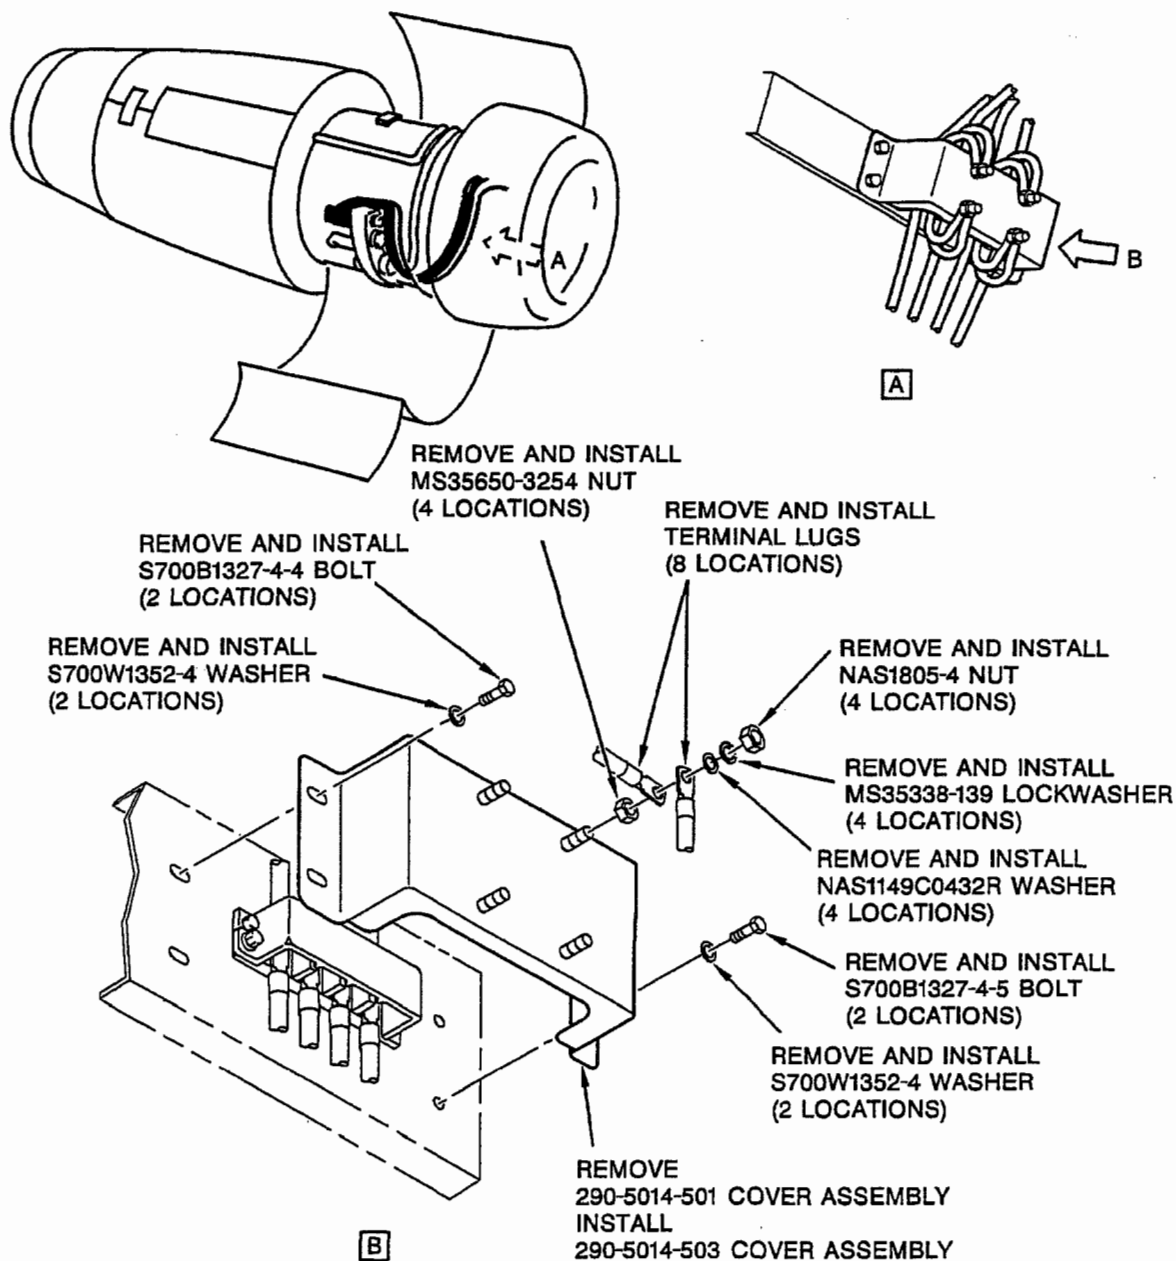
VSCF POWER FEEDER HARNESS COVER REPLACEMENT
FIGURE 1

Insufficient clearance between cover assembly and hydraulic hoses.

Potential interference discovered during installation of hydraulic hoses to pylon interface.

- (1) Remove and retain four NAS1805-4 nuts, four MS35338-139 spring washers, and four NAS1149C0432R washers which attach VSCF power feeder cable terminal lugs to cover assembly. Refer to Figure 1.
- (2) Remove eight VSCF power feeder cable ground pigtails.
- (3) Remove and retain four MS35650-3254 nuts from 290-5014-501 cover assembly.
- (4) Remove and retain two S700B1327-4-5 bolts, two S700B1327-4-4 bolts and four S700W1352-4 washers that attach the 290-5014-501 cover assembly. Remove and discard the 290-5014-501 cover assembly.
- (5) Install the 290-5014-503 cover assembly with four S700W1352-4 washers, two S700B1327-4-4 bolts and two S700B1327-4-5 bolts.
- (6) Install four MS35650-3254 nuts on 290-5014-503 cover assembly.
- (7) Install eight VSCF power feeder cable terminal lugs with four NAS1149C032R washers, four MS35338-139 spring washers, and four NAS1805-4 nuts.
