V2500 Propulsion System — Nacelle

SERVICE BULLETIN

NACELLE — ELECTRICAL POWER — POWER FEEDER HARNESS, VARIABLE SPEED
CONSTANT FREQUENCY (VSCF) GENERATOR — GROUND TERMINAL ATTACH BOLT,
AND POWER FEEDER HARNESS SUPPORT CLAMPS — REPLACEMENT OF

V2500-NAC-24-0010
Page 1 of 12

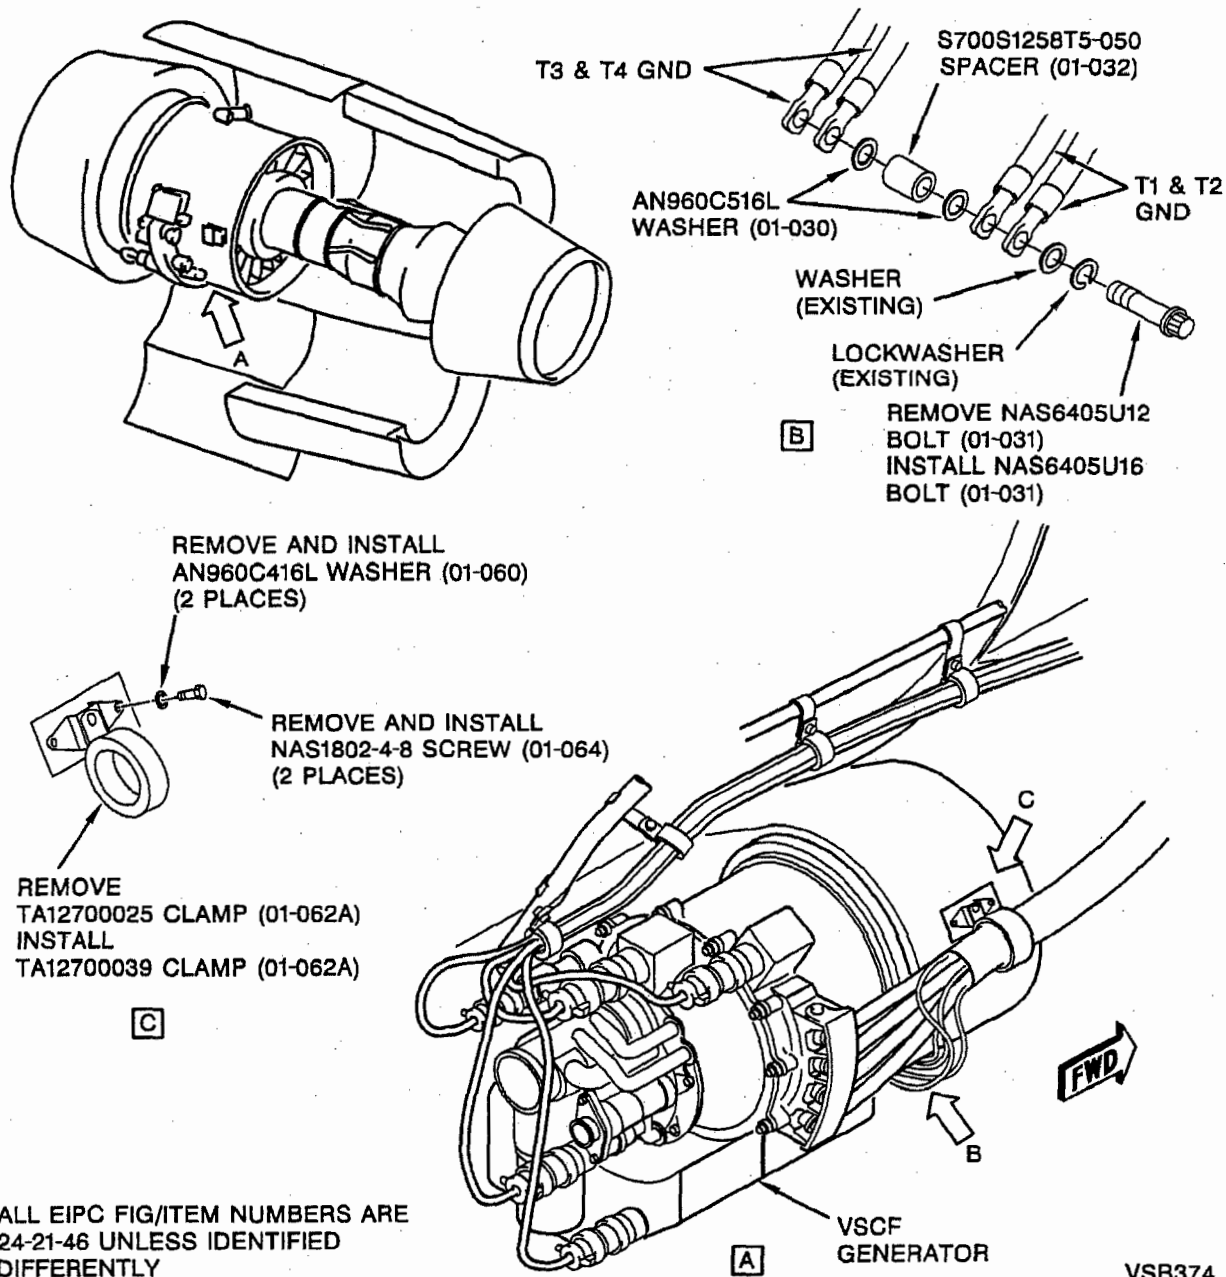
POWER FEEDER GROUND TERMINAL BOLT AND CLAMP REPLACEMENT - LH ENGINE
FIGURE 1.

The addition of the overbraid to the VSCF feeder cable introduced in Service Bulletin V2500-NAC-24-0006 increased the diameter of the harness requiring larger clamps. Continued use of the existing clamps may cause wear to the harness.

The depth of thread for the bolt introduced in Service Bulletin V2500-NAC-24-0006 used to attach the VSCF power feeder cable ground terminals to the VSCF generator was incorrectly calculated, which may make the bolt difficult to install.

- (1) Install the left hand engine NAS6405U16 VSCF power feeder ground terminal bolt.
 - (a) Install the NAS6405U16 bolt (24-21-46, 01-031), four VSCF ground terminals, S700S1258T5-050 spacer (24-21-46, 01-032), two AN960C516L washers (24-21-46, 01-030), and existing plain washer and lock washers on the VSCF generator. Refer to Figure 1.

- (2) Repeat step (1) above for the right hand engine. Refer to Figure 2.
- (3) Install the left hand engine TA12700039 power feeder support clamp.
 - (a) Attach the TA12700039 clamp (24-21-46, 01-062A) to the engine with two NAS1802-4-8 screws (24-21-46, 01-064) and AN960C416L washers (24-21-46, 01-060). Refer to Figure 1.
