**V2500-A1/A5 NACELLE SERVICE BULLETIN**

This document transmits the Initial Issue of Service Bulletin NV2500-24-0014

**V2500-NAC-24-0014**  
Transmittal - Page 1 of 2

NACELLE – POWERPLANT – IDG COOLING TUBES – 'O' RING SEALS – REPLACEMENT OF

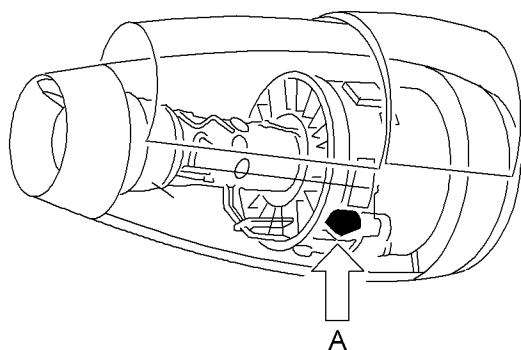
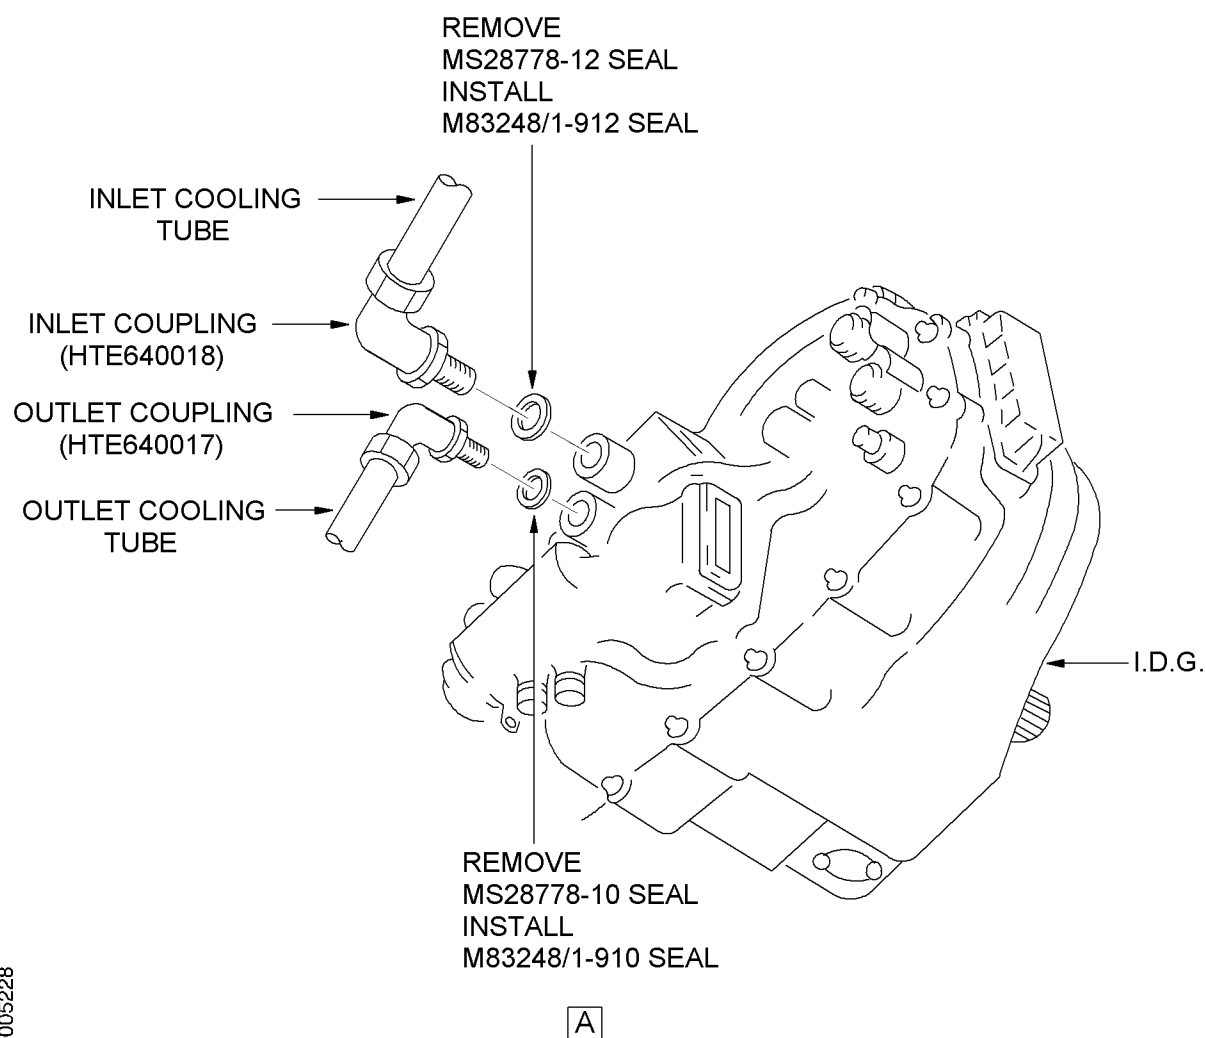
Replacement of IDG Cooling Tube Seals - L/H and R/H  
Figure 1

The packing seals installed at the IDG inlet and outlet cooling tubes may experience compression set and become brittle and so reduce the effectiveness of the seals.

The packing seals installed at the IDG inlet and outlet ports were found to be of an inadequate specification for the operating temperature range of the IDG.

- (1) Cut and remove the lockwire from the IDG 640018 inlet and the HTE 640017 outlet couplings on the IDG. Refer to Figure 1.
- (2) Remove and retain the circlips and disconnect the inlet and outlet couplings from the IDG.
- (3) Remove and discard the MS28778-10 and MS28778-12 packing seals.

- (4) Lubricate the new M83248/1-912 packing seal with clean system oil (CoMat 10-077) and install to the HTE 640018 inlet coupling. Connect the HTE 640018 inlet coupling.
- (5) Torque the HTE 640018 inlet coupling to 550-600 LBFIN (62-68 NM) and install the circlip removed in step 2.B.(2). Refer to the Standard Practices/Processes Manual, Task 70-41-02-410-501.
- (6) Lubricate the new M83248/1-910 packing seal with clean system oil (CoMat 10-077) and install to the HTE 640017 outlet coupling. Connect the HTE 640017 outlet coupling.
- (7) Torque the HTE640017 outlet coupling to 380-405 LBFIN (43-48 NM) and install the circlip removed in step 2.B.(2). Refer to the Standard Practices/Processes Manual, Task 70-41-02-410-501.
- (8) Safety the inlet and outlet couplings with lockwire (CoMat 02-138).
