V2500 Propulsion System - Nacelle **SERVICE BULLETIN**

Subject: Transmittal of Revision 2 to Service Bulletin Number V2500-NAC-24-0016

NACELLE – ELECTRICAL POWER – CONTROL HARNESS, VARIABLE SPEED CONSTANT
FREQUENCY (VSCF) GENERATOR – CLIPPING POINT BRACKET – RH NACELLE -
MODIFICATION OF

V2500-NAC-24-0016

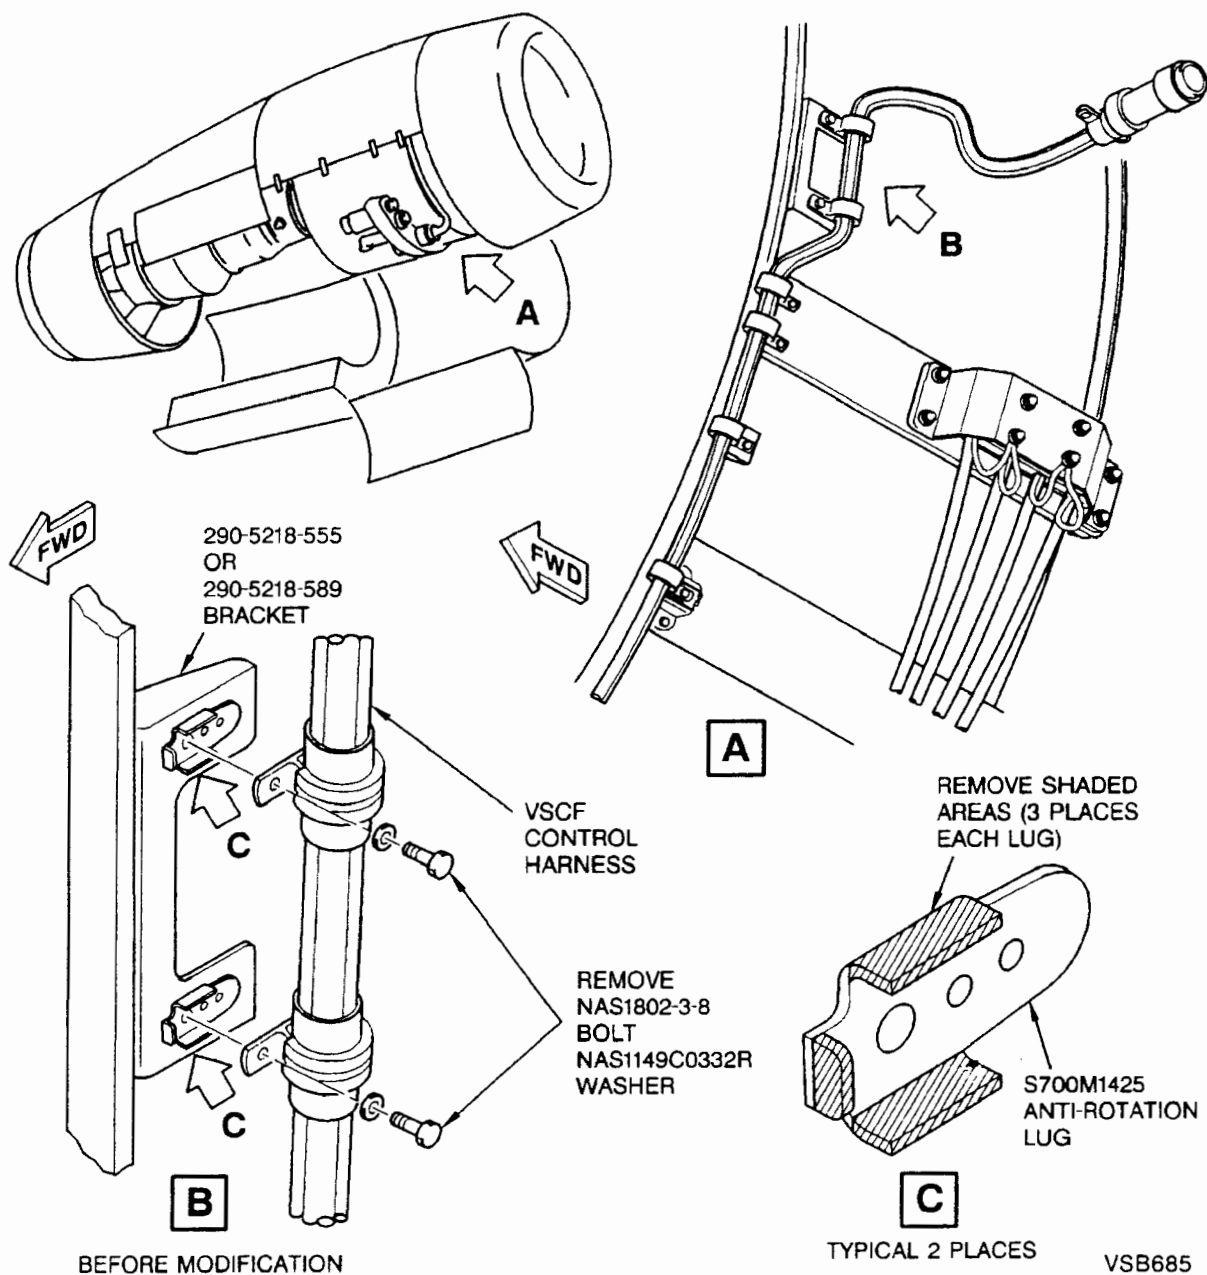
Clipping Point Modification – RH Nacelle Only
Figure 1 (sheet 1)

Interference between a VSCF control harness clipping point and the pylon-mounted hydraulic disconnect panel has been detected in the RH nacelle.

- A. On the RH nacelle, open the lower fan cowl. Refer to the MD90 Aircraft Maintenance Manual, Chapter 71-13-00.
- B. Remove the clamps from the 290-5218-555 or 290-5218-589 bracket assembly. Keep the attaching hardware for later use. Refer to Figure 1.

- C. Remove material from the S700M1425 anti-rotation lugs. Refer to Figure 1.
- D. Reidentify the modified 290-5218-555 bracket assembly as the 290-5220-1J. Reidentify the modified 290-5218-589 bracket assembly as the 290-5220-3J. Use rubber stamp and ink (CoMat 06-073). Refer to the IAE Standard Practices/Processes Manual, Chapter 70-09-00.

- E. Install the 290-5218-599 bracket and clamp on the 290-5220-1J or 290-5220-3J bracket assembly. Refer to Figure 1.
- F. Install the clamp on the 290-5218-599 bracket. Refer to Figure 1.

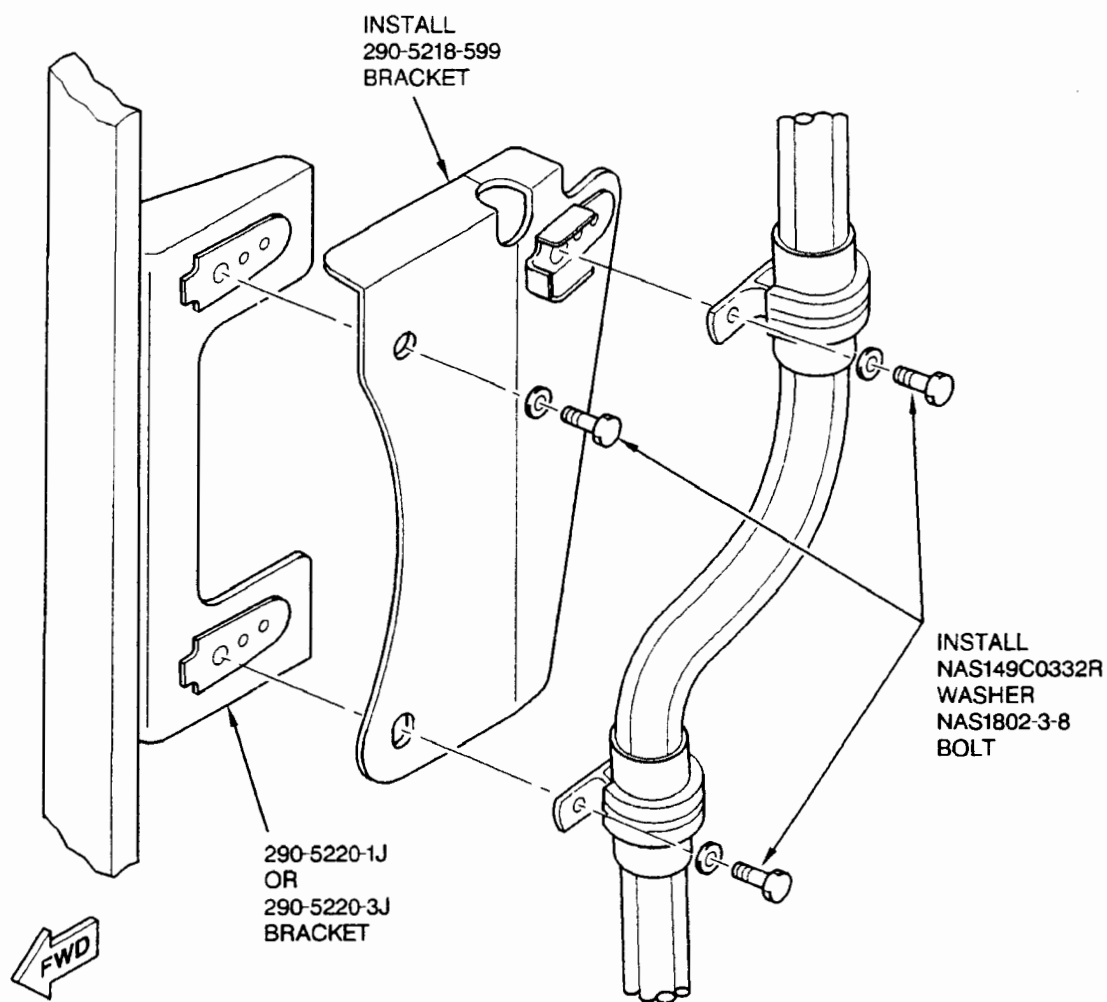
Clipping Point Modification – RH Nacelle Only
Figure 1 (sheet 2)

AFTER MODIFICATION
