## V2500-A1/A5 SERIES PROPULSION SYSTEMS SERVICE BULLETIN

This document transmits Revision 2 to Service Bulletin V2500-ENG-24-0020 and Revision 2 to the Supplement

**V2500-NAC-24-0020**  
Transmittal - Page 1 of 1

NACELLE – POWERPLANT – ENGINE BUILT UNIT (EBU) – REPLACEMENT OF THE IDG EARTH STUD  
BRACKET

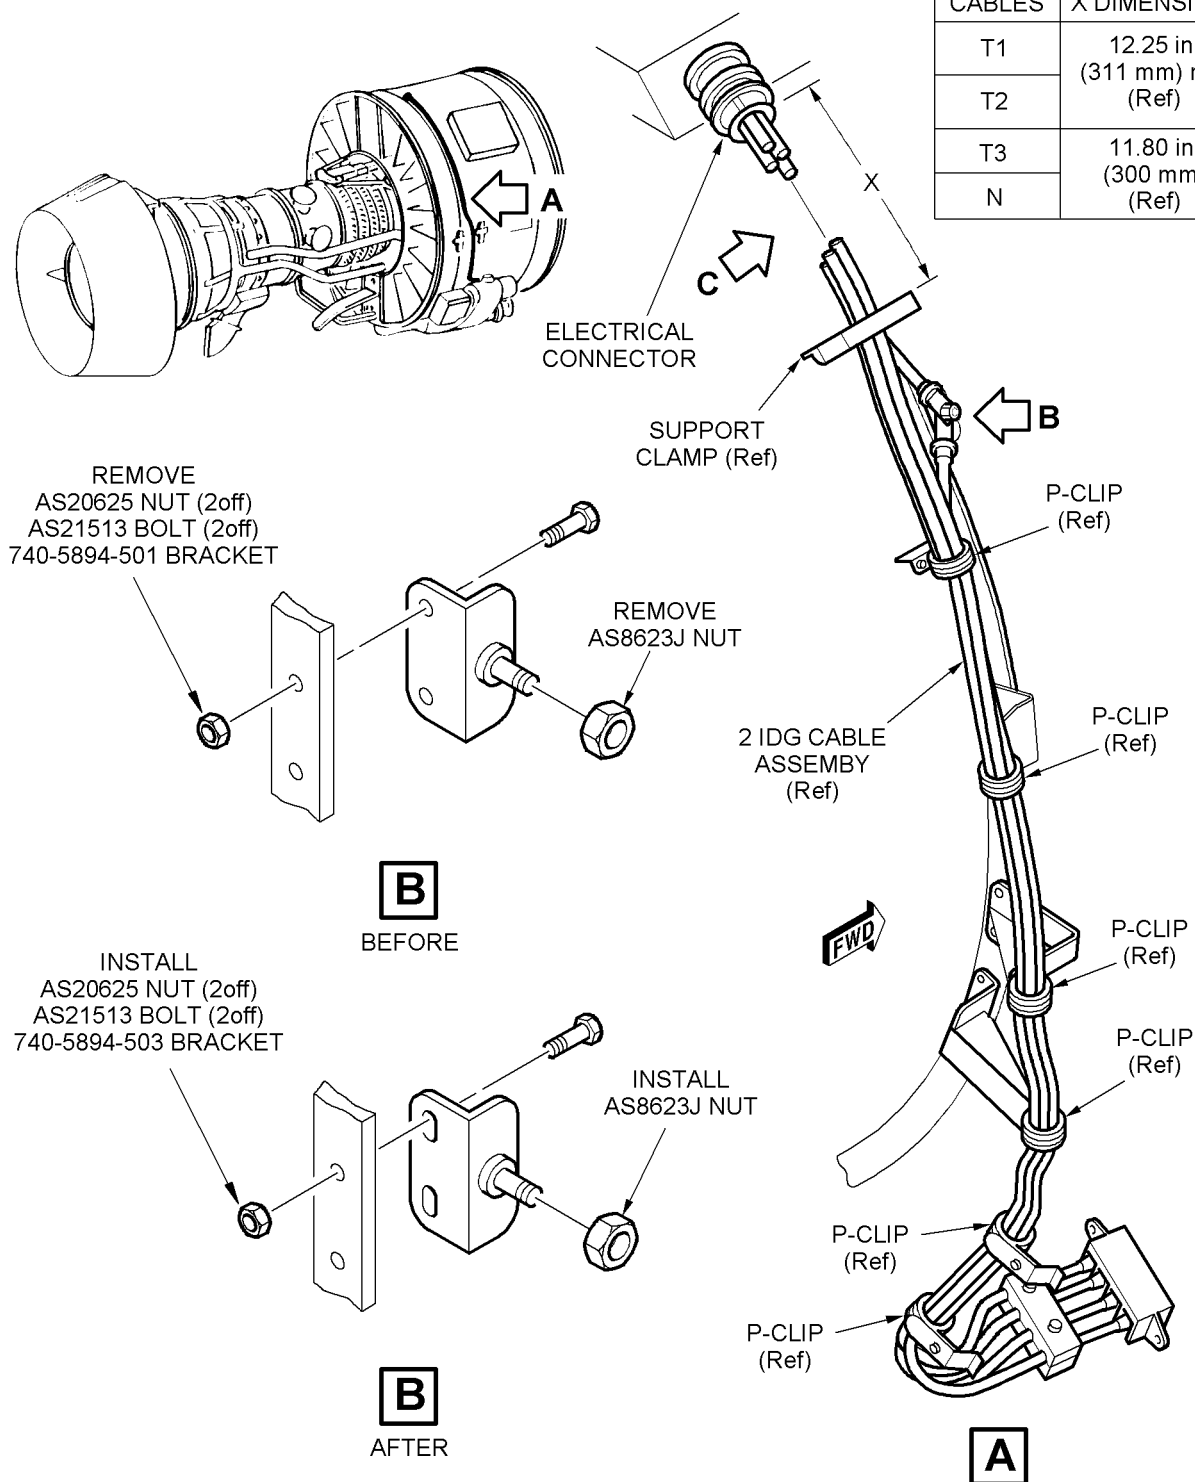
Replacement of the IDG Earth Stud Bracket  
Figure 1 sheet 1

The rigidity of the IDG Harness can prevent adjustment of length between the Pylon Connector and the IDG Earth Stud Bracket. Consequently, the Harness may not be installed at the optimum routing when entering the Pylon Connector which could lead to stress on the Contacts.

- (1) Loosen the two bolts that attach the Support Clamp to the Engine to allow adjustment of the IDG Harness. Refer to Figure 1 sheet 1.
- (2) At six locations, loosen the bolt that attaches the p-clip to the Engine to allow adjustment of the IDG Harness.
- (3) Confirm that the IDG Electrical Connector is correctly installed to the Pylon Receptacle.

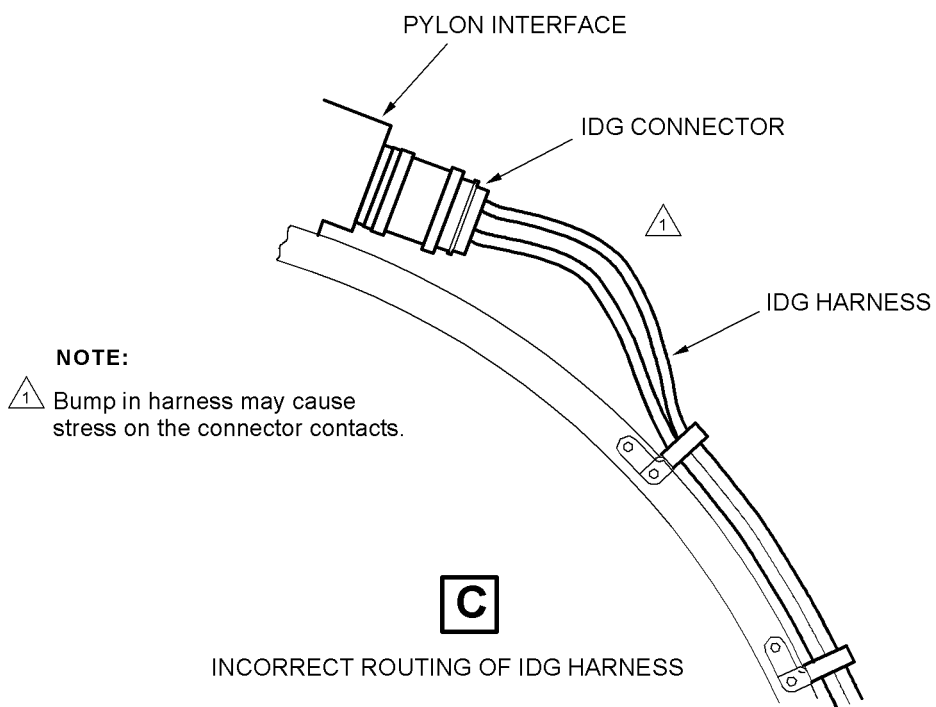
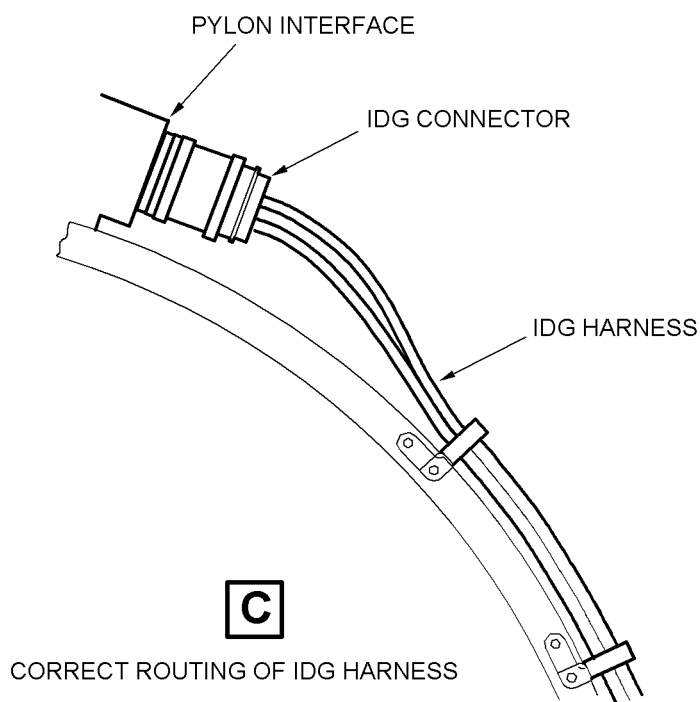
Replacement of the IDG Earth Stud Bracket  
 Figure 1 sheet 2

- (11) Confirm that there are no excessive bends in the harness routing between the Pylon interface and the new Bracket. Refer to Figure 1 sheet 2.

NOTE: To remove excessive bends, adjust the IDG Harness routing and bracket position.
