V2500-A1 SERIES NACELLE SERVICE BULLETIN

V2500-NAC-26-0002

NACELLE – POWERPLANT – FIRE PROTECTION – OVERHEAT DETECTOR – REPLACEMENT OF1. Planning InformationA. Effectivity

TITLE: MODIFICATION OF NACELLE TEMPERATURE SENSOR

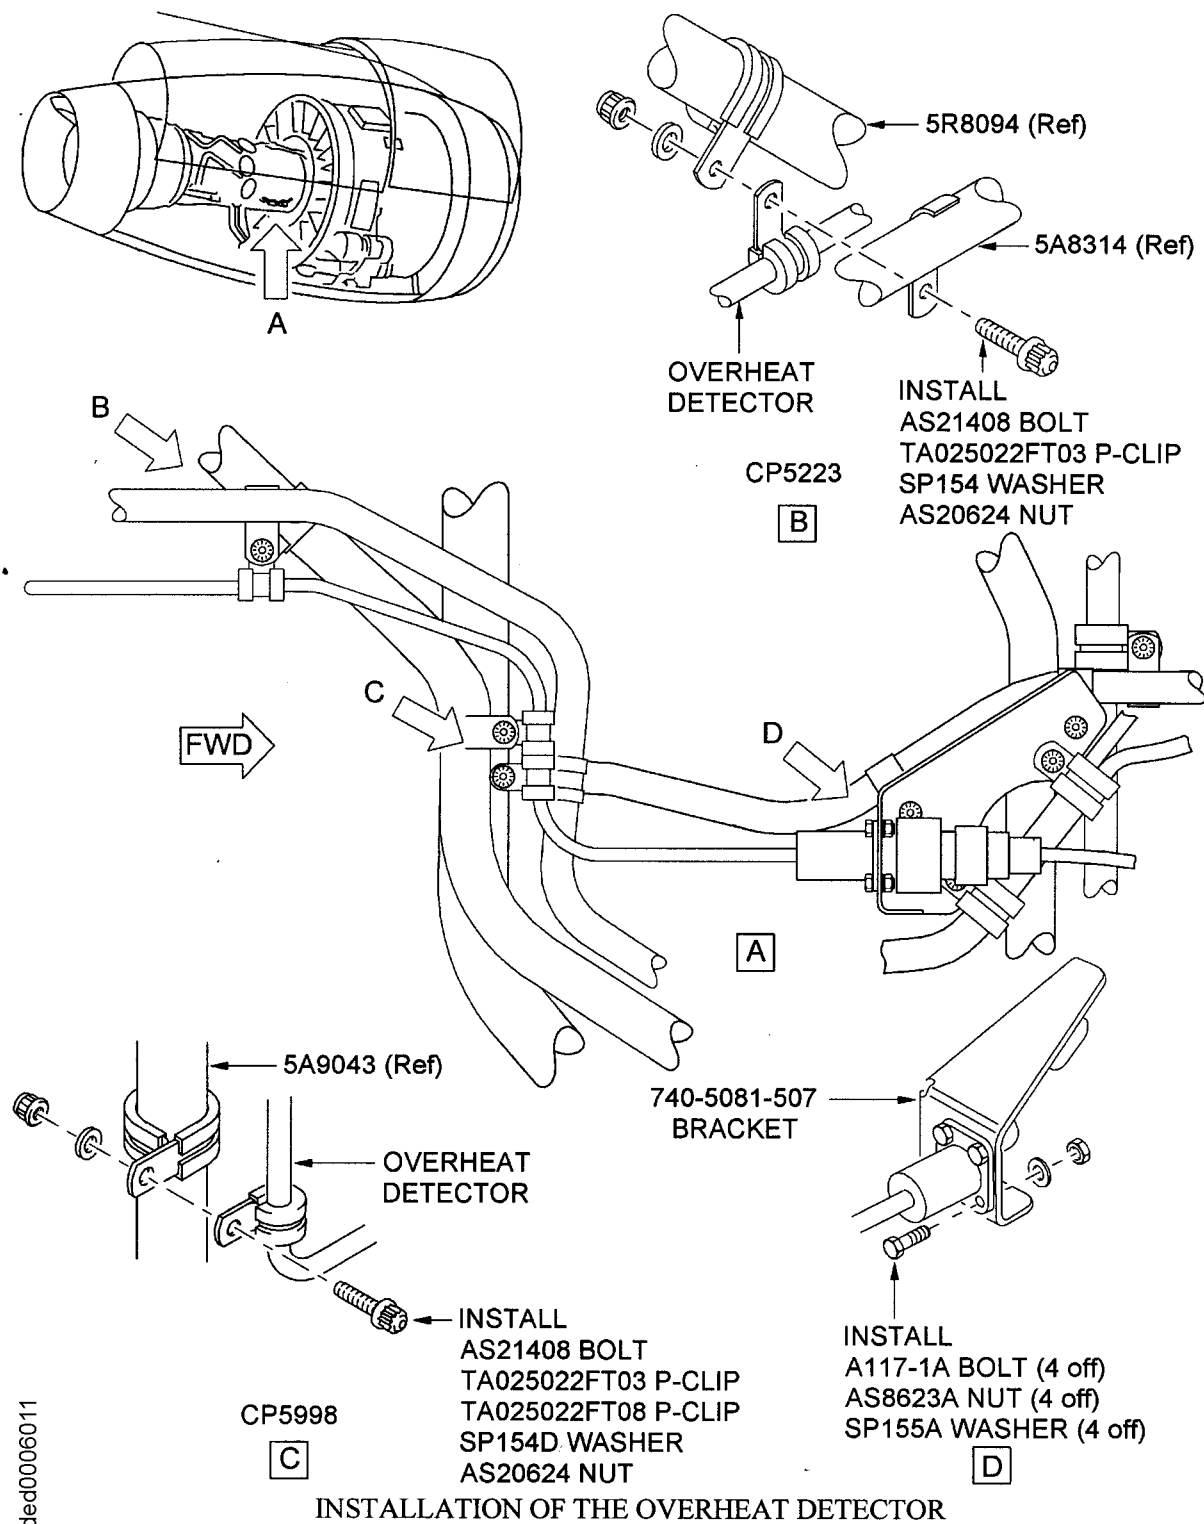
Installation of the Overheat Detector
Figure 1

The Overheat Detector may encroach the minimum clearance requirements between itself and adjacent structure/tubes.

(a) Clipping point CP5998 replaces clipping point CP5221 to accommodate the new Overheat Detector. The remaining clipping point (CP5223) is unaffected. Refer to Figure 1.

- (1) Install the RP162-02 Overheat Detector to the 740-5081-507 Bracket with the four A117-1A Bolts, four AS8623A Nuts, and four SP155-A Washers. Hand tighten the Nuts. Refer to Figure 1.
- (2) Safety the Overheat Detector to the 5A9043 Tube (clipping point CP5998) with the TA025022FT03 Clamp, TA025022FT08 Clamp, AS21408 Bolt, SP154D Washer, and AS20624 Nut. Hand tighten the Nuts.
- (3) Safety the Overheat Detector at clipping point CP5223 as shown, with the TA025022FT03 Clamp, AS21408 Bolt, SP154D Washer, and AS20624 Nut. Hand tighten the Nut.
- (4) Make sure there is a minimum clearance of 0.25in (6,3 mm.) between the Overheat Detector and adjacent structure/tubes.
- (5) Torque the Nuts in step (1) to 20 to 25 lbf in (2 to 3 Nm).
- (6) Torque the Nuts in steps (2) and (3) to 40 lbf in (4,5 Nm).

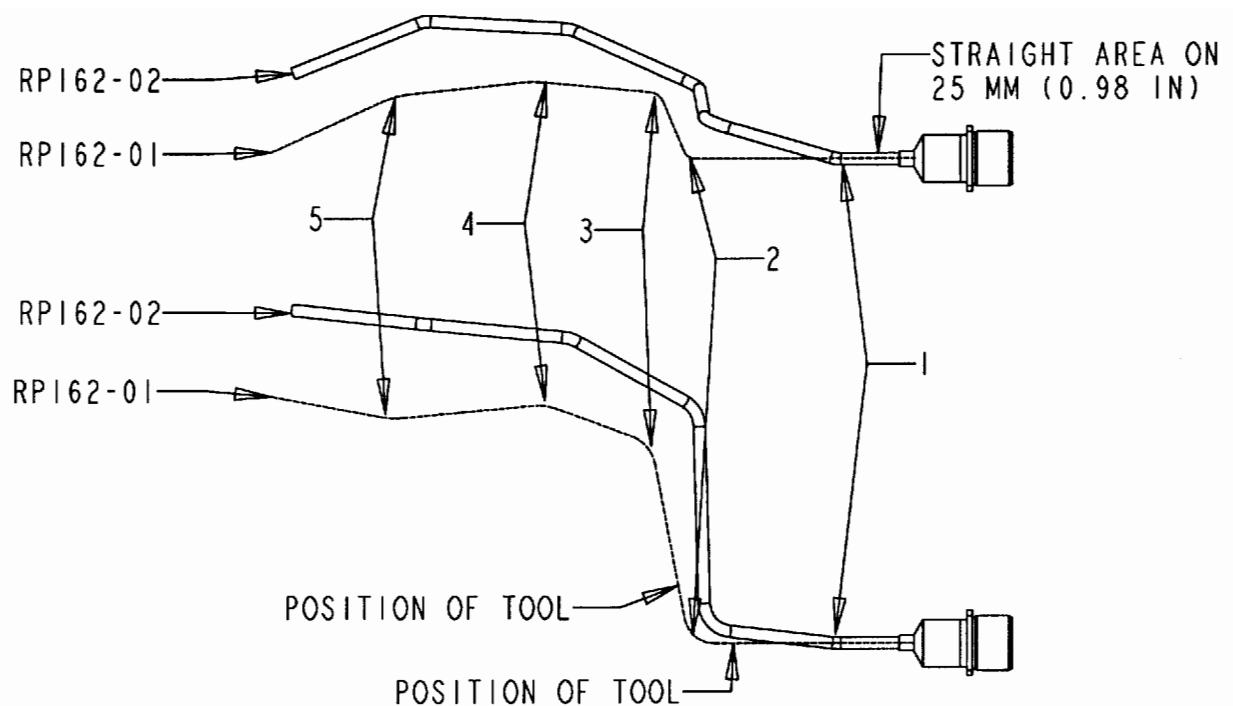
Figure 2

The temperature sensor is modified to the new configuration using a locally manufactured tool (see figure 2).

CAUTION: NEVER BENT THE RIGID METAL SHEATH IN THE STRAIGHT AREA 25 MM (0.98 IN). SEE FIGURE 2.

1. Insert the two shaping tools on both sides of each bending radius to the different areas to be modified (Note positions of tools for area 2 on figure 2) curve lightly the rigid metal sheath and obtain dimensions defined figure 3.
2. Proceed step by step from area 1 to 5.
