SERVICE BULLETIN

NACELLE - POWERPLANT - FIRE PROTECTION - CORE ZONE FIRE DETECTOR - CLIPPING POINT - DELETION OF - CATEGORY 4. ACCOMPLISH AT THE FIRST VISIT OF THE NACELLE OR NACELLE COMPONENT TO A MAINTENANCE BASE CAPABLE OF COMPLIANCE WITH THE ACCOMPLISHMENT INSTRUCTIONS REGARDLESS OF THE PLANNED MAINTENANCE ACTION FOR THE NACELLE OR NACELLE COMPONENT. - MOD.NAC-26-0004

V2500-NAC-26-0004

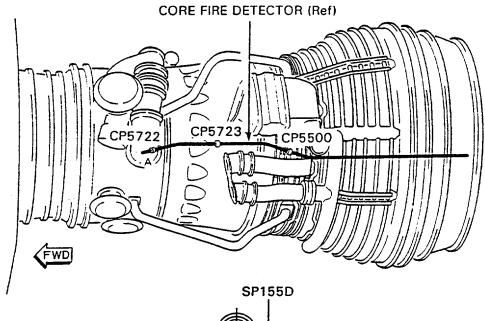
Clipping Point 5723 After Alteration Fig.6

Service Bulletin V2500-ENG-75-0049 should have deleted clipping point CP5723 from ATA chapter 26-12-17 and transferred those parts to ATA chapter 75-32-49. Clipping point CP5723 was modified however and introduced revised hardware. Consequently, this Service Bulletin deletes clipping point CP5723 from ATA chapter 26-12-17.

VIEW LOOKING REARWARD CLIPPING POINT 5723 (EBU) BEFORE ALTERATION

VIEW LOOKING REARWARD
AFTER ALTERATION
FOR REFERENCE ONLY

- A. Pre-Requisite Instructions
 - (1) Open the thrust reverser halves with procedures in the A320 Aircraft Maintenance Manual, Task 78-32-00-010-010.
- B. Rework or Modification Instructions
 - (1) Remove an AS21420 bolt, SP155D washer, ST1698D50 spacer and an AS20624 nut from clipping point CP5723 (Refer to Figure 1.)
