International
Aero Engines

V2500 Propulsion System — Nacelle

**NACELLE - FIRE PROTECTION - HARNESS ASSEMBLY, OVERHEAT SENSOR -
REPLACEMENT OF**

V2500-NAC-26-0009
Page 1 of 9

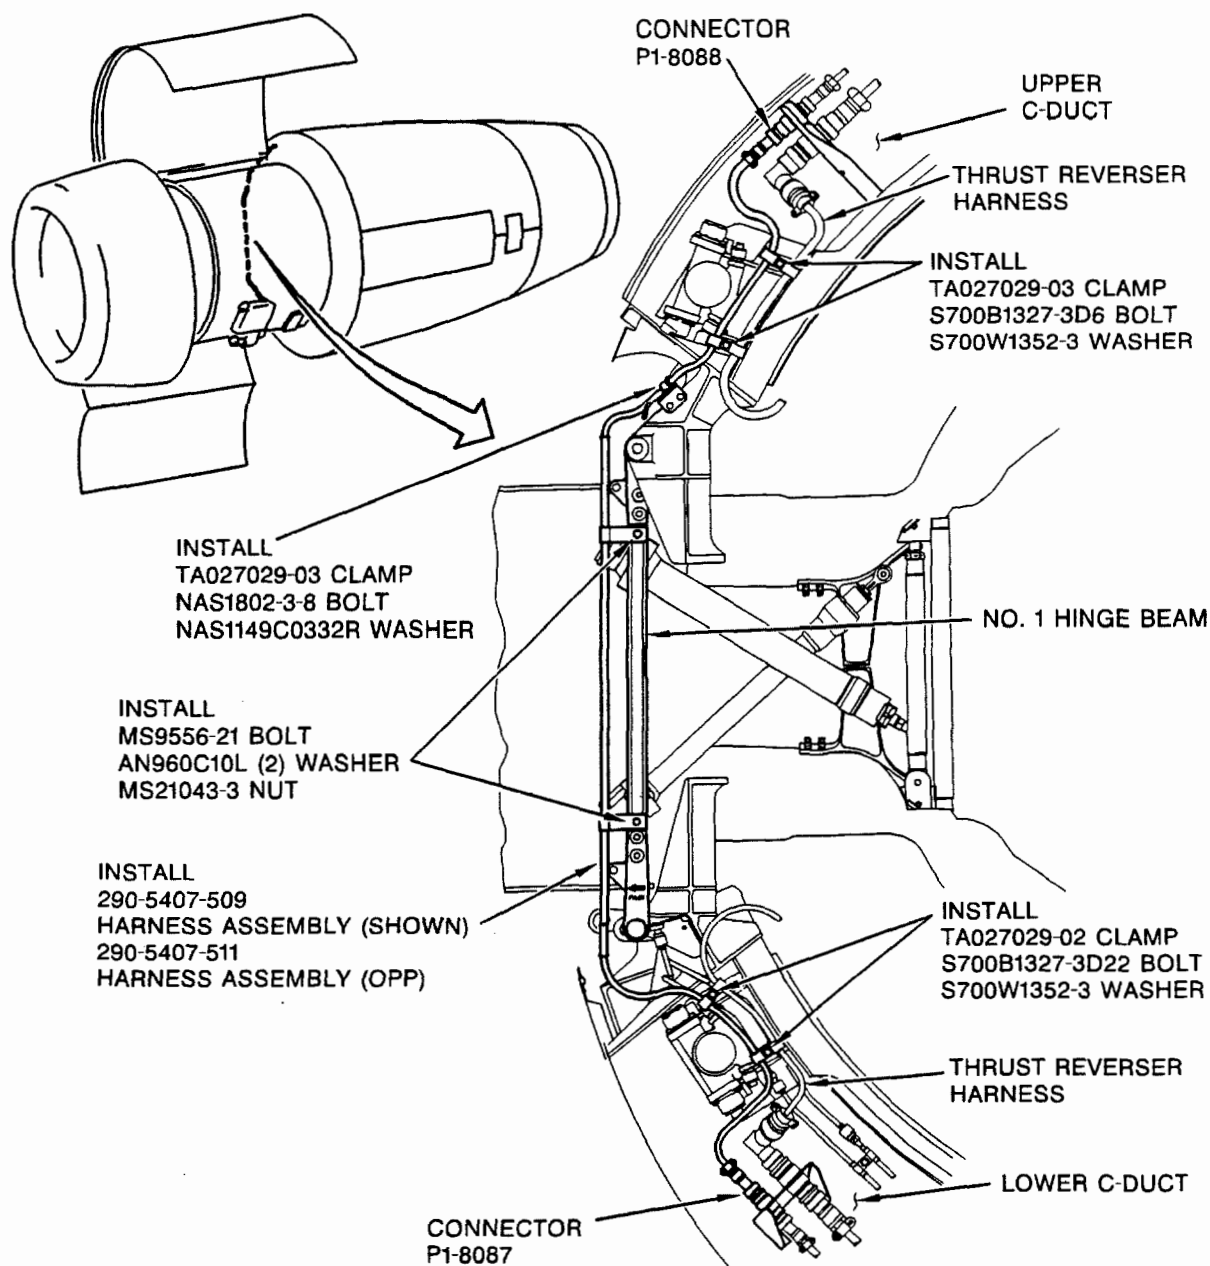
OVERHEAT SENSOR HARNESS ASSEMBLY INSTALLATION.
FIGURE 1.

Existing routing of harness assemblies may limit access to ground support equipment attach point on hinge beam.

- R (1) Attach 290W5407-509 overheat sensor harness assembly to #1
hinge beam with two MS9556-21 bolts, four AN960C10L
washers, and two MS21043-3 nuts. Refer to Figure 1.

- (2) Attach overheat sensor harness assembly to upper C-duct
with TA027029-03 clamp, NAS1802-3-8 bolt, and
NAS1149C0332R washer.
- (3) Attach overheat sensor harness assembly and existing
thrust reverser harness to upper C-duct with two TA027029-
03 clamps, two S700B1327-3D6 bolts, and two S700W1352-3
washers.

- (4) Connect overheat sensor harness connector P1-8088 to upper
C-duct connector.
- (5) Attach overheat sensor harness assembly and existing
thrust reverser harness to lower C-duct with two TA027029-
02 clamps, two S700B1327-3D22 bolts, and two S700W1352-3
washers.

- (6) Connect overheat sensor harness connector P1-8087 to lower
C-duct connector.
- R (7) Repeat steps in paragraph (1) through (6) for 290W5407-511
right hand overheat sensor harness assembly.
