**International
Aero Engines**

V2500 Propulsion System — Nacelle

NACELLE - EXHAUST - SUPPORT BRACKETS, OVERHEAT DETECTOR, THRUST REVERSER
MODIFICATION OF

V2500-NAC-26-0011

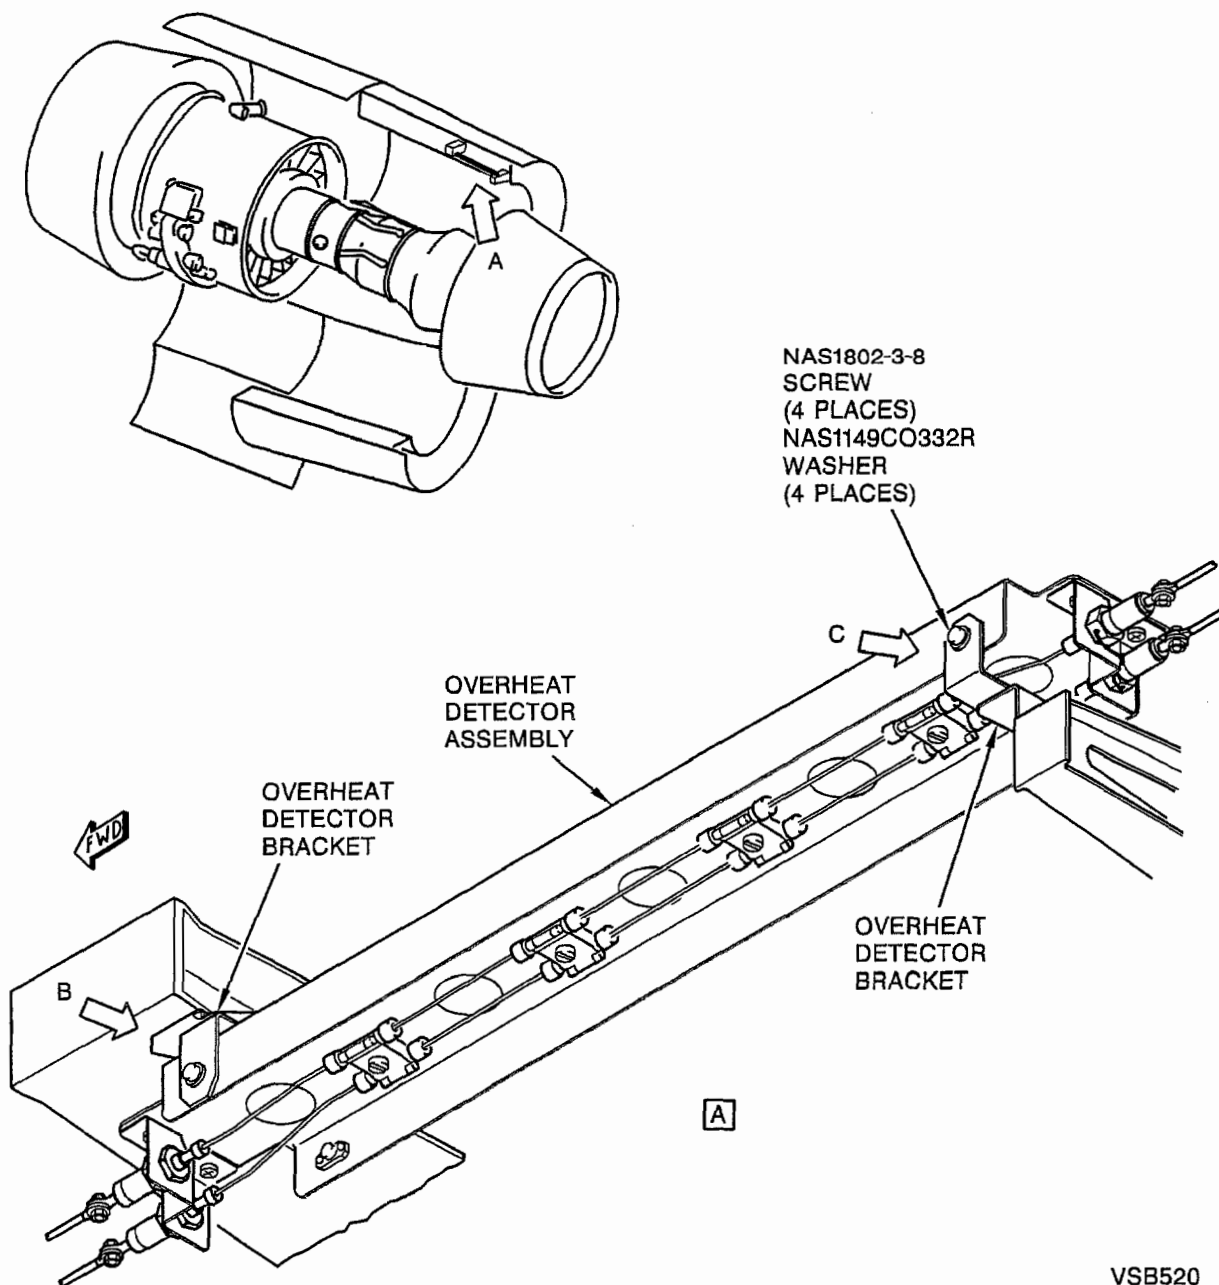
Overheat Detector Support Bracket Modification
Figure 1 (Sheet 1)

The fasteners which attach the thrust reverser outboard bifurcation overheat detector sensor support brackets to the thrust reverser have failed in service.

- (1) Remove the four NAS1802-3-8 screws, NAS1149C0332R washers and the overheat detector assembly from the support brackets. Refer to Figure 1 (Sheet 1).

- (1) Remove the rivets and the 290-5265-501 bracket assembly from the latch housing. Refer to Figure 1 (Sheet 1).
- (2) Remove the rivets and separate the 290-5265-3 bracket from the 290-5265-5 bracket. Discard the 290-5265-5 bracket. Keep the 290-5265-3 bracket. Refer to Figure 1, Detail B.

- R (1) Install the overheat detector assembly on the support brackets with the NAS1149C0332R washers and NAS1802-3-8 screws. Torque the screws to 20-25 inlbs (2.26-2.82 N.m). Refer to Figure 1 (Sheet 1).

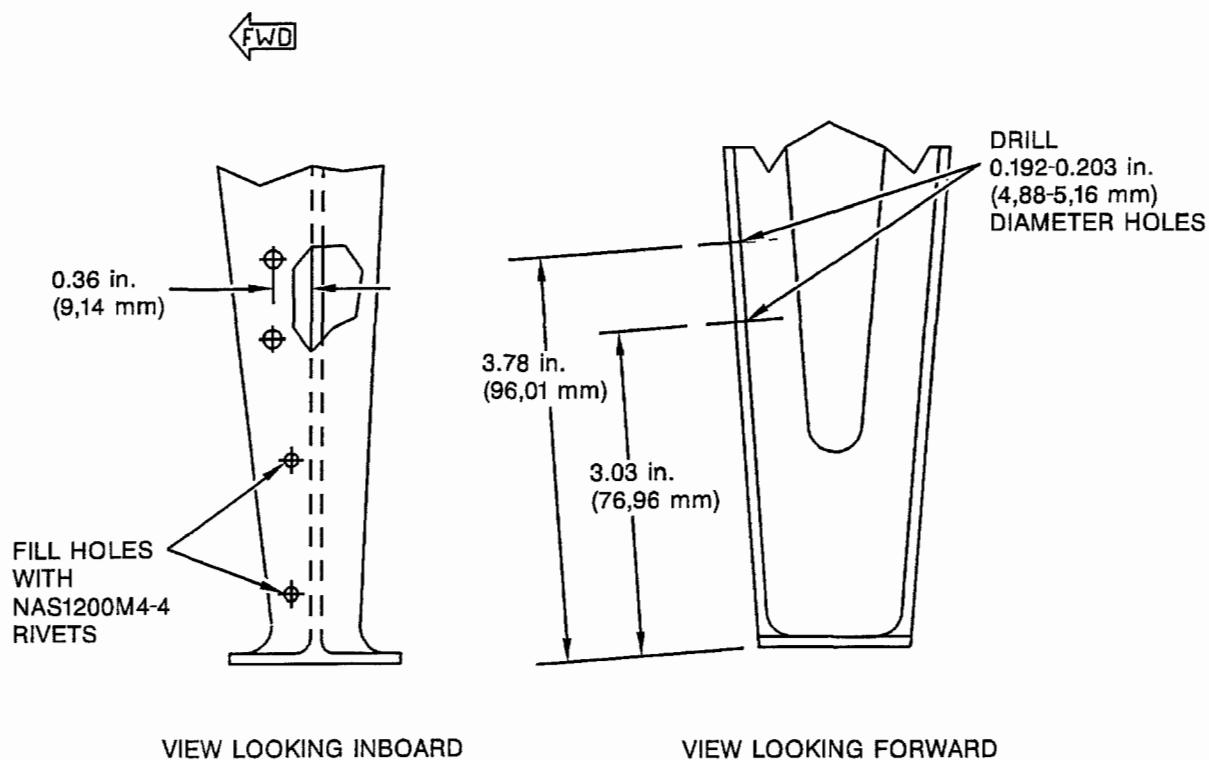
Overheat Detector Support Bracket Modification
Figure 1 (Sheet 4)

(1) To correct inch-to-millimeter conversion in Figure 1 (sheet 4).
