V2500 Propulsion System — Nacelle

SERVICE BULLETIN

NACELLE - EXHAUST - BRACKET, INBOARD BIFURCATION OVERHEAT DETECTOR -
MODIFICATION OF

V2500-NAC-26-0012

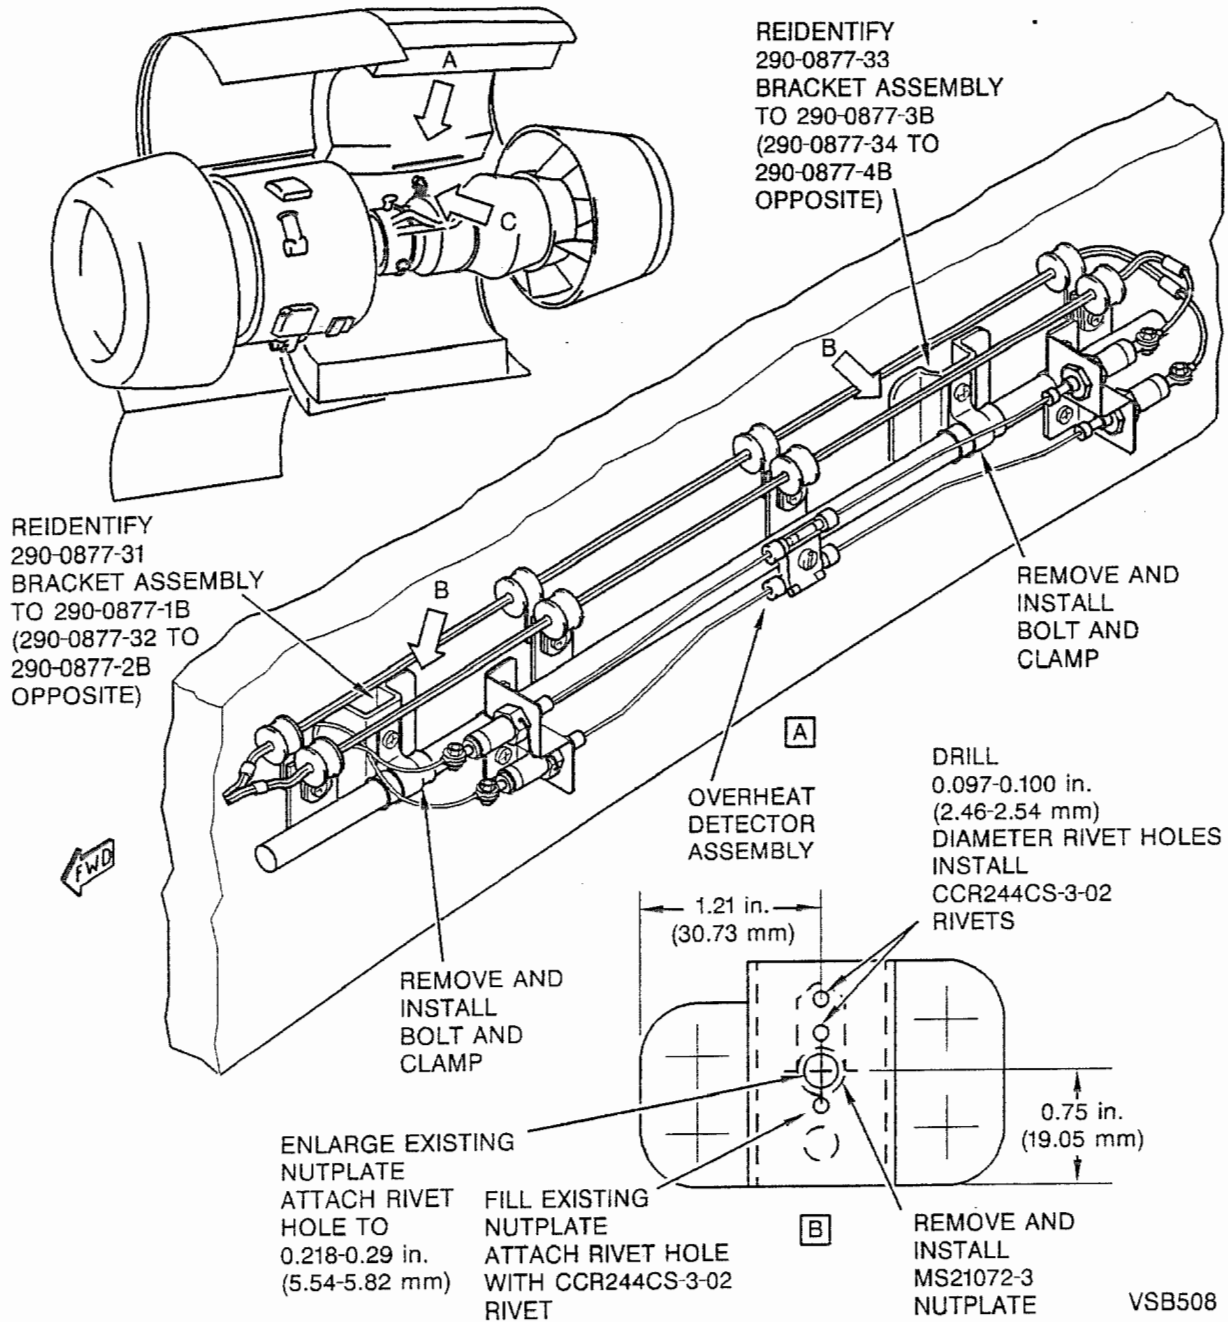
Inboard Overheat Detector Installation Modification
Figure 1

The inboard bifurcation overheat detector may interfere with the fan air elbow duct.

Interference between the inboard bifurcation overheat detector and the fan air elbow duct has been found on several production units.

- (1) Remove the inboard bifurcation overheat detector from the 290-0877-31, 290-0877-32, 290-0877-33 and 290-0877-34 brackets on the upper thrust reverser half. Refer to Figure 1.

- (1) Remove the rivets and nutplates from the 290-0877-31, 290-0877-32, 290-0877-33 and 290-0877-34 brackets. Refer to Figure 1.
- (2) Install a CCR244CS-3-02 rivet to fill one of the nutplate attach rivet holes. Refer to Figure 1.
- (3) Enlarge the other existing nutplate attach rivet hole to 0.218-0.229 inch (5.54-5.82 mm). Refer to Figure 1.
- (4) Drill the holes for the new nutplate attach rivets. Refer to Figure 1.
- (5) Install the MS21072-3 nutplates with the CCR244CS-3-02 rivets. Refer to Figure 1.
- (6) Reidentify the brackets as follows:

290-0877-31 as 290-0877-1B
290-0877-32 as 290-0877-2B
290-0877-33 as 290-0877-3B
290-0877-34 as 290-0877-4B
