NACELLE - POWERPLANT - REPLACEMENT OF FIRE DETECTOR CLAMPS

V2500-A1 V2527-A5 V2530-A5

26-00-00

V2500-NAC-26-0013

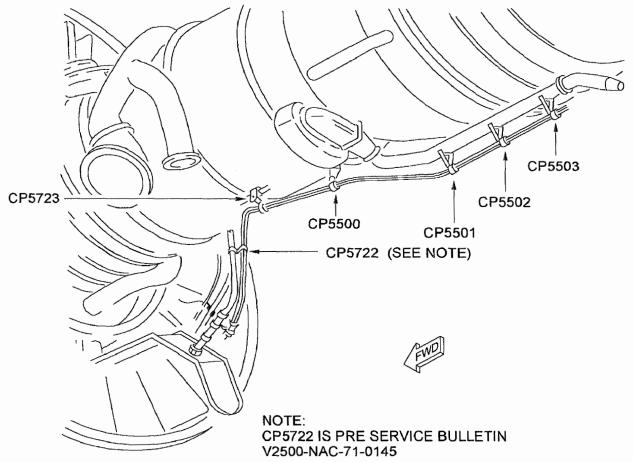
ROUTING OF THE CORE FIRE DETECTOR FIGURE 1, SHEET 1 OF 4

Excessive wear has been found on the insulation on the clamps that support the Core Fire Detector.

There have been several reports from Operators indicating excessive wear of the Core Fire Detector clamps. In some instances the insulation has worn through.

The clamps that support the Core Fire Detector are replaced with new, more durable clamps.
