# IAE Propulsion System NON-MODIFICATION SERVICE BULLETIN

Subject: Transmittal of Revision 1 to Service Bulletin Number V2500-NAC-26-0014

# V2500-NAC-26-0014

**NACELLE - POWERPLANT – FIRE PROTECTION – CORE ZONE FIRE DETECTOR –  
INSPECTION AND REPLACEMENT OF FIRE DETECTOR CLAMPS  
(NON-MODIFICATION SERVICE BULLETIN)**

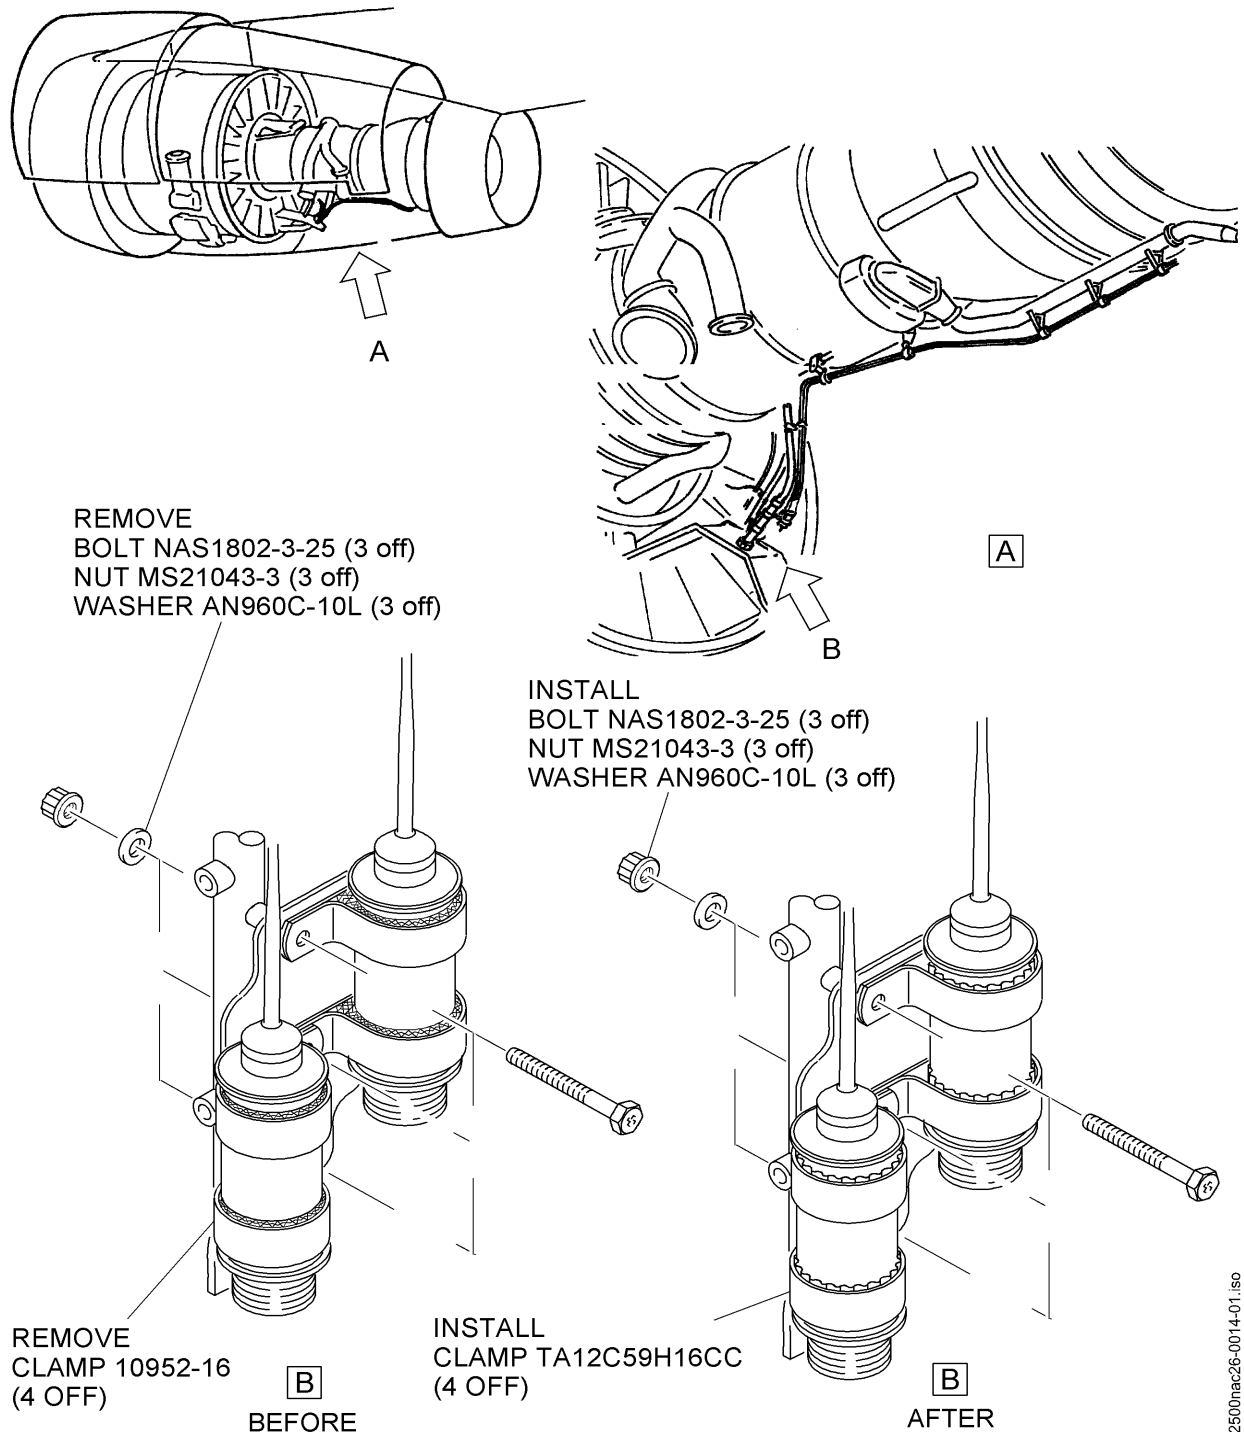
Removal and installation of the responder housing clamps  
Figure 1

A number of unapproved clamps have been installed on the core fire detector assembly. These clamps attach the core fire detector responders to the fire detector rail. It has been discovered that the unapproved clamps, part number 10952-16 may not apply sufficient clamping force to hold the responder housings in place. This could cause the responders to become loose inside the clamps.

- (3) Do a general visual inspection of the core fire detector (4001WD1) 7827-02 and (4001WD2) 7827-02 and the responder housing clamps as follows. Refer to Figure 1.

- (a) Identify the clamps that attach the two 3601-97 responder housings to the 8246 firewire bracket.
  - (b) If the responder housing clamps are identified as ADEL Part Number 10952-16 with a braided wire insert they must be removed and replaced with Part Number TA12C59H16CC clamps as instructed in Part B.

- (c) If the clamps are identified as ADEL Part Number 10952-16 you must also examine the core fire detector for damage (damage will be visibly apparent and the detector sensor tube could be fractured/broken). If the fire detector is damaged then it must be removed and replaced as instructed in the Aircraft Maintenance Manual (M-V2500-1IA) Task 26-12-17-000-010.

- (1) Remove the three NAS1802-3-25 Bolts, MS21043-3 Nuts and AN960C-10L Washers that attach the four 10952-16 Clamps to the responder housings. Remove and discard the four 10952-16 Clamps and the braided wire inserts.
- (2) Install four new TA12C59H16CC Clamps and inserts with the NAS1802-3-25 Bolts, MS21043-3 Nuts and AN960C-10L Washers removed in Step (1).

- (3) Torque the NAS1802-3-25 Bolts to between 20 and 25 pounds inches (2.26-2.83Nm). Make sure the responder housings do not rotate or slide within the clamps.
- (4) Close the thrust reverser halves as instructed in the Aircraft Maintenance Manual (M-V2500-1IA) Task 78-32-00-410-010.
- (5) Close the left and right fan cowls as instructed in the Aircraft Maintenance Manual (M-V2500-1IA) Task 71-13-00-410-010.
