V2500 Propulsion System — Nacelle

SERVICE BULLETIN

S.B. V2500-NAC-29-0001
Revision No 1

NACELLE - HYDRAULIC POWER - HYDRAULIC HOSE
TO LOW PRESSURE SWITCH - REPLACEMENT OF.

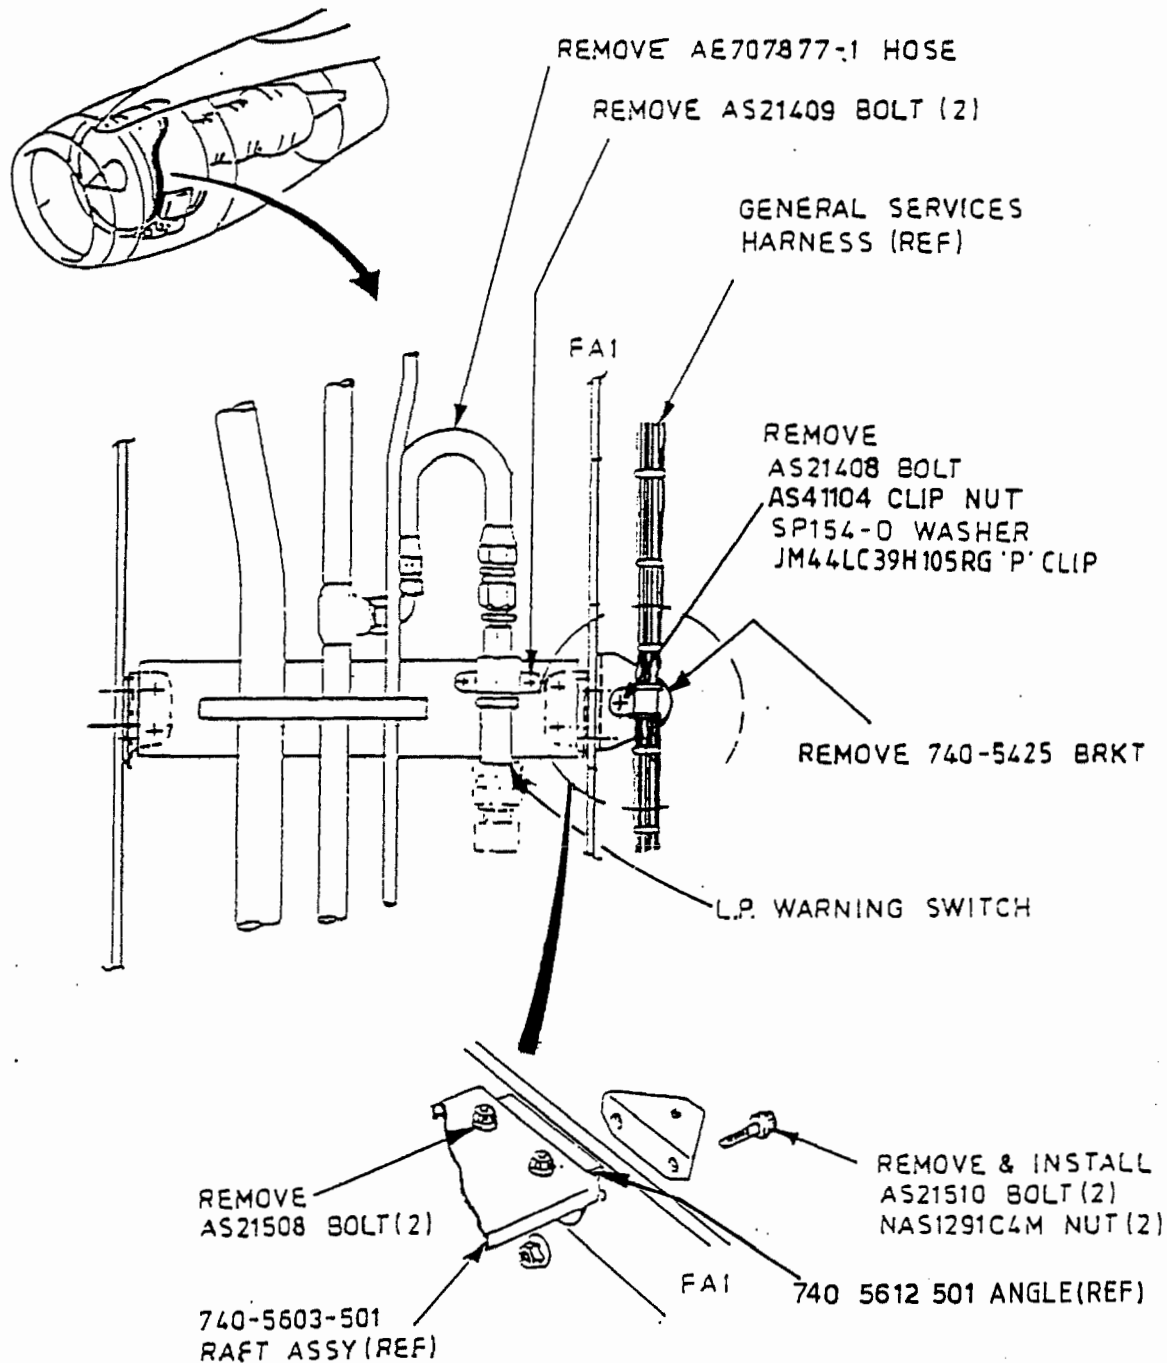
REMOVAL OF DEFECTIVE HYDRAULIC HOSE
FIGURE 1

The hydraulic hose connecting the pressure tube to the low pressure (LP) warning switch is subject to failure.

Several operators have reported failures of the hose.

- (2) Remove and discard the AE707877-1 hose. Install blanks in the open couplings (Refer to Figure 1).
