**International  
Aero Engines**

NACELLE – HYDRAULIC POWER – LOW PRESSURE (LP) HYDRAULIC SWITCH –  
INSTALLATION OF ANCHOR TABS AND LOCKING WIRE

December 6, 2000

# **V2500-NAC-29-0262**

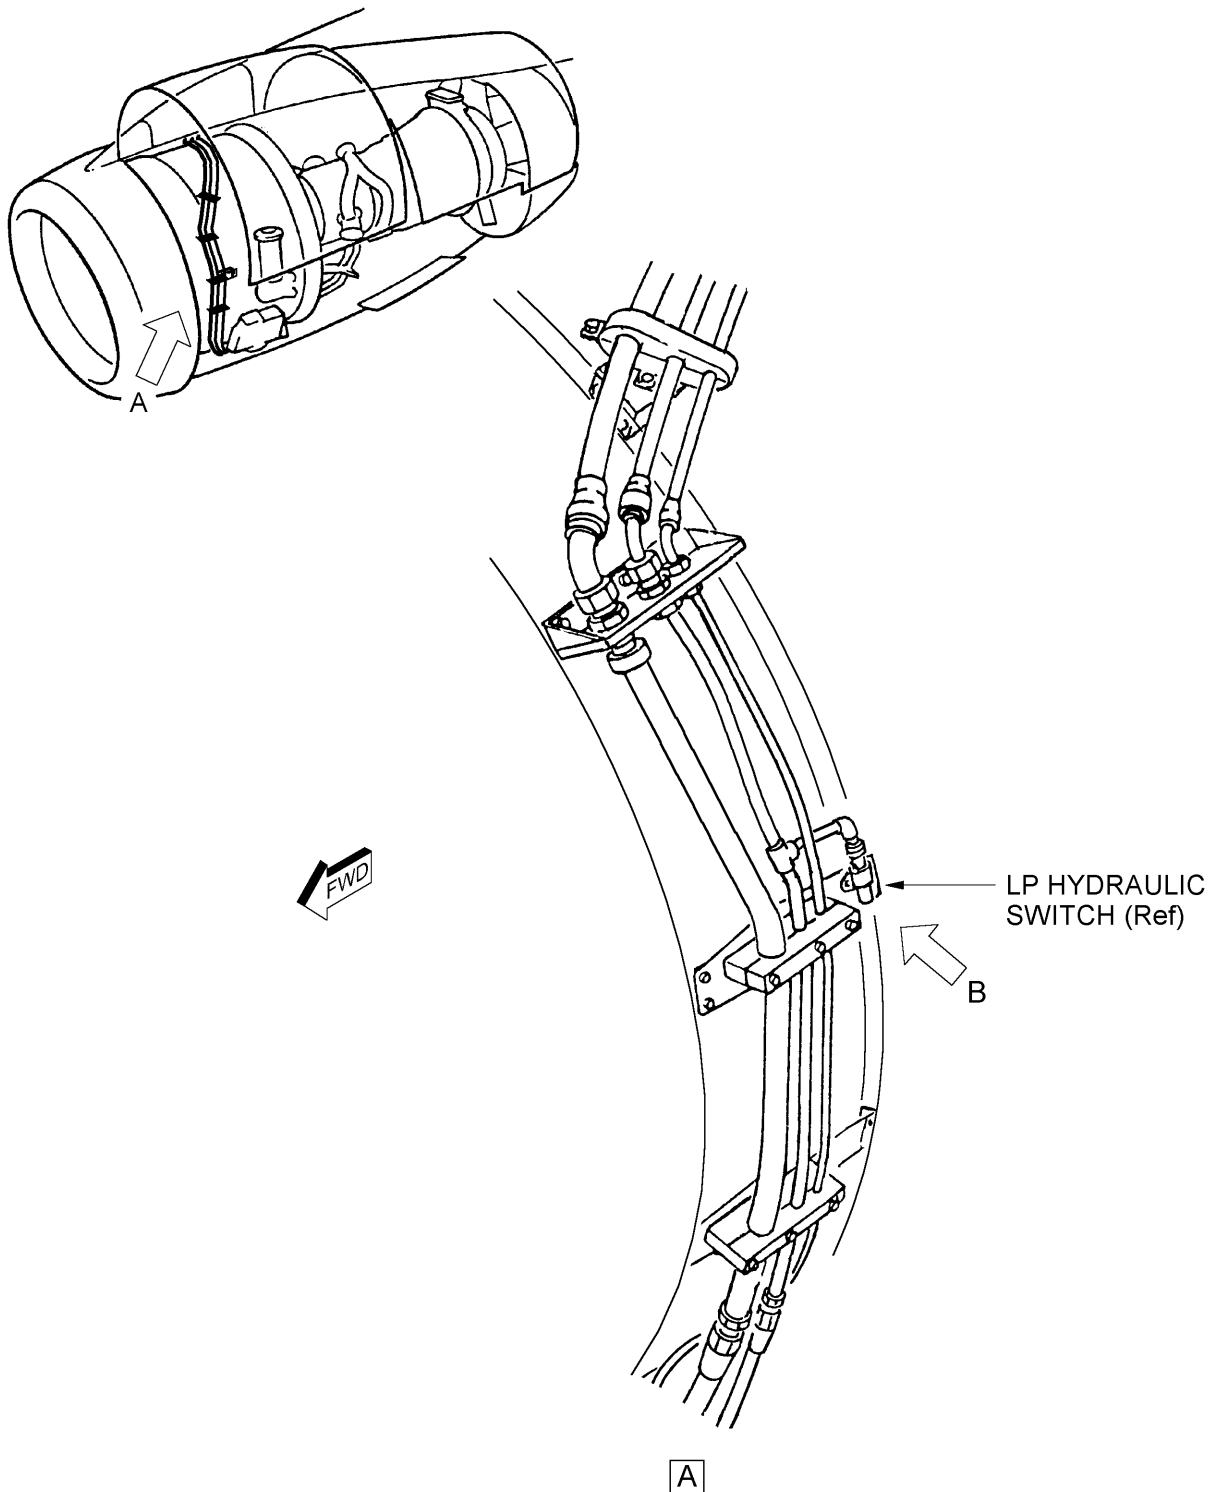
Installation of the Anchor Tabs and Locking Wire to the LP Hydraulic Switch  
Figure 1, Sheet 1 of 2

The LP Hydraulic Switch can become loose due to the effects of the hydraulic pump ripple.

- (1) Remove the two AS21409 Bolts from the Raft Assembly. Refer to Figure 1.

- (5) Safety the LP Hydraulic Switch Flareless Union to the 745-5022-501 Anchor Tab with CoMat 02-147 Locking Wire. Refer to the SPP-V2500-1IA Standard/Processes Manual, Chapter 70-42-05.
