NACELLE – HYDRAULIC SYSTEM – REPLACEMENT OF UNION ON THE ENGINE DRIVEN PUMP (EDP) SUCTION LINE OUTLET

Turbojet Engine Service Bulletin No. V2500-NAC-29-0266 Revision No. 1 dated March 23, 2020

V2500-NAC-29-0266

29-11-49

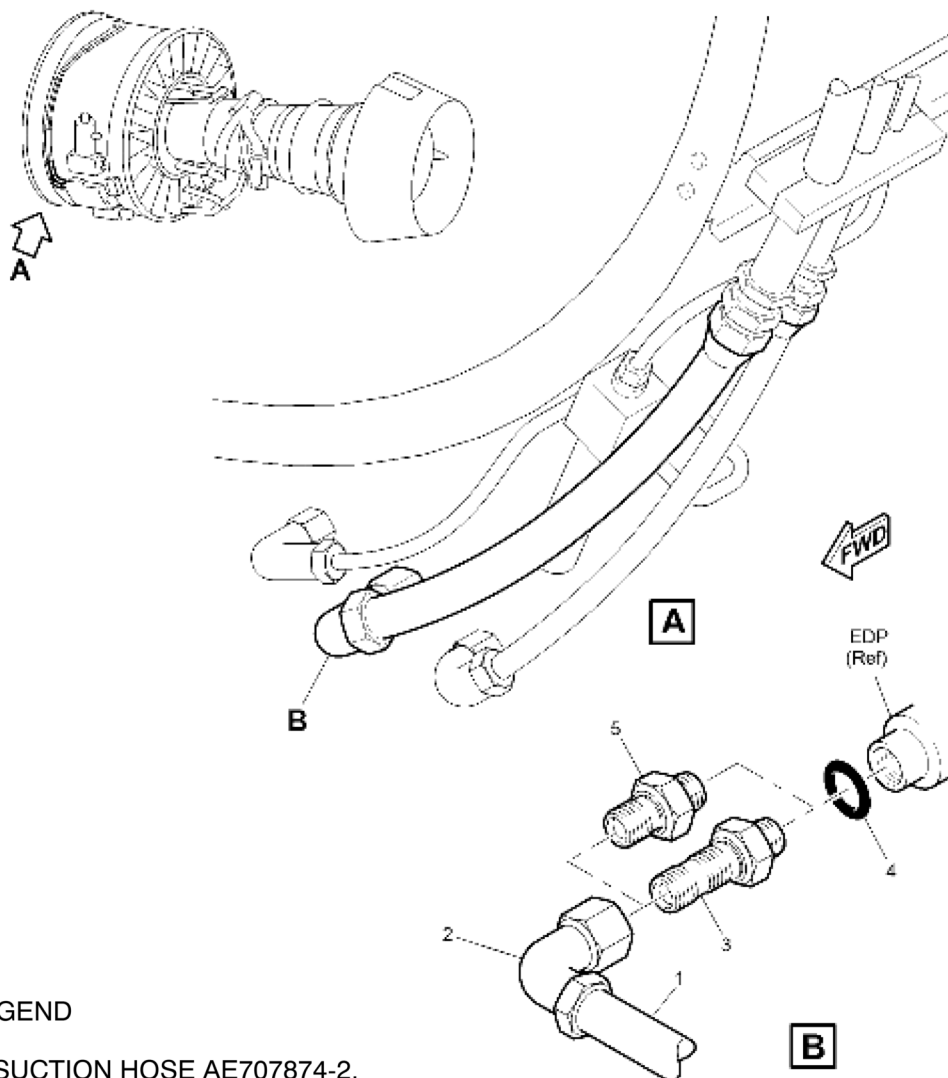
**REPLACEMENT OF EDP UNION
FIGURE 1**

1. Condition: Clearance between the union on the EDP suction line outlet and adjacent hydraulic parts may be close to the minimum if the dampener is installed to Eaton EDPs (as per VSB V2500-NAC-29-0265 or MOD 159213).

2. Background: A close to minimum clearance condition was observed between the Eaton EDP suction line union and adjacent hydraulic parts when the dampener is installed (as per VSB V2500-NAC-29-0265 or MOD 159213).
3. Objective: This Service Bulletin is to inform operators that when the current union on the EDP suction line outlet is removed that it should be replaced with the new union.
4. Substantiation: All hardware changes have been substantiated by satisfactory engineering analysis.
5. Effects of Bulletin on:
Removal/Installation: Not Affected.
Disassembly/Assembly: Not Affected.
Cleaning: Not Affected.
Inspection/Check: Not Affected.
Repair: Not Affected.
Testing: Not Affected.
6. Supplemental Information
None.

A. Removal of the union (3) from the EDP (ref). Refer to Figure 1.

- (1) Put a suitable container below the coupling (2) / union (3) connection to the EDP.
- (2) Hold the union (3) with an applicable wrench and disconnect the coupling (2) from the union.
- (3) Let the hydraulic fluid flow into the container.
- (4) With an applicable wrench, remove the union (3) and packing (4) from the EDP (ref).
- (5) Discard the packing (4).
- (6) Put a suitable protective cover on the end of the coupling (2) and the EDP (ref).

B. Installation of the new union (5) on the EDP (ref).

- (1) Remove the covers from the new union (5), the coupling (2) and the EDP (ref).
- (2) Lightly lubricate the threads and abutment faces of the union (5) and the coupling (2) with the hydraulic fluid used in the aircraft hydraulic system.
- (3) Lubricate the new packing (4) with the hydraulic fluid used in the aircraft hydraulic system (ref SPM Task 70-44-01-400-501) and install the union (5) and packings (4) to the EDP.
- (4) Torque the union (5) to 900 – 1000 lbf-in. (101.7 – 113.0 N.m).
- (5) Connect the coupling (2) to the union (5).
- (6) Hold the union (5) with an applicable wrench and with a second wrench, torque the connector nut of the coupling (2) to 800 – 900 lbf in. (90.4 – 101.7 Nm).
