# SERVICE BULLETIN

NON-MODIFICATION SERVICE BULLETIN — NACELLE — HYDRAULIC  
SYSTEM — REPLACEMENT OF SUSPECT PACKING ON THE ENGINE DRIVEN  
HYDRAULIC PUMP PRESSURE SWITCH

V2500 Series 29-0267

# V2500-NAC-29-0267

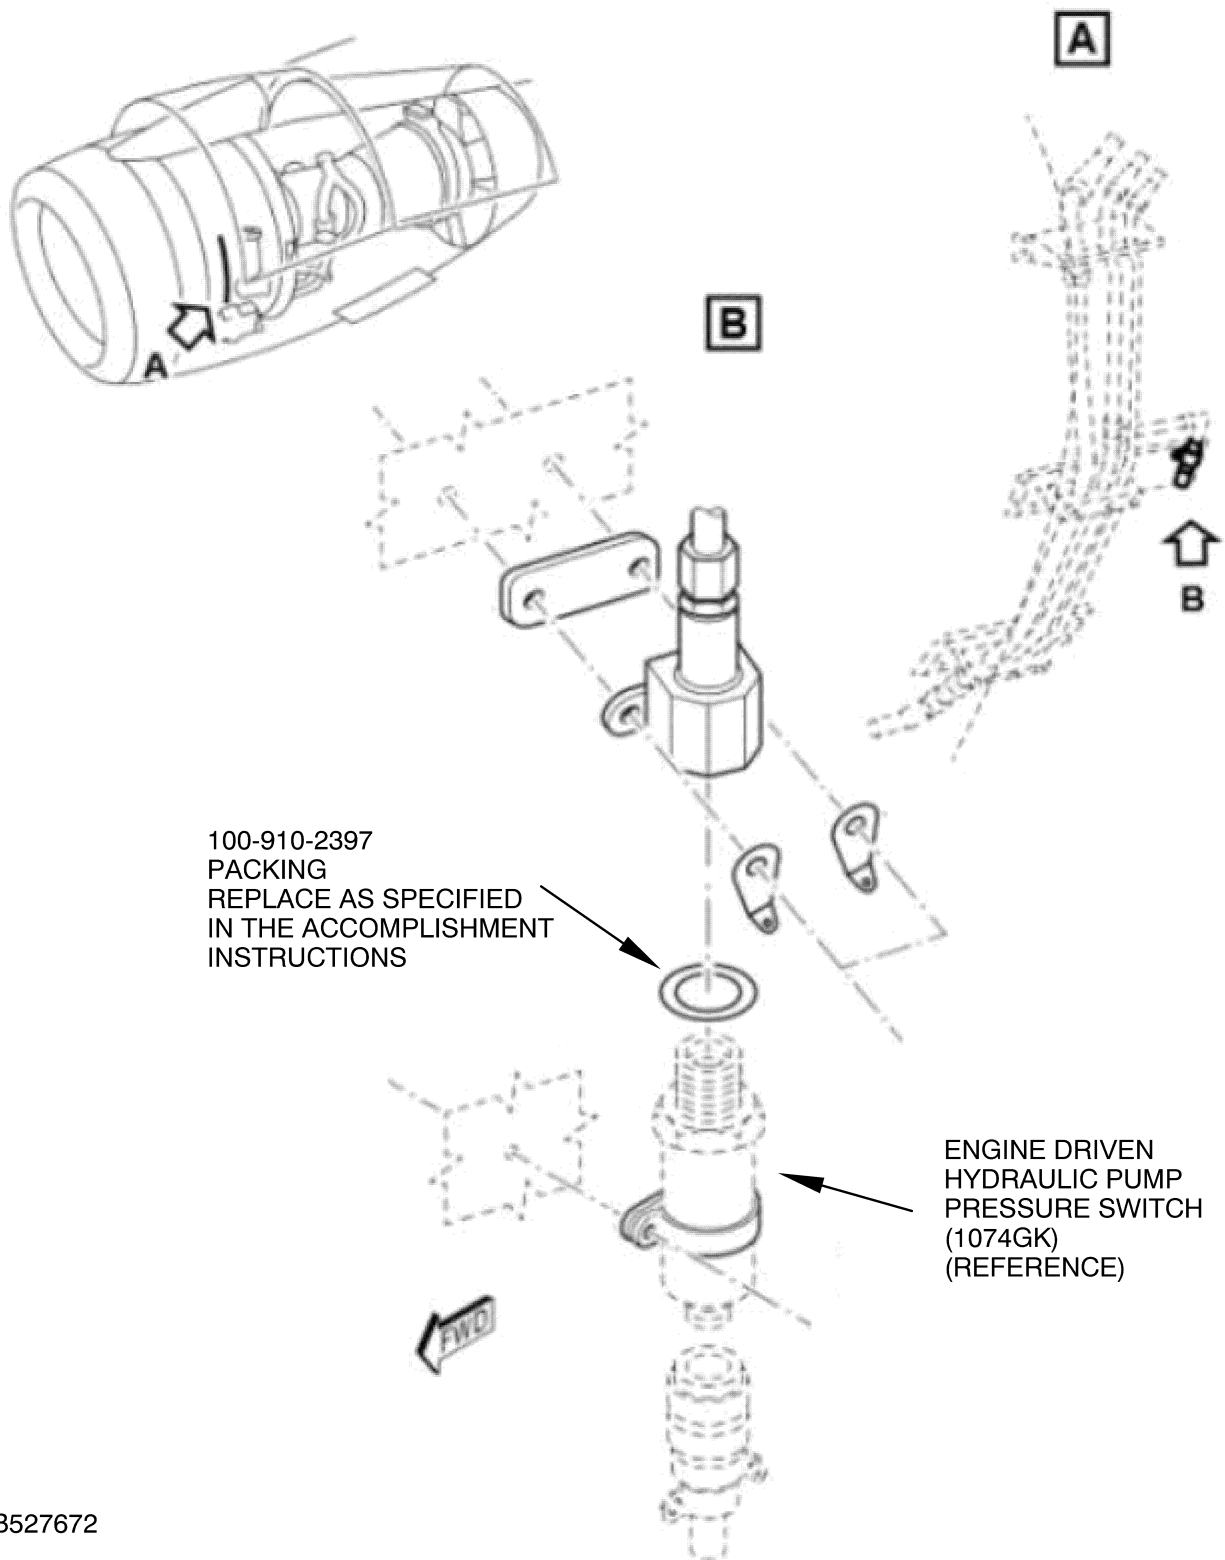
LOCATION OF THE PACKING  
29-11-17 AND 29-13-17  
FIGURE 1

1. Condition: Hydraulic fluid leaks have been attributed to a suspect packing installed on the engine driven hydraulic pump pressure switch.
2. Background: There have been two reports of in-flight hydraulic system leaks from the engine driven hydraulic pump pressure switch. This has been attributed to a suspect packing installed on the engine driven hydraulic pump pressure switch that did not meet the packing material specifications.

Replace the suspect packing with a new non-suspect packing.

1. Gain access to the engine as follows:
  - A. Open the fan cowl doors as specified in Reference 5, AMM Task 71-13-00-010-010.
2. Replace the engine driven hydraulic pump pressure switch packing as follows:
  - A. Remove the engine driven hydraulic pump pressure switch as specified in Reference 5, AMM Task 29-13-17-000-010 or Task 29-13-17-000-010. See Figure 1.
  - B. Remove and discard the suspect Packing, PN 100-910-2397.
  - C. Install a non-suspect Packing, PN 100-910-2397 and engine driven hydraulic pump pressure switch as specified in Reference 5, AMM Task 29-13-17-400-010 or Task 29-13-17-400-010.
3. Close access to the engine as follows:
  - A. Close the fan cowl doors as specified in Reference 5, AMM Task 71-13-00-410-010.
4. Recording Instructions
  - A. A record of accomplishment is required.
