PNEUMATIC SYSTEM - NACELLE - POWERPLANT - TUBES, PRESSURE INDICATING - SERVO TUBE -
REPLACEMENT OF - CATEGORY CODE 4. - MOD.NAC-36-0001

V2500-NAC-36-0001

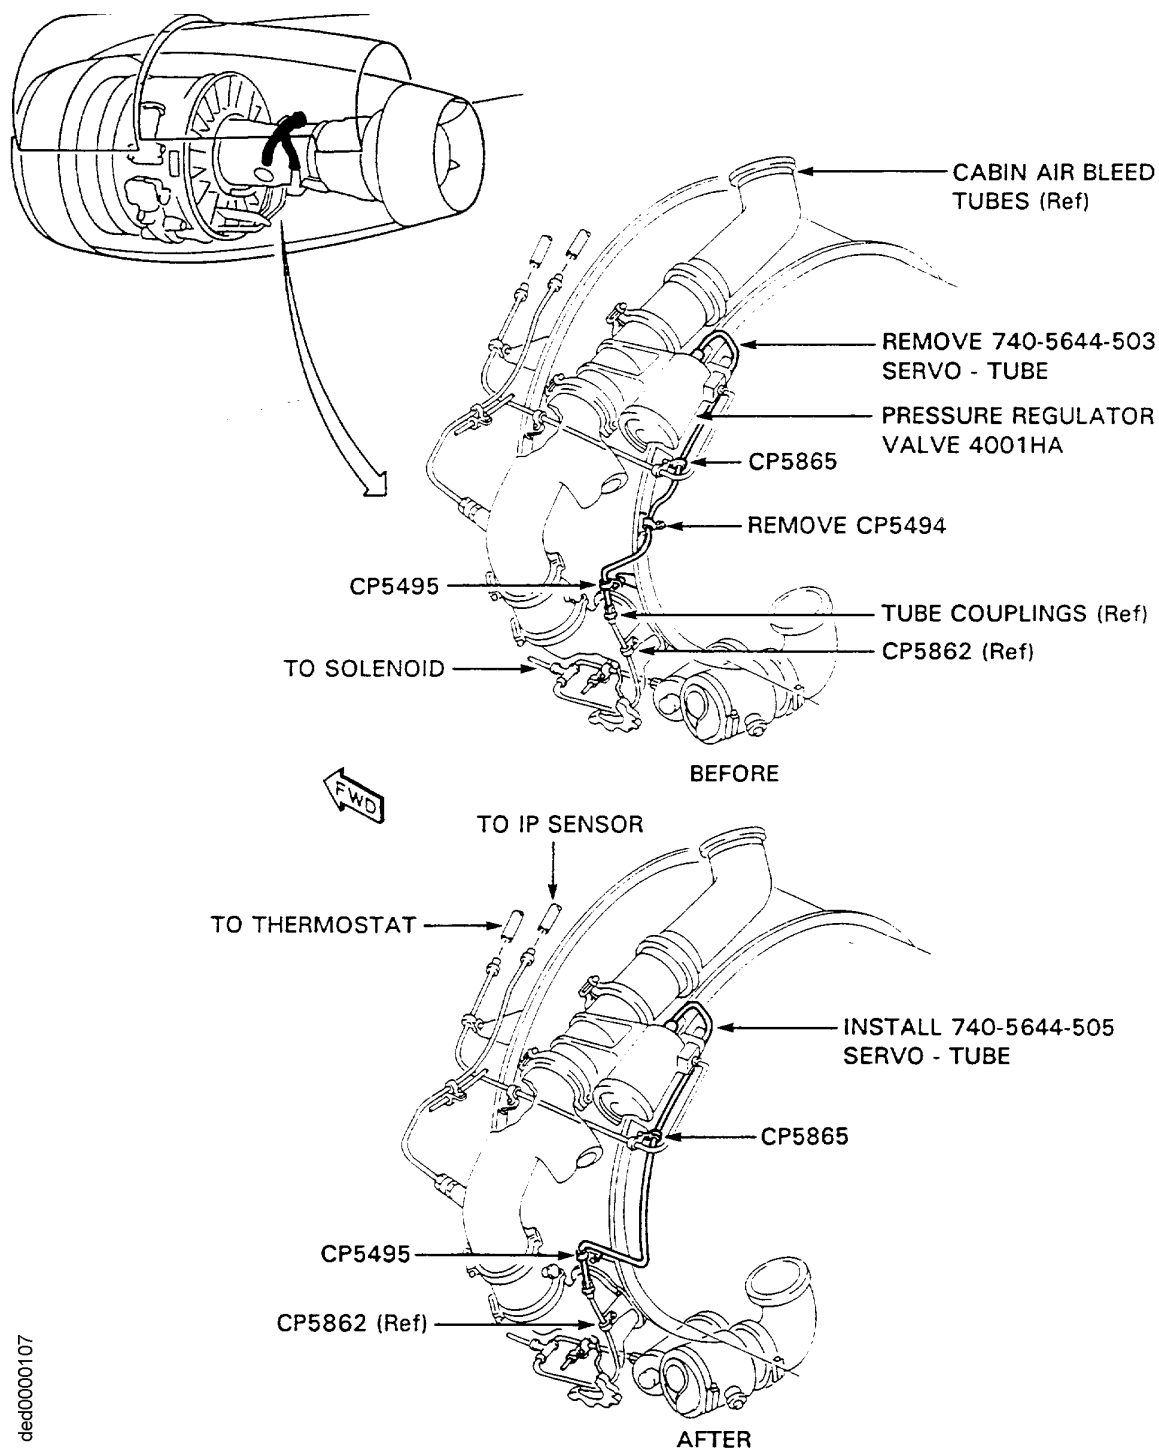
Replacement of the servo-tube
Fig.1

Under adverse conditions the clearance between the 10th stage Gimbal (on the cabin air bleed tubes) and servo tube may be inadequate.

To provide improved clearance between the 10th stage gimbal and the servo tube (to the pressure regulator valve).

- (a) The servo tube to the bleed-air pressure regulator valve is replaced. Clipping points CP5865 and CP5495 are disassembled/ assembled to facilitate this and clipping point CP5494 (comprising bolt, nut and 'P' clip) is modified.

- (1) Open the left thrust reverser half with instructions in the A320 Aircraft Maintenance Manual, TASK 78-32-00-010-010.
- (2) Find the 740-5644-503 servo tube on the left side of the engine core (Refer to Figure 1).
