V2500 Propulsion System — Nacelle

SERVICE BULLETIN

NACELLE — PNEUMATIC — SUPPORT BRACKETS, SENSE LINES,
ENVIRONMENTAL CONTROL SYSTEM - REPLACEMENT OF

V2500-NAC-36-0002

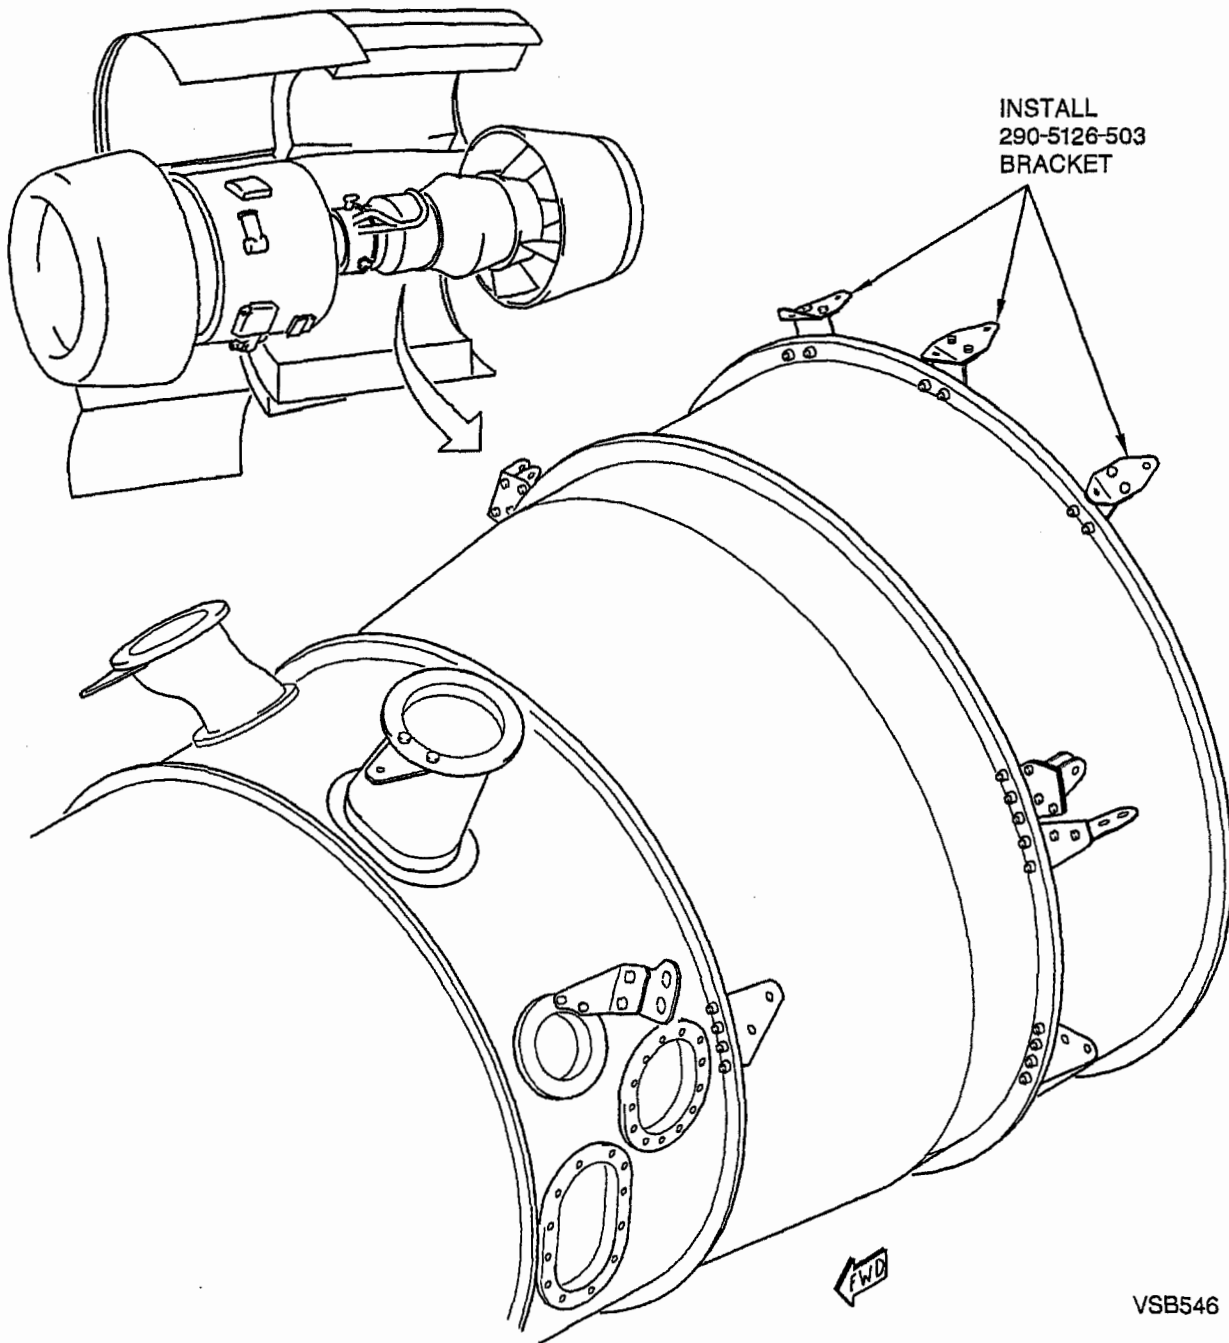
ECS Sense Line Support Bracket Installation
Figure 1

Environmental control system (ECS) sense lines can interfere with the ECS system crossover duct.

Interference between the ECS sense lines and the crossover duct has been found on several installations.

- (1) Install the 290-5126-503 brackets on the engine brackets with the bolts, washers, and nuts. Torque the nuts to 20-25 lbfin (2-3 Nm). Refer to Figure 1.
