Number: V2500-NAC-36-0004

Date: April 25, 2002

SUBJECT: "MODIFICATION SERVICE BULLETIN" - "NACELLE - POWERPLANT - ECS SENSE
LINE SUPPORT BRACKET - MODIFICATION OF"

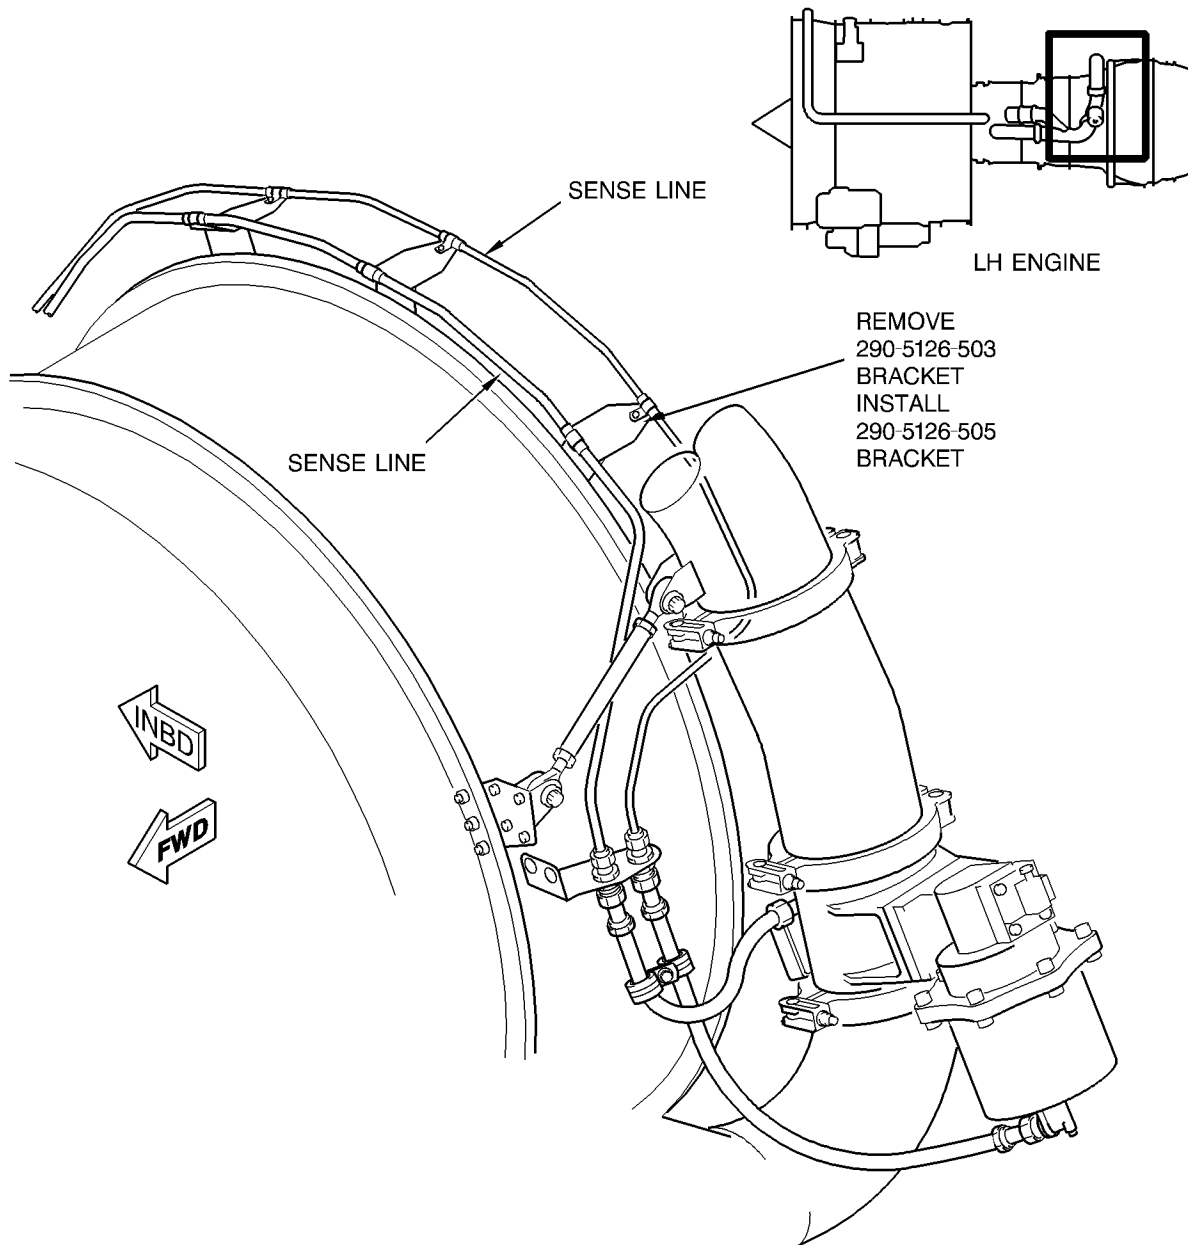
ECS Sense Line Bracket Modification
Figure 1 (sheet 1)

The shape of the ECS sense line support bracket can cause the sense line to interfere with the underside of the ECS crossover duct.

- A. Open the thrust reverser halves. Refer to the MD-90 Aircraft Maintenance Manual, Chapter 78-32-00, Page Block 201.
- B. Remove the ECS sense line from the indicated bracket. For the LH engine, refer to Figure 1 (sheet 1). For the RH engine, refer to Figure 1 (sheet 2).

- C. Remove the indicated bracket from the engine brackets. For the LH engine, refer to Figure 1 (sheet 1). For the RH engine, refer to Figure 1 (sheet 2).

- E. Install the 290-5126-505 bracket on the engine bracket. For the LH engine, refer to Figure 1 (sheet 1). For the RH engine, refer to Figure 1 (sheet 2).

- F. Install the ECS sense line on the 290-5126-505 bracket. For the LH engine, refer to Figure 1 (sheet 1). For the RH engine, refer to Figure 1 (sheet 2).

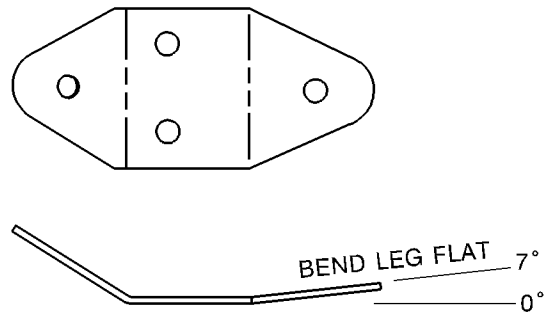
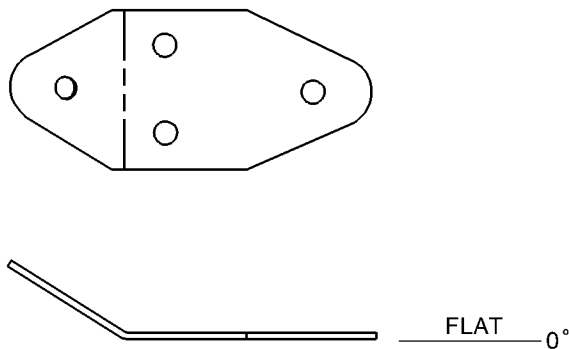
ECS Sense Line Bracket Modification
Figure 1 (sheet 3)

- (1) Problem
 - (a) The ECS sense line can interfere with the underside of the ECS cross-over duct.
- (2) Cause
 - (a) The contour of one ECS sense line support bracket on each engine may put the ECS sense line too close to the ECS cross-over duct.
- (3) Background
 - (a) Interference between the ECS sense line and the underside of the ECS cross-over duct has been found in service.
- (4) Objective
 - (a) The changes in configuration recommended in this Service Bulletin are intended to maintain reliability of the thrust reverser by preventing the ECS sense line from contacting the ECS cross-over duct.
- (5) Substantiation
 - (a) By analysis.

- D. Modify the bracket.
 - (1) Bend the bracket as shown in Figure 1 (sheet 3).
 - (2) Do a 10X visual inspection of the bracket for cracks. Replace the bracket if you find cracks.
