**International  
Aero Engines**

V2500 Propulsion System — Nacelle

**NACELLE — PNEUMATIC — FLANGE, FAN AIR VALVE SUPPORT  
— REPLACEMENT OF**

**V2500-NAC-36-0005**

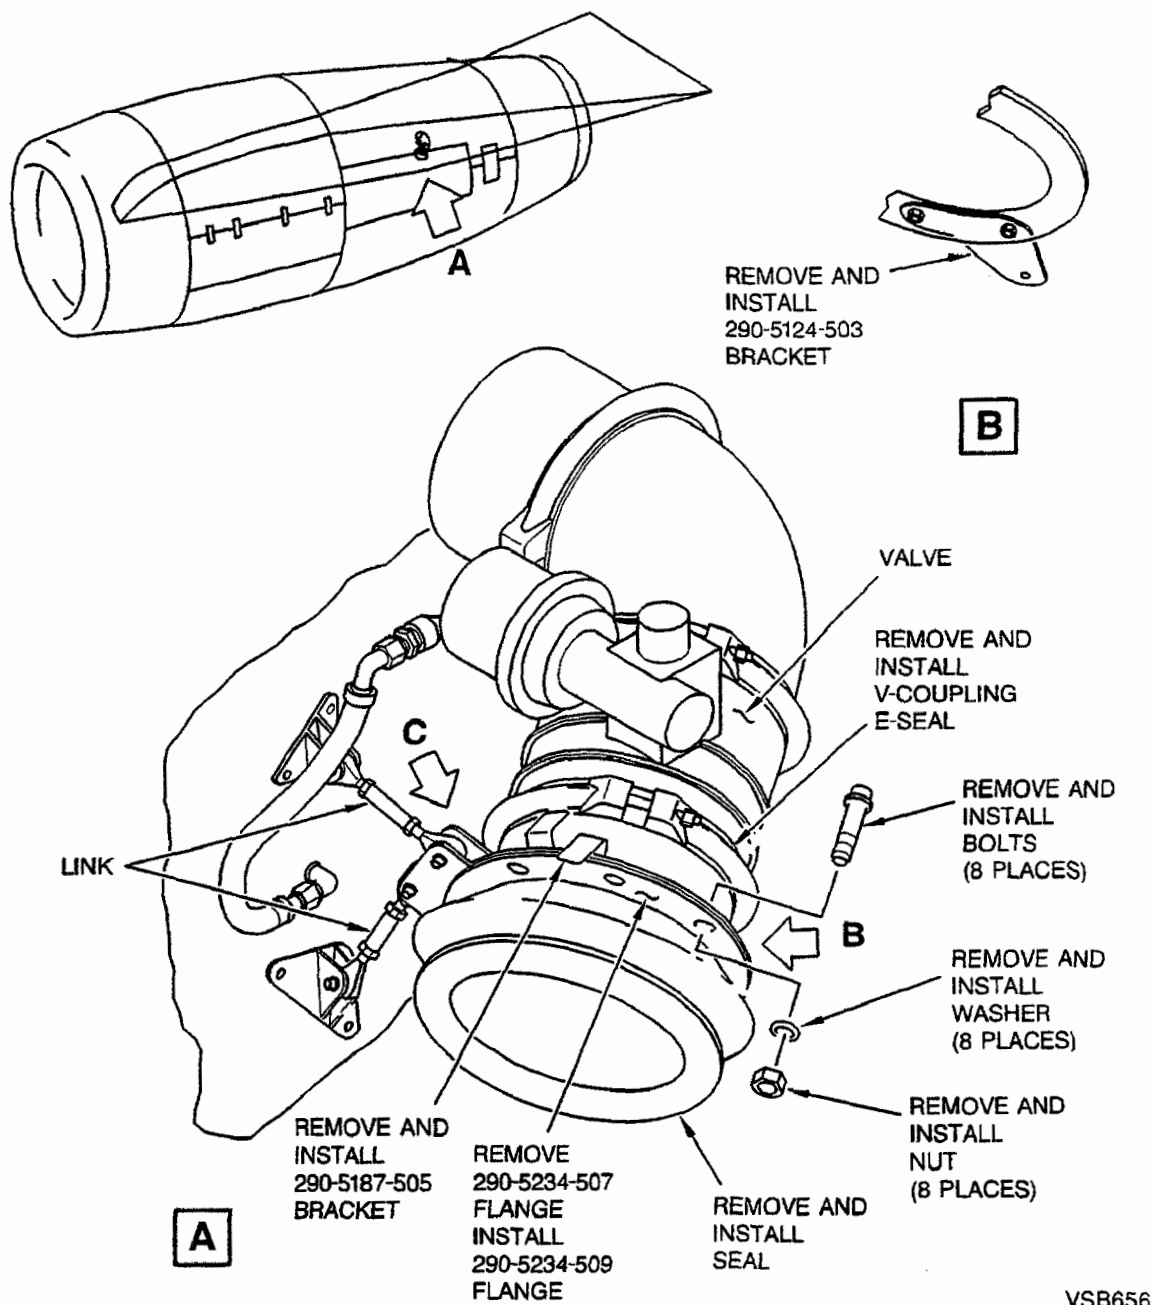
LH Pylon Valve Support Flange Replacement  
Figure 1 (sheet 1)

The fan air valve support flanges installed on the aircraft listed in paragraph 1.A. are not the correct configuration.

- (1) Remove the nuts, washers, bushings, and bolts and disconnect the links from the 290-5234-505 (-506) flange. Refer to Figure 1 (Figure 2).
- (2) Loosen the clamp and remove the 290-5234-505 (-506) flange and e-seal from the valve.

- (3) Remove the nuts, washers, bolts, seal, 290-5187-505 (-507) bracket, and 290-5124-503 (-504) bracket from the flange. Discard the flange.
- (4) Install the 290-5124-503 (-504) bracket, 290-5187-505 (-507) bracket, and seal on the 290-5234-509 (-510) flange with the bolts, washers, and nuts.
