V2500 Propulsion System — Nacelle

V2500-NAC-71-0010

NACELLE – POWERPLANT – IDG CABLES - 400VC-A CONNECTOR –  
PRESSURE SPRINGS – INSTALLATION OF

V2500-A1

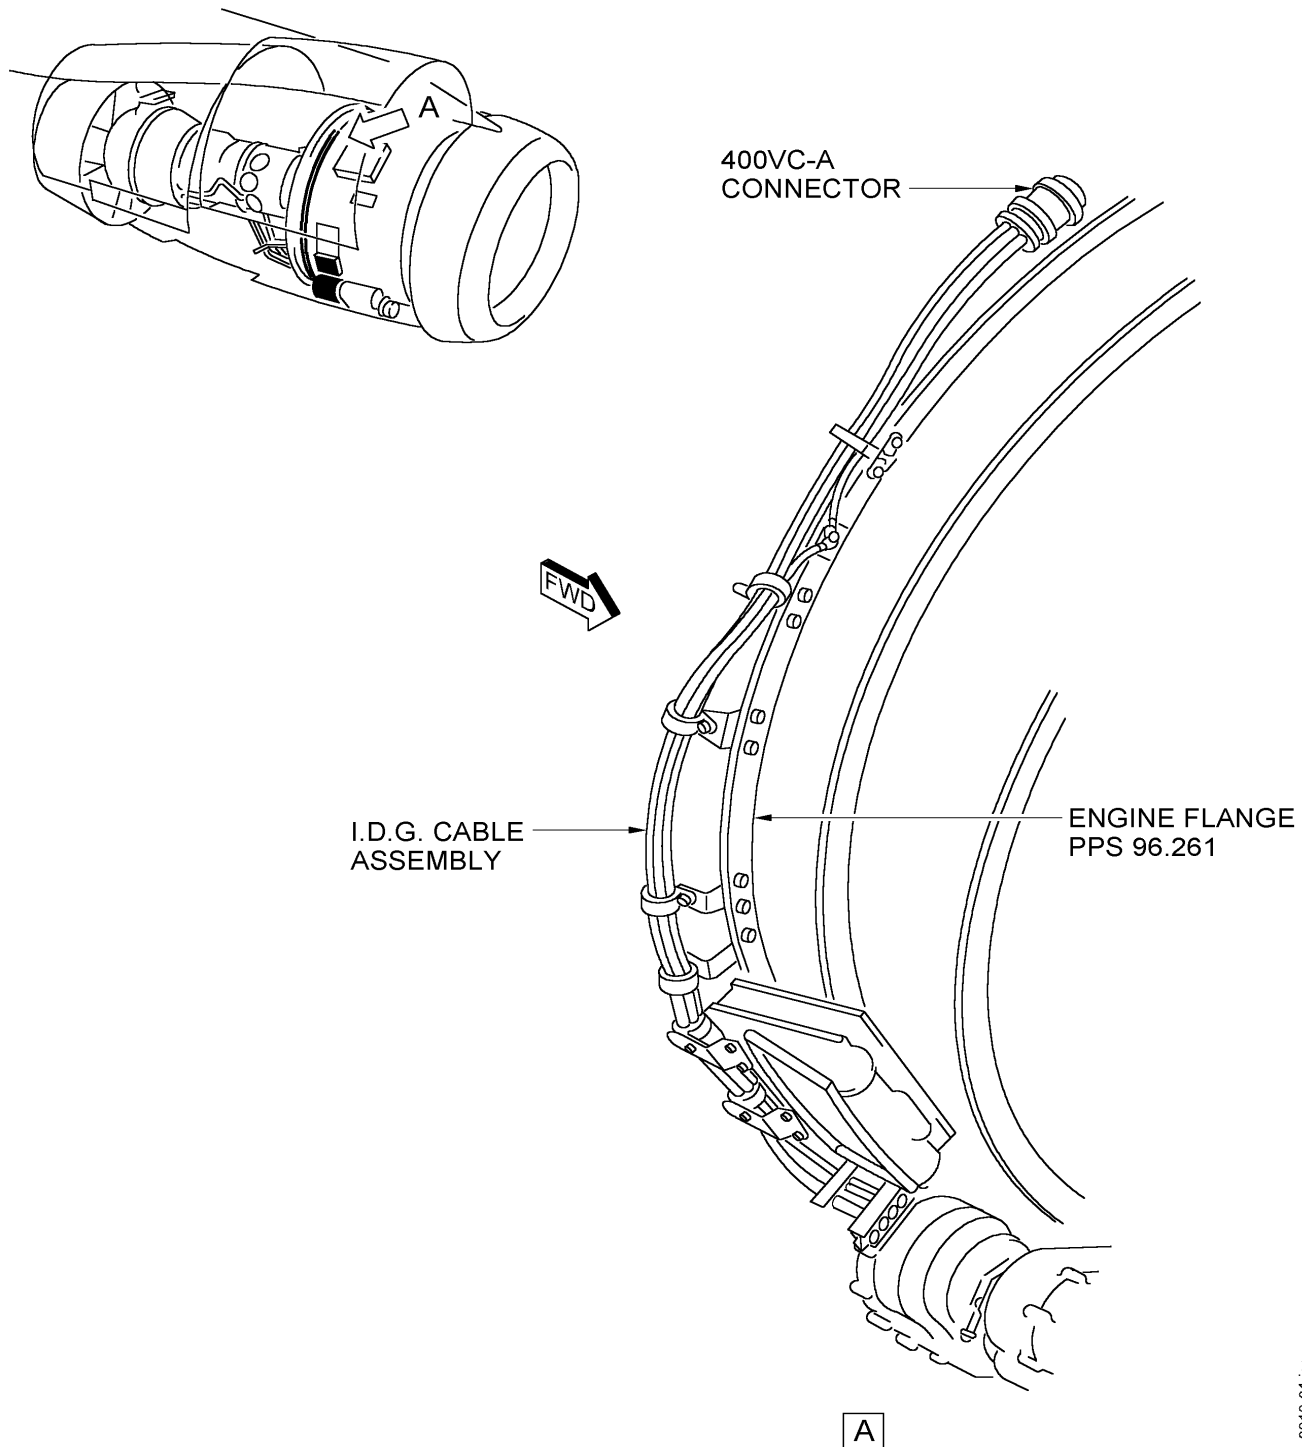
Location of the 400VC-A Connector  
Figure 1, sheet 1

Arcing may occur between the socket tines of the 400VC-A Connector and the pin contacts of the Pylon interface.

Several incidents of arcing have occurred in service. The socket tines of the 400VC-A Connector may separate due to the removal/installation of the Pylon interface pin contacts with the connector. The gaps between the tines caused by the separation may cause arcing between the tines and also between the tines and the pin contacts.

- (1) Open the right Fan Cowl Door as specified in the Engine Maintenance Manual, Task 71-13-00-010-010.
- (2) Find the 400VC-A Electrical Connector on the IDG Cable Assembly at the right side of the Engine Fancase. Disconnect the 400VC-A Electrical Connector. Refer to Figure 1.

- (1) Connect the 400VC-A Connector to the Pylon interface. Make sure the Connector is fully engaged (shown by the indicator on the Connector Body). Refer to Figure 1.
- (2) Close the right Fan Cowl Door as specified in the Engine Maintenance Manual, Task 71-13-00-410-010.
- (3) Do an operational test of the IDG electrical system as specified in the Engine Maintenance Manual, Task 71-00-00-700-012.
