SERVICE BULLETIN

NACELLE - POWER PLANT - CLIPPING POINTS, CORE FIRE SERVICES HARNESS - MODIFICATION OF
- CATEGORY CODE 4 - MOD.NAC-71-00111. Planning InformationA. Effectivity

V2500-NAC-71-0011

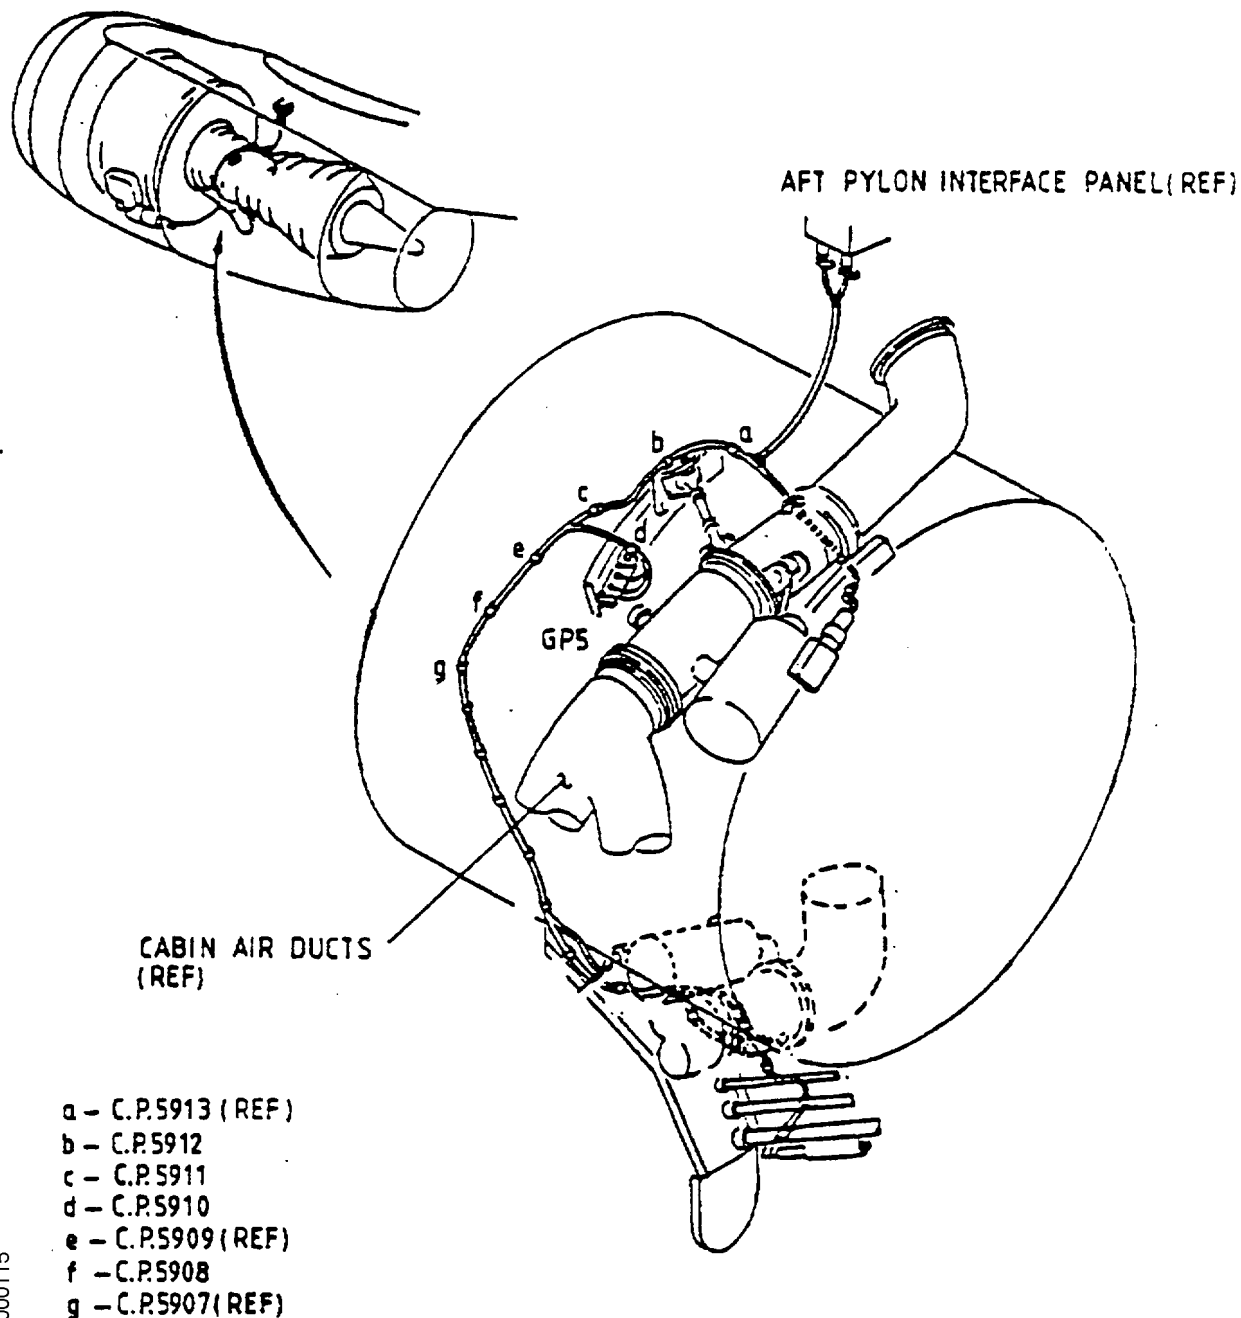
Location of Engine Core Harness Assembly Clipping Points
 Fig.1

- (1) Open the thrust reverser halves as specified in the V2500 Aircraft Maintenance Manual, Task 78-32-00-010-010.
- (2) Find the GP5 ground point on the left side of the engine core at PPS 117.90. (Refer to Figure 1.)

- (1) Remove an AS21407 bolt, an AS20624 nut, a SP154-D washer, and a TA027000-PH-07-WC 'P' clip from clipping point CP5912. Discard the bolt, nut, washer, and 'P' clip. (Refer to Figures 1 and 2.)

- (3) Remove an AS21407 bolt, an AS20624 nut, a SP154-D washer, and a TA027000-PH-07-WC 'P' clip from clipping point CP5908. Keep the bolt, nut, washer, and 'P' clip. (Refer to Figures 1 and 3.)

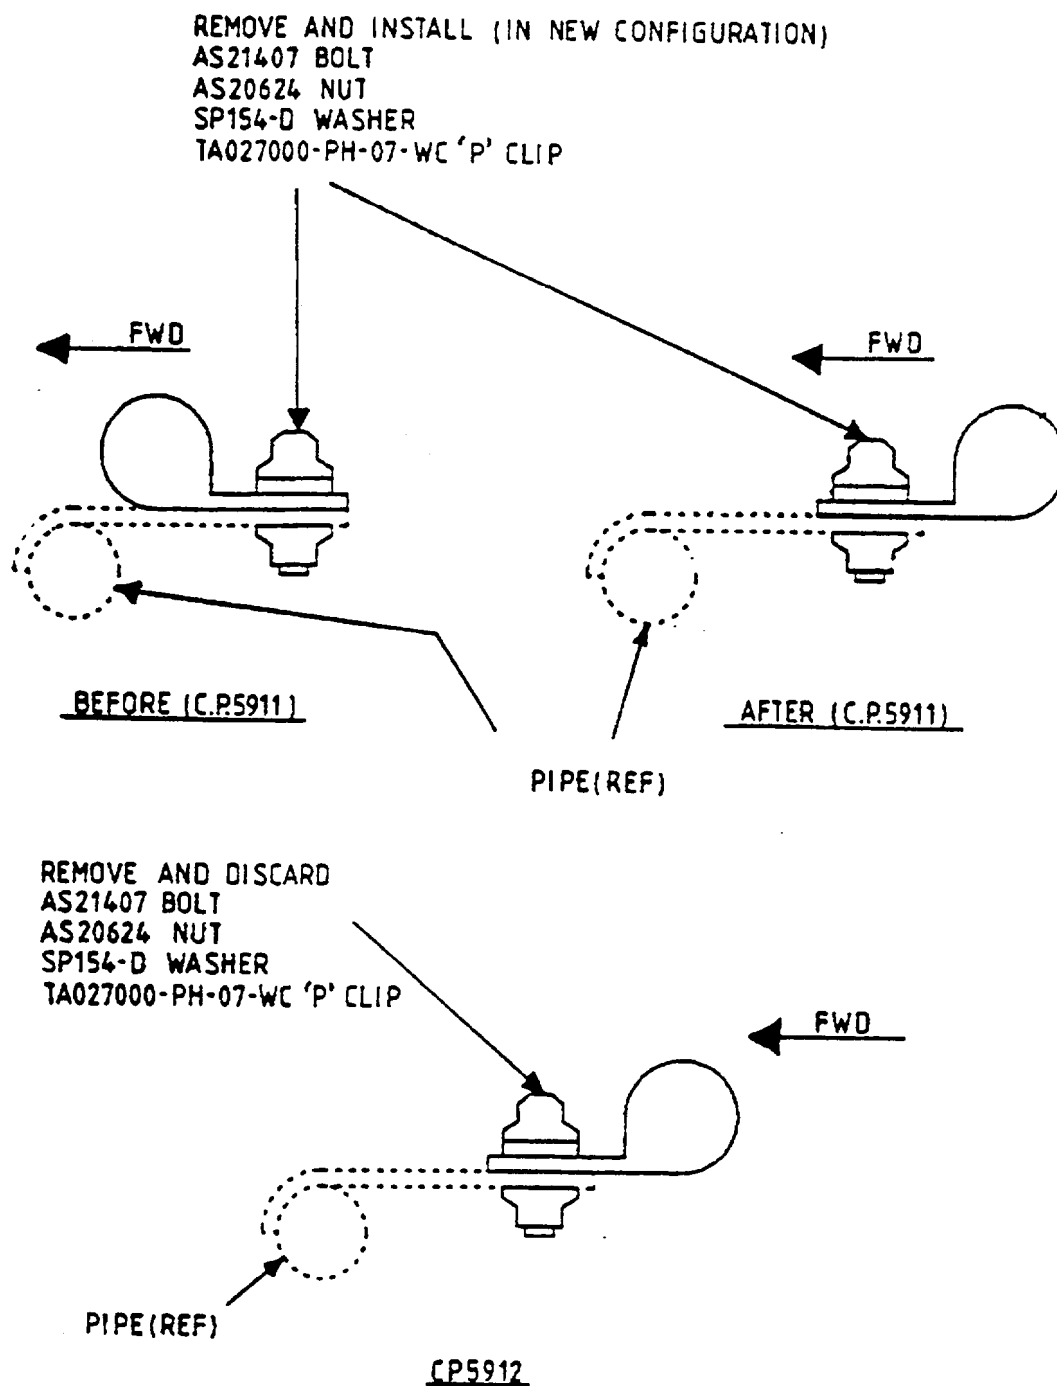
Before and after Views of the Clipping Point Changes to the Engine Core Harness Assembly
Fig.2

Clipping point 5912 is removed and discarded. Clipping points 5911 and 5908 are adjusted (refer to Figures 2 and 3) and a spacer is installed at clipping point 5910. (Refer to Figure 3.) These changes will increase the clearance between the core fire services harness and the hot air pipe. Also it will give clearance between the harness and the engine support to prevent damage to the harness while in transit.

- (6) Install the AS21407 bolt, AS20624 nut, SP154-D washer, and the TA027000-PH-07-WC 'P' clip (in the new configuration) to clipping point CP5908. Torque the bolt to 40 lb-in. (4.25 N.m). (Refer to Figure 3.)
- (7) Install the AS21407 bolt, AS20624 nut, SP154-D washer, and the TA027000-PH-07-WC 'P' clip (in the new configuration) to clipping point CP5911. (Refer to Figure 2.) Torque the bolt to 40 lb-in. (4.52 N.m).
