SERVICE BULLETIN

NACELLE - POWER PLANT - MODIFICATION RECORD PLATES - REPLACEMENT OF - CATEGORY CODE 5 - MOD.NAC-71-0015

V2500-NAC-71-0015

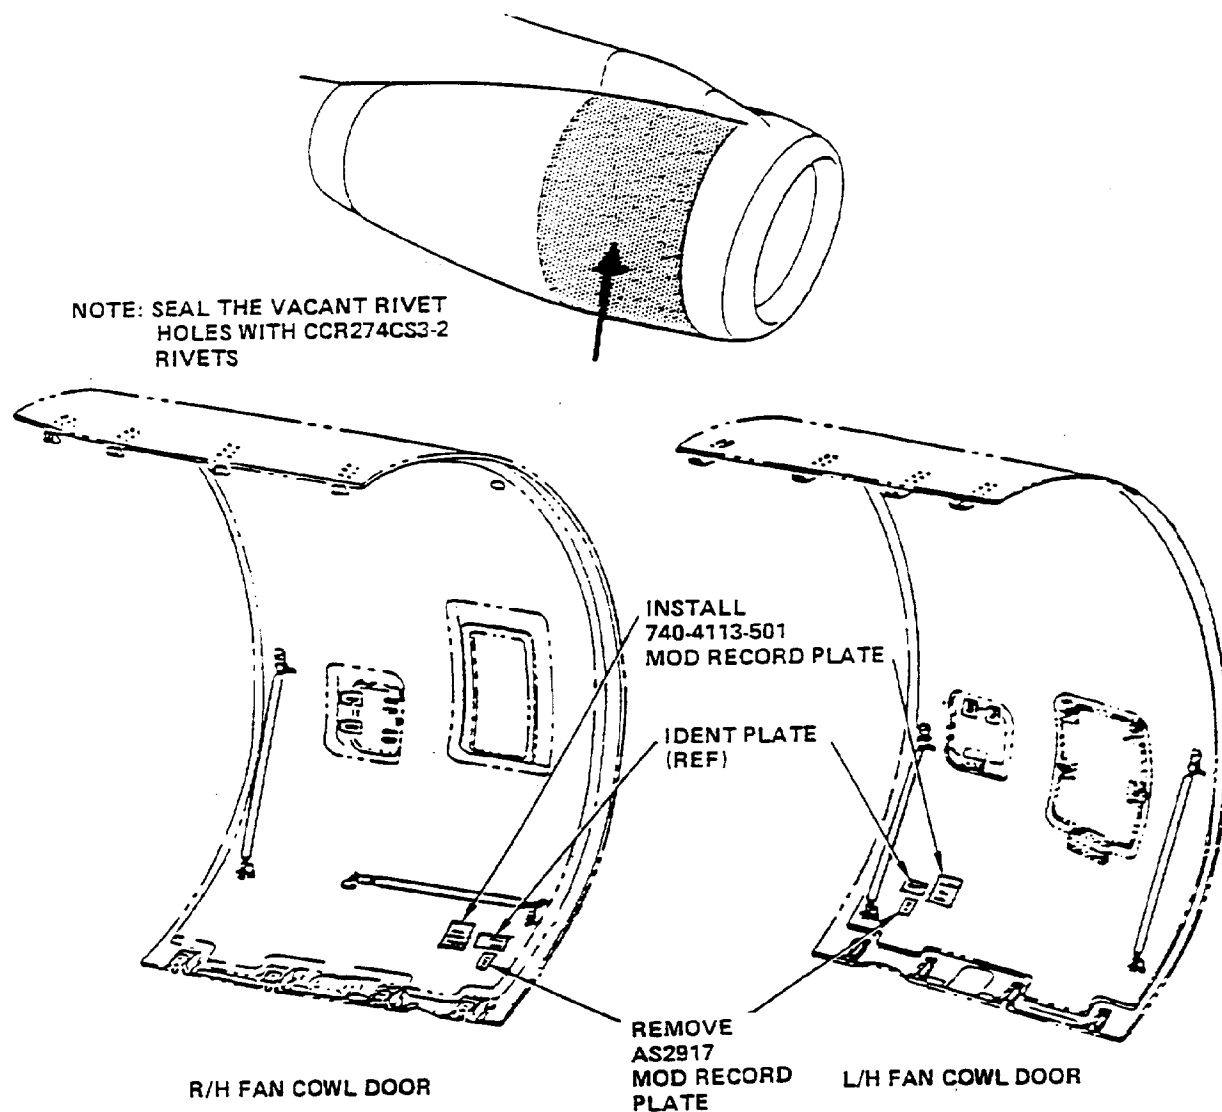
Removal and Installation of the Mod Record Plate
Fig.1

The modification record plates on the inlet cowl rear bulkhead and on the fan cowl doors are not fire resistant.

- (a) Find the AS2917 modification (mod) record plate on the 740-4002-563 right fan cowl door and 740-4001-571 left fan cowl door. (Refer to Figure 1.) Remove four rivets to release the mod record plate.

- (b) Seal the four rivet holes in each fan cowl door with four CCR274CS3-2 rivets.
- NOTE: Use a 'drill stop' to make sure that the drill goes through the inside skin only.

- (c) Hold the new 740-4113-501 mod record plate in the approximate position shown on the fan cowl door. Use the mod record plate as a template and drill four holes 0.098 inch (2.50 mm) diameter into the fan cowl door. Remove any burrs from the holes.

- (d) Apply PL32 Hylomar jointing compound to the bottom face of the 740-4113-501 mod record plate. Rivet the mod record plate in position with four CCR274CS3-2 rivets. Remove any unwanted Hylomar with a clean rag.

- (e) Copy the modification record onto the new mod record plate from the old. Discard the old mod record plate.
- (f) Reidentify the left fan cowl door to 740-4001-575. Reidentify the right fan cowl door to 740-4001-567.

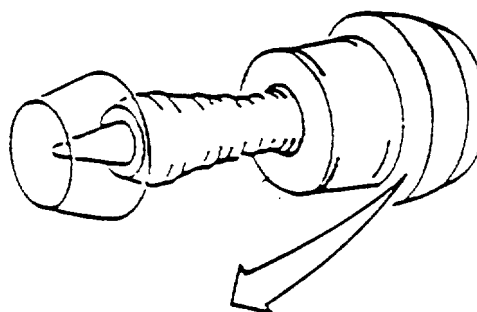
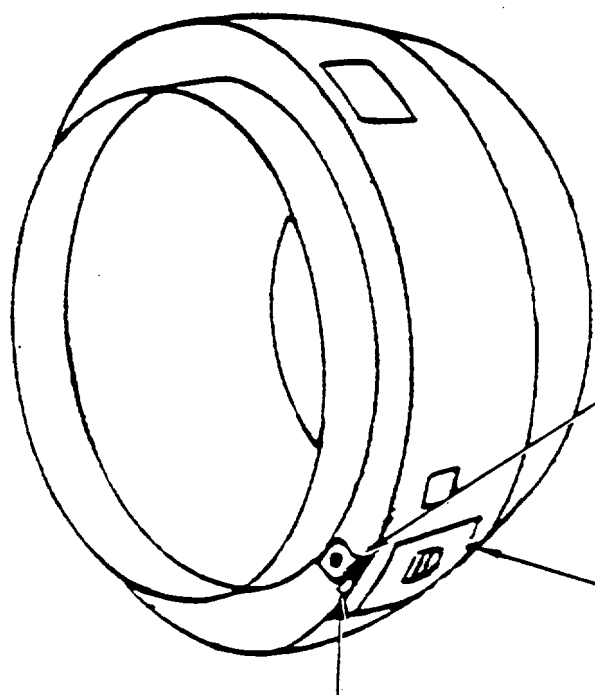
Removal of the Mod Record Plate (Non Fire Resistant)
Fig.2

REMOVE
AS2917 MOD RECORD PLATE
(SEAL THE VACANT RIVET HOLES
WITH CR3523-5-4 RIVETS)

- (a) Find the AS2917 mod record plate on the 740-3000-573 inlet cowl rear bulkhead. (Refer to Figure 2.) Remove four rivets to release the mod record plate.

- (b) Seal the four rivet holes in the bulkhead with four CR3523-5-4 rivets.
- (c) Remove rivets as necessary from the 1-07752-00-00 insulation blanket to gain access to rivets at locations (A) and C. (Refer to Figure 3.)
