SERVICE BULLETIN

NACELLE - POWER PLANT - HOIST POINTS - BLANKING PLUGS - INSTALLATION OF - CATEGORY
CODE 4 - MOD.NAC-71-0016

V2500-NAC-71-0016

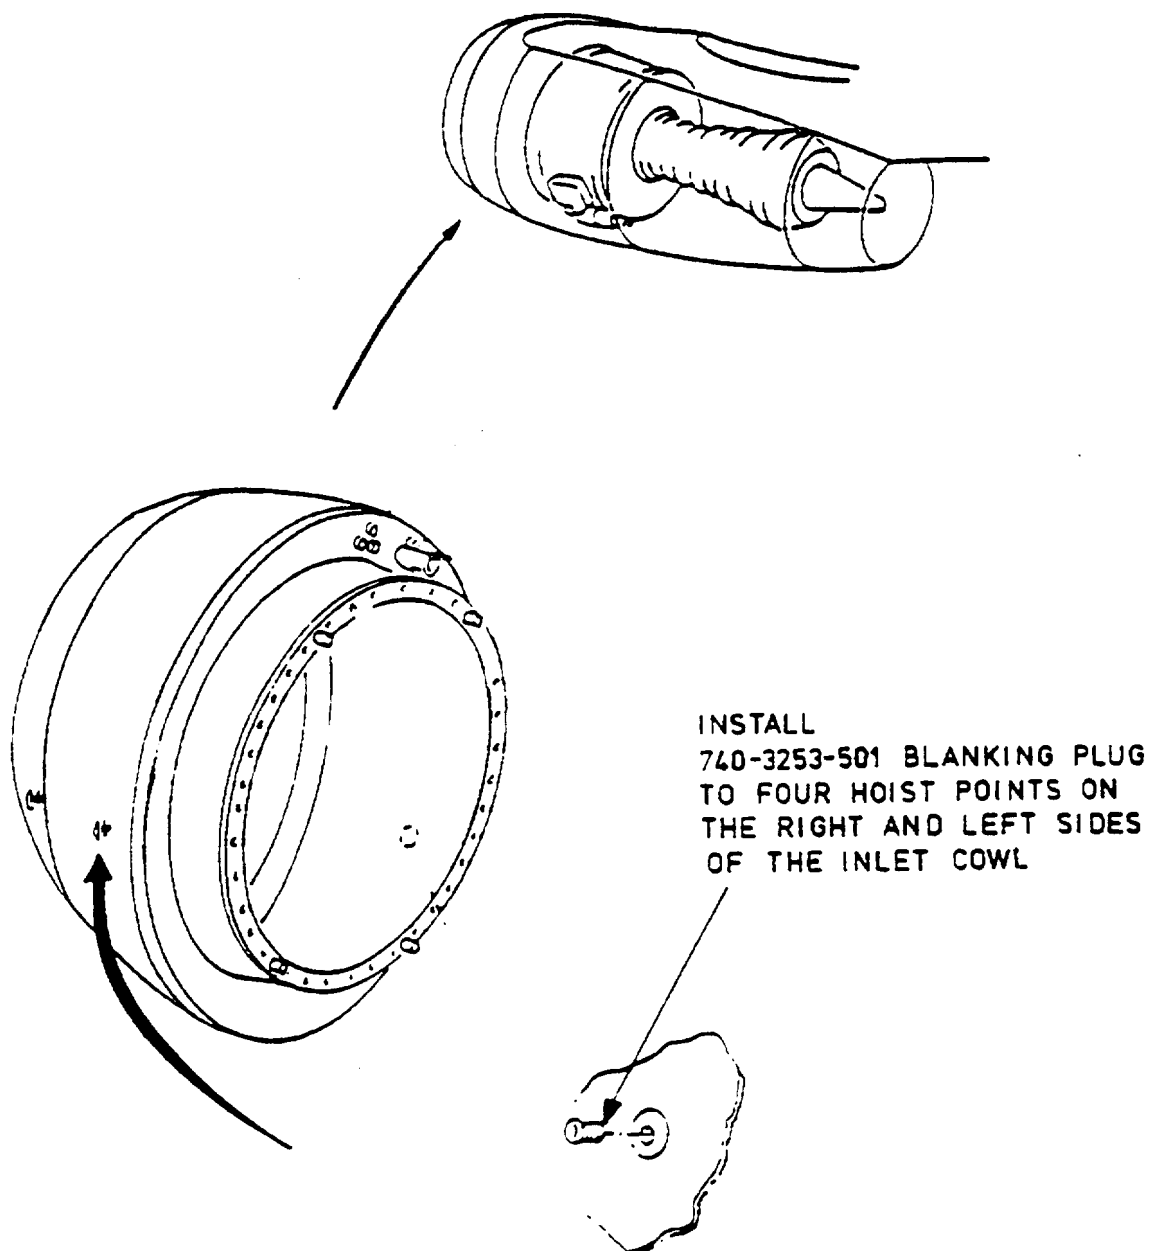
Installation of a Blanking Plug to the Inlet Cowl Hoist Points
Fig.1

Blanking plugs for the hoist points (on the inlet cowls and fan cowls) may not have been installed on the early nacelles.

- (1) Find the four hoist points on the right and left sides of the inlet cowl. (Refer to Figure 1.)
- (2) Remove any unwanted material from inside the hoist points and install a 740-3253-501 blanking plug in each hoist point.
- (3) Find the four hoist points on the right and left fan cowl doors. (Refer to Figure 2.)
- (4) Remove any unwanted material from inside the hoist points and install a 740-4116-501 blanking plug in each hoist point.
