NACELLE - POWER PLANT - DRAINS MAST, BOLTS - REPLACEMENT OF

V2500-A1

V2500-NAC-71-0017 Page 1 of 9

(1) Airplane: Airbus A320

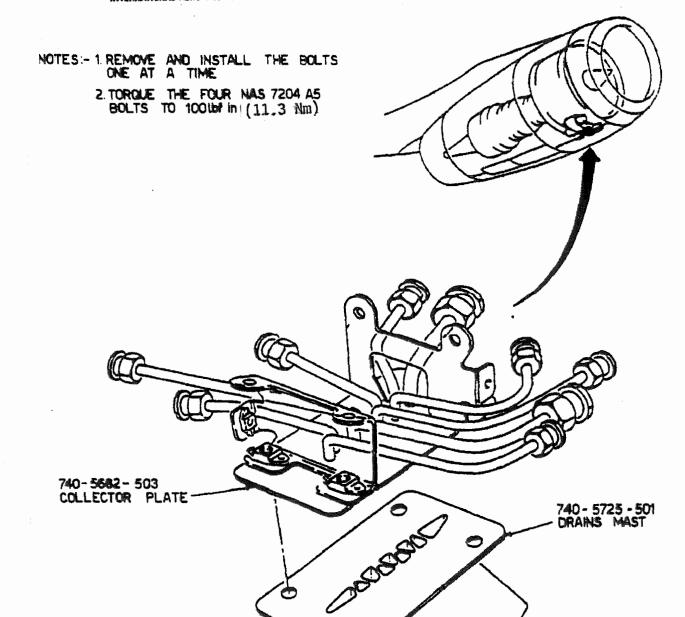
Replacement of the Bolts which Attach the Drains Mast Figure 1

The drawing shows four mushroom head bolts for the installation of the drains mast. It is not possible to install mushroom head bolts in the cast drains mast because the four bolt holes have been countersunk. Countersink head bolts must be used.

REMOVE THE FOUR
A114-2-E MUSHROOM
HEAD BOLTS
INSTALL THE FOUR
NAS 7204 A5 C'SK
HEAD BOLTS

- (1) Replace the four bolts which attach the 740-5725-501 drains mast and the 740-5682-503 collector plate to the engine as follows:
  - (a) Remove the four All4-2-E mushroom head bolts from the drains mast. Install the four NAS7204A5 countersink bolts in the drains mast. (Refer to Figure 1.)
    - NOTE: Remove and install the bolts one at a time. This will prevent the removal/installation of the drains mast and collector plate.
  - (b) Torque the four NAS7204A5 countersink head bolts to 100 lb-in. (11.3 N.m) as specified in the V2500 Aircraft Maintenance Manual, Task 70-23-11-911-010.
