POWER PLANT – NACELLE – POWERPLANT – GEARBOX BREATHER OUTLET – OVERBOARD GEARBOX VENT –
REPLACEMENT OR INSTALLATION OF. – CATEGORY CODE 4 – MOD.NAC-71-0046

V2500-NAC-71-0046

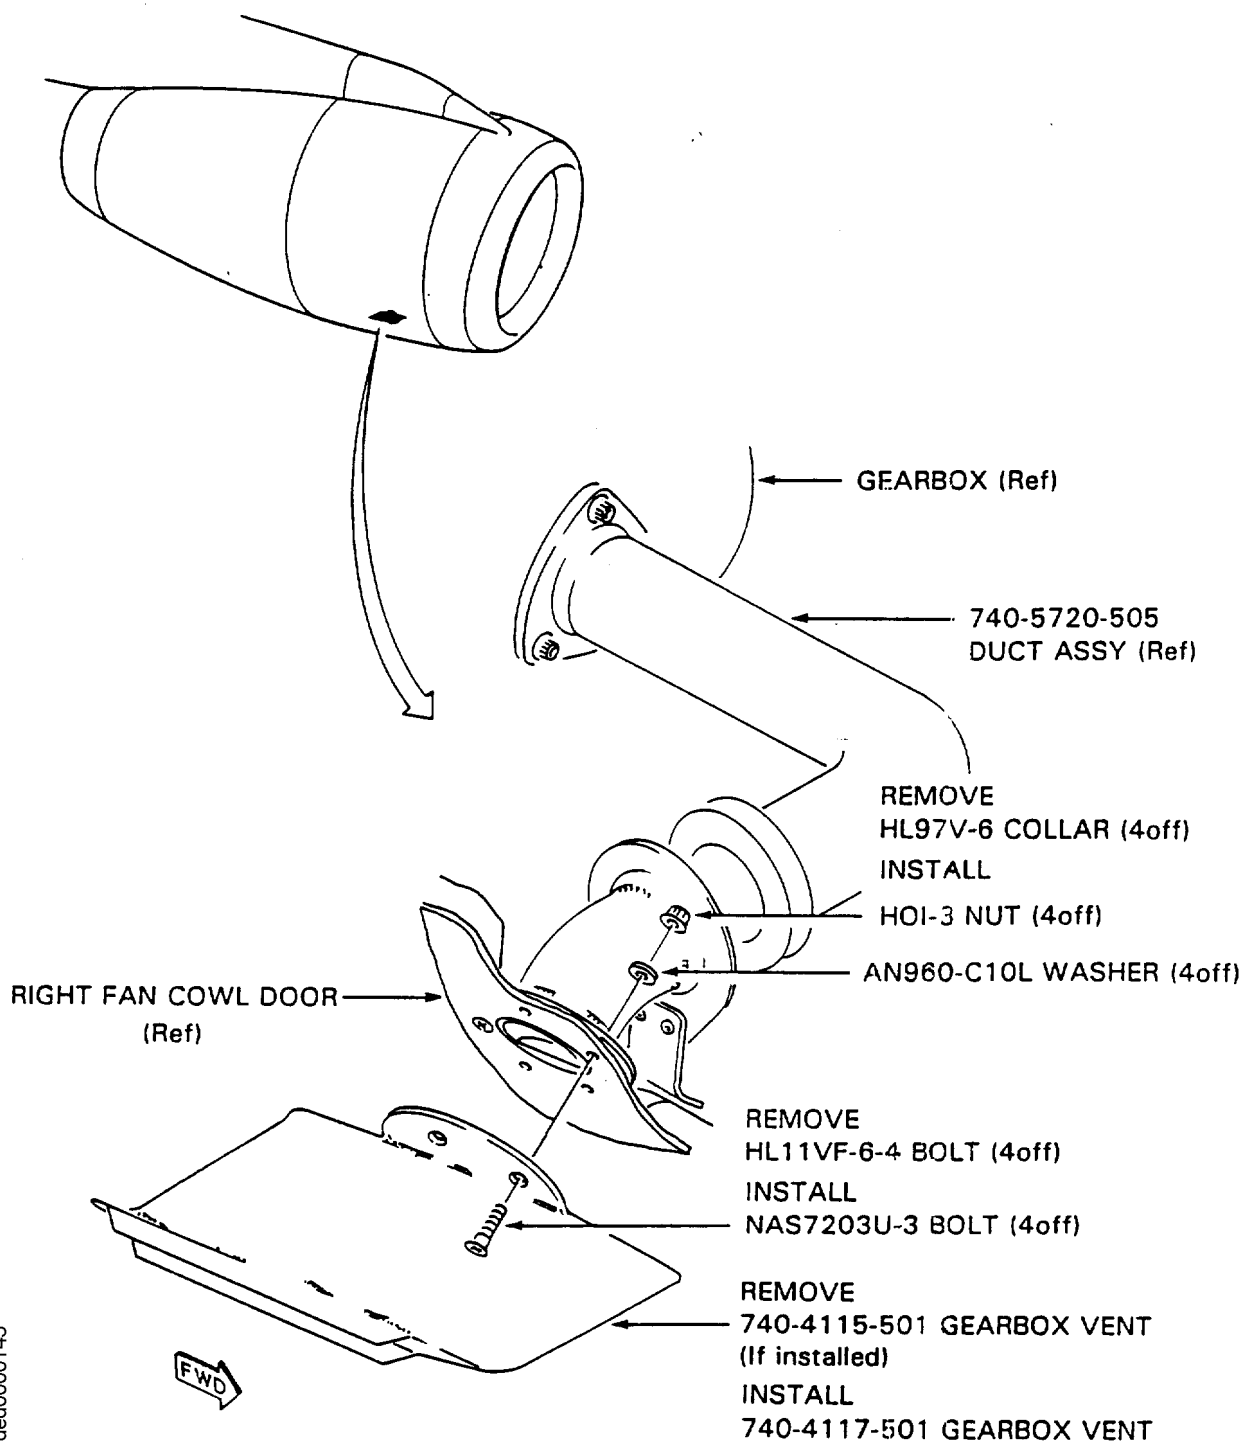
REPLACEMENT OF THE GEARBOX VENT
Fig.1

Airbus Industries have requested changes to the design of the gearbox breather vent to improve oil dispersion.

To prevent staining of the fan cowl door.

- (1) Remove four HL11VF-6-4 Hi-lok bolts and four HL97V-6 Hi-lok collars to release the 740-4115-501 gearbox vent. (Refer to Illustrations 1 & 2). Discard the vent, bolts and collars.

- (3) Apply PL32 Hylomar to the base of the 740-4117-501 gearbox vent and install on the 740-4002- fan cowl door with four NAS7203U-3 bolts, four H01-3 nuts and four AN960-CLOL washers. Torque the nuts to 40 lbf in (4.52 Nm).
