# NACELLE - POWER PLANT - PIPE ASSEMBLY, OIL TANK SCUPPER DRAIN - REPLACEMENT OF CATEGORY CODE 7 - MOD.NAC-71-0047

(1) Airplane: Airbus A320

(2) Nacelle: V2500-A1 Nacelles

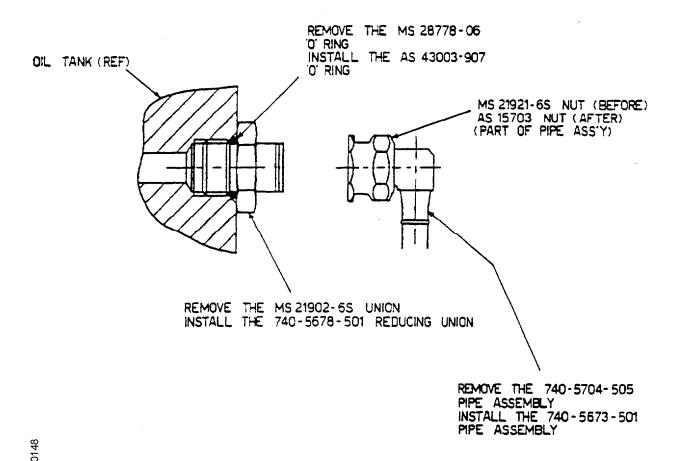
Removal/Installation of the Oil Tank Scupper Pipe Assembly (Oil Tank End) Fig.5

It is not possible to install the 740-5704-505 oil-tank, scupper-drain pipe assembly with the new oil tank.

IAE installed a new oil tank which included a reshaped scupper drain with a larger diameter outlet in a new position. The position of the oil fill and overflow connectors was also changed. Thus, the 740-5704-505 pipe assembly was not satisfactory for installation with the new oil tank.

- (c) Loosen the MS21921-6S nut which connects the 740-5704-505 pipe assembly to the MS21902-6S union at the oil tank. (Refer to Figure 5.)
  - (d) Remove the 740-5704-505 pipe assembly. Discard the pipe assembly.

- (4) Replace the union at the oil tank interface as follows: (Refer to Figure 5.)
  - (a) Remove the MS21902-6S union from the oil tank. Discard the the union and the MS28778-02 O-ring.
  - (b) Lubricate the new AS43003-907 0-ring with Co Mat V10-039 engine oil. (Refer to the V2500 Aircraft Maintenance Manual, Section 70-30-00.) Put the 0-ring on the small diameter end of the 740-5678-501 reducing union.

- (c) Install the 740-5678-501 reducing union in the new oil tank.
- (d) Torque the reducing union to 215-245 lb-in. (24.295-27.685 N.m) as specified in the V2500 Aircraft Maintenance Manual, Task 70-23-11-911-010.

- (5) Install the 740-5673-501 pipe assembly as follows:
  - (a) Set the 740-5673-501 pipe assembly in position.
  - (b) Connect the 740-5673-501 pipe assembly to the 740-5678-501 reducing union at the oil tank. Hand tighten the AS15703 nut to the reducing union. (Refer to Figure 5.)
