V2500 Propulsion System — Nacelle

SERVICE BULLETIN

NACELLE - POWER PLANT - EEC COOLING -
REMOVAL OF

V2500-NAC-71-0069
Page 1 of 18

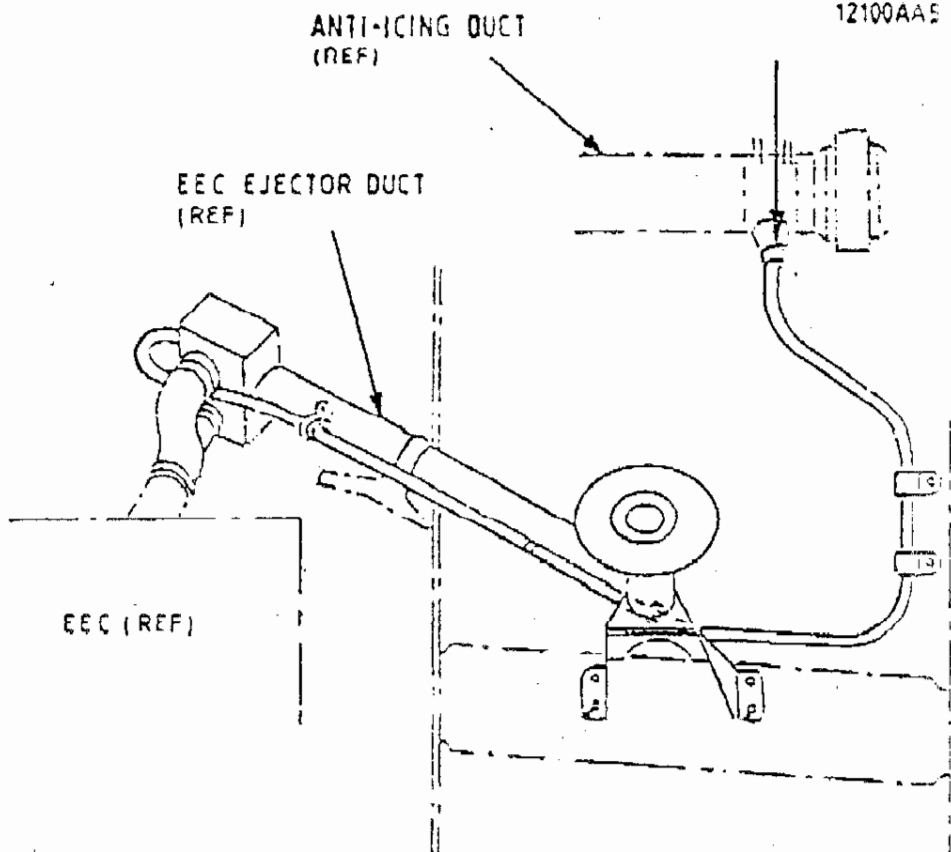
Removal of EEC Outlet Assembly
Figure 2

The EEC cooling inlet assembly and outlet assembly with associated pipes, clips, bolts, nuts, washers, and support bracket are removed from the engine fan case/fan cowl door. Blanks are bolted to the inlet and outlet holes on the fan cowl door and a blank is installed to the anti-icing duct. (Refer to Figure 2.)

- (1) Remove the EEC cooling ejector duct with instructions in V2500 Aircraft Maintenance Manual, Task 75-25-49-000-010. Discard all parts removed by this task.
- (2) Remove the EEC cooling flexible hoses with instructions in V2500 Aircraft Maintenance Manual, Task 75-28-48-000-010. Discard all parts removed by this task.
- (3) Remove the EEC cooling inlet duct with instructions in the V2500 Aircraft Maintenance Manual, Task 75-28-49-000-011. Discard all parts removed by this task except 17 (Bolt), 18 (Washer), and 19 (Nut). Install these items back to the engine flange. Torque to 100 lb-in. (11.3 N.m).
- (4) Remove the MS21902-55 union from the anti-icing duct and install a 740-5141-501 blank with a 12100AA5 seal in its place. Torque to 135-145 lb-in. (15.25-16.38 N.m).

NOTE: REFER TO THE V2500 AIRCRAFT MAINTENANCE MANUAL SECTION 75-28-49 FOR REMOVAL OF THE EEC EJECTOR DUCT.

REMOVE MS21902-SS UNION
INSTALL 740-5141-501 BLANK
12100AA5 SEAL
