POWER PLANT - NACELLE - POWERPLANT - GEARBOX BREATHER OUTLET DUCT SEAL - REPLACEMENT OF
- CATEGORY CODE 4 - MOD.NAC-71-0075

V2500-NAC-71-0075

SERVICE BULLETIN

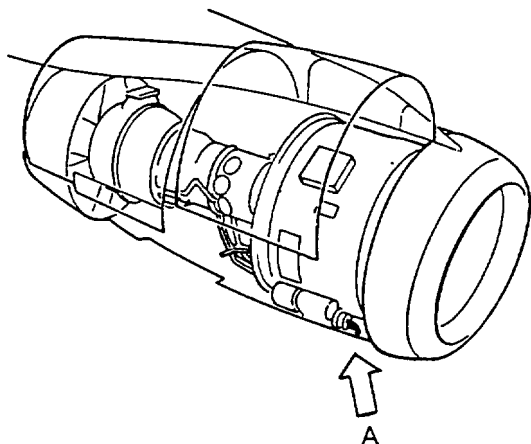
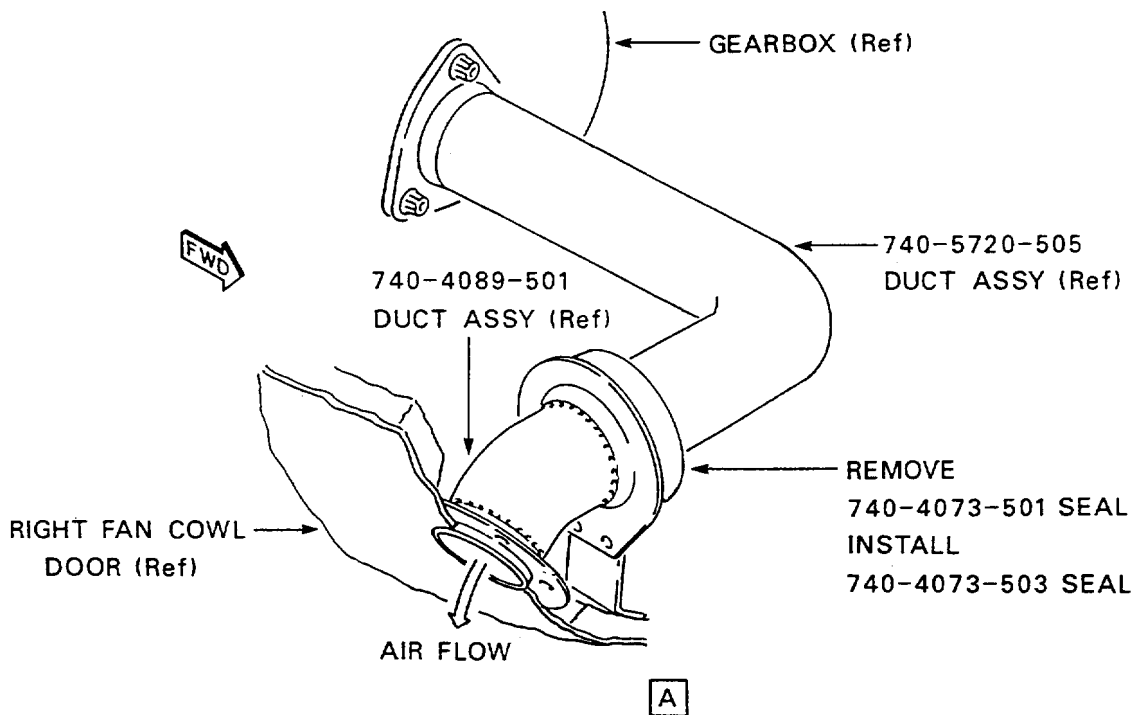
REPLACEMENT OF GEARBOX BREATHER OUTLET DUCT SEAL
Fig.1

During certain flight conditions the gearbox breather outlet duct seal may depressurize, which results in oil staining of the fan cowl door.

- (a) The silicone seal on the gearbox breather outlet duct is removed and replaced by a perforated seal.

- (1) Locate the 740-4073-501 seal on the 740-5720-505 duct assembly at the engine gearbox. (Refer to figure 1). Remove and discard the seal.
- (2) Install the 740-4073-503 seal on the 740-5720-505 duct assembly.
