V2500 Propulsion System - Nacelle **SERVICE BULLETIN**

Subject: Transmittal of Revision 5 to Service Bulletin Number V2500-NAC-71-0082

NACELLE - POWER PLANT – MOUNTS -
AFT ENGINE MOUNT BARREL NUTS - REPLACEMENT OF

V2500-NAC-71-0082

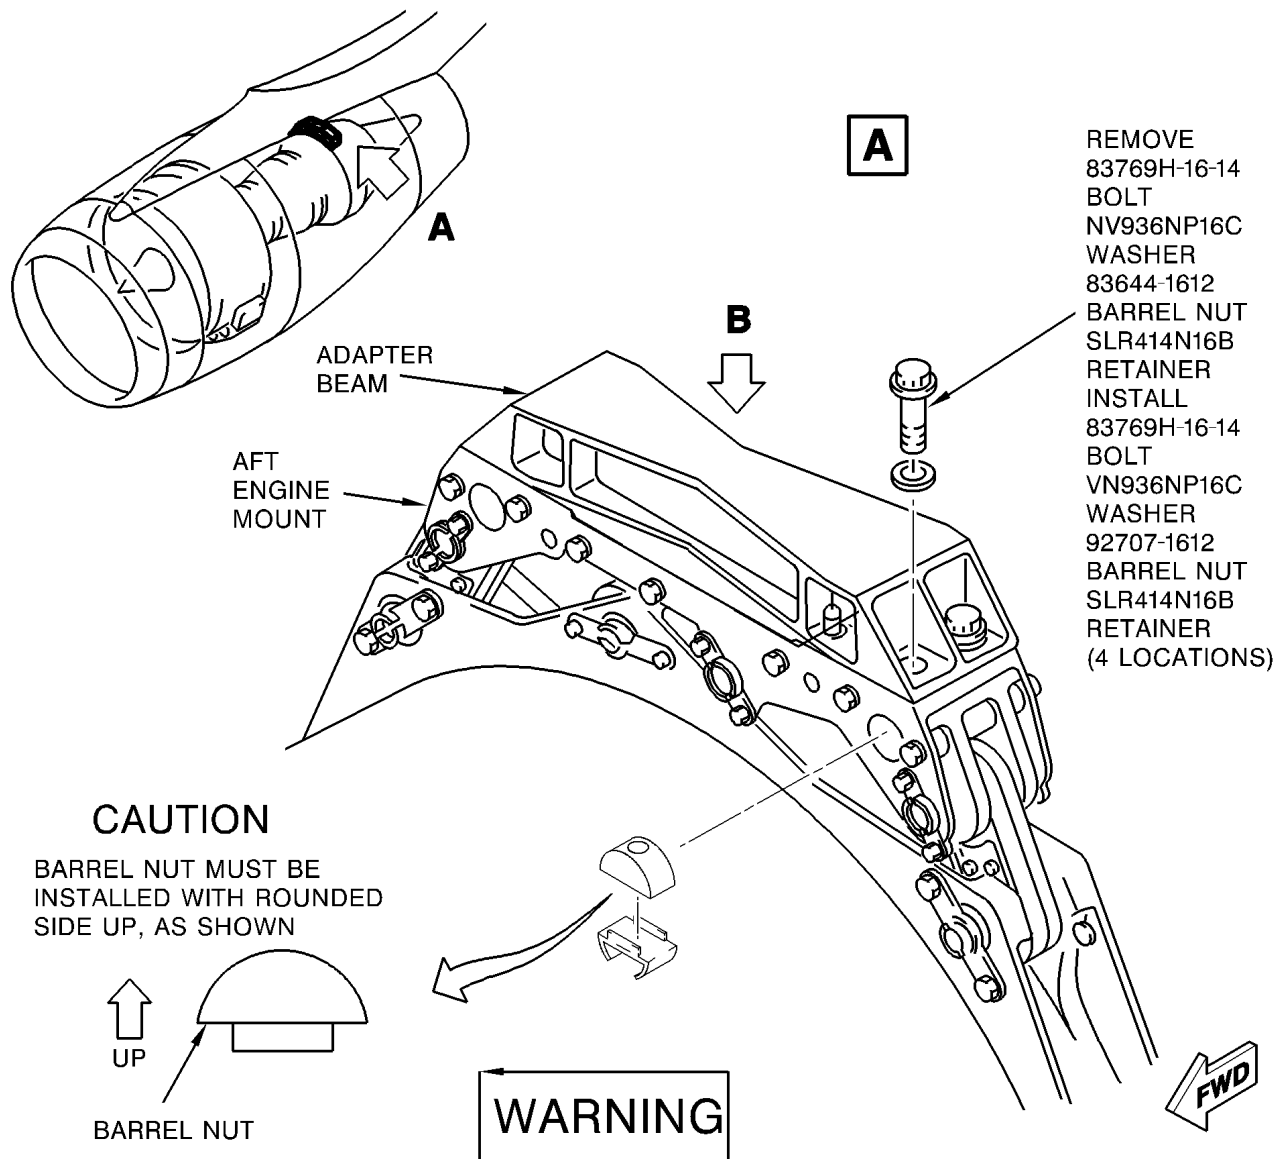
Removal and Installation of the Aft Engine Mount Barrel Nuts
Figure 1 (sheet 1)

Aft engine mount barrel nuts have been found with cracks.

- (2) Remove barrel nuts as follows (Refer to Figure 1):
 - (a) Remove one only 83769H-16-14 bolt, VN936NP16C washer, 83644-1612 barrel nut, and SLR414N16B barrel nut retainer from aft engine mount.
 - (b) Identify the nut with the engine serial number code and nut position number on the end opposite the 'X' mark.
 - 1 The engine serial number code is the last three digits of the engine serial number.
 - 2 The nut position number is the position of the indicator based on the following scheme:
 - (c) Retain bolt, washer, and retainer. Return the nut to Rohr. See paragraph 2.C..

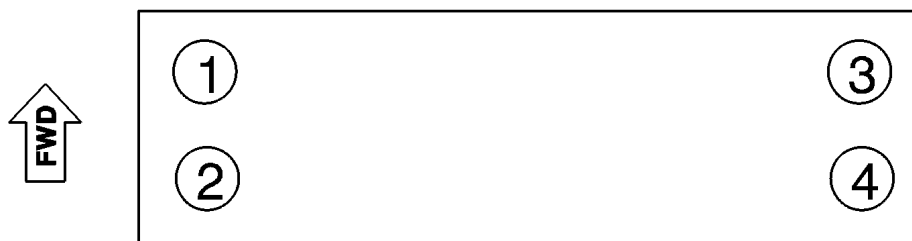
Removal and Installation of the Aft Engine Mount Barrel Nuts
Figure 1 (sheet 2)

EXAMPLE: '112/4' BEING A NUT USED ON ENGINE
SERIAL NUMBER V0112 AT MOUNT POSITION 4.
