SERVICE BULLETIN

POWER PLANT - NACELLE - POWERPLANT - FAN COWL DOOR (LH); HOLD OPEN ROD STOWAGE BRACKET
- TO RE-POSITION - CATEGORY CODE 4 - MOD.NAC-71-0096

V2500-NAC-71-0096

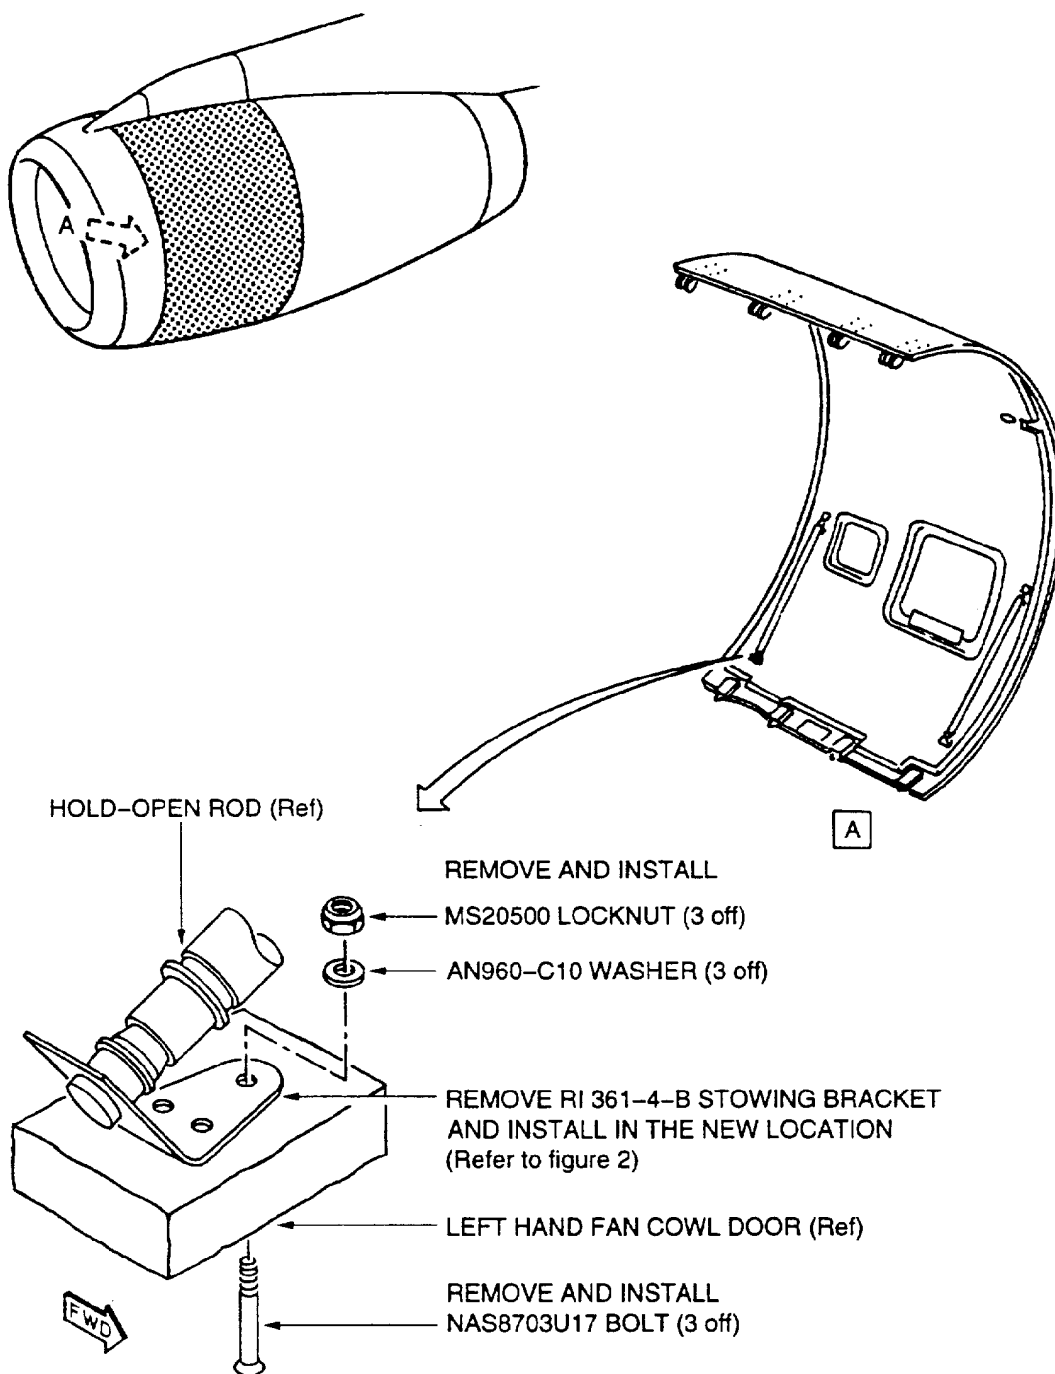
REMOVAL AND INSTALLATION OF THE STOWING BRACKET
Fig.1

When stowed, the aft hold-open rod on the LH fan cowl door may interface with the EEC Electrical Harness.

The stowing bracket for the aft hold-open rod on the LH fan cowl door is removed. It is moved over (horizontally) one hole pitch so that the bracket picks up on one of its existing holes (see Figure 1). Two new bolt holes are drilled in the fan cowl door and the stowing bracket then bolted in its new position. The two vacated bolt holes are sealed with a filler and the paint finish then restored.

- (1) Remove three NAS8703U17 bolts, three MS20500 locknuts and three AN960-C10 washers to release the RI.361-4-B stowing bracket. Remove the stowing bracket from the door (Refer to Figure 1).
- (2) Remove any sealant from the mating faces of the RI.361-4-B stowing bracket and the fan cowl door.
- (3) Install the RI.361-4-B stowing bracket back to the fan cowl door (temporarily) in its new position. Refer to Figure 2.

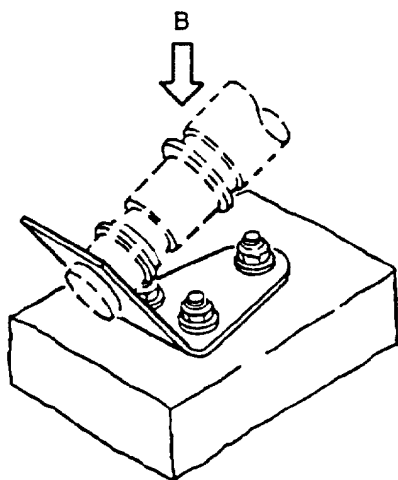
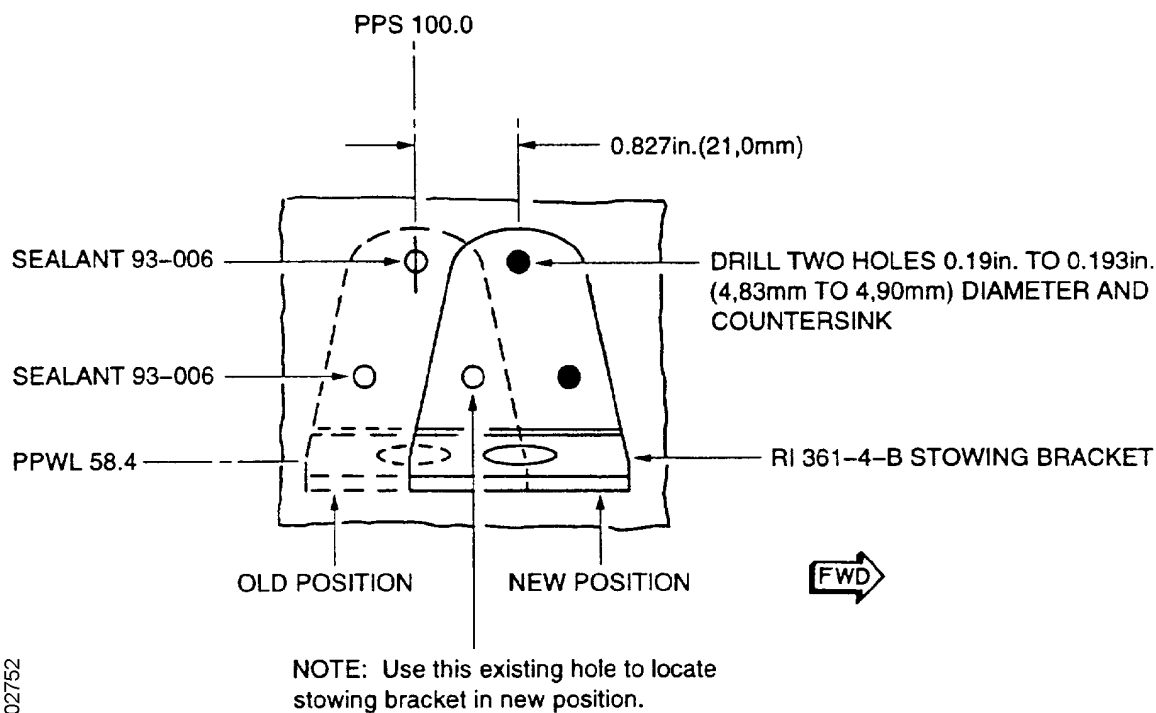
NEW LOCATION OF THE LEFT FAN COWL DOOR HOLD-OPEN ROD
Fig.2

To provide satisfactory clearance between the hold-open rod and the harness.

- (4) Drill two holes, .190/.193in (4.83/4.90mm) diameter through the fan cowl door, from the stowing bracket and remove all burrs.
- (5) Countersink the external surface of the fan cowl door (for the installation of two NAS8703U17 bolts) 100 deg by .049in deep.

- (7) Apply PL32M jointing compound to the mating face of the RI.361-4-B stowing bracket and install it in its new position.
- (8) Wet install with PL32M jointing compound: three NAS8703U17 bolts, three MS20500 locknuts and three AN960-C10 washers. Torque the nuts to 40 lbf in (4.52 Nm).

- (9) Put sealant (CoMat 08-033) in the two remaining holes and make it level with the internal and external surfaces of the fan cowl door. Follow the manufacturers instructions for application.
- (10) Paint the fan cowl door as necessary. Refer to the A320/V2500-A1/A320/A321/V2500-A5 Engine Manual (E-V2500-1IA), chapter 71-11-11.
