**International
Aero Engines**

V2500 Propulsion System — Nacelle

SERVICE BULLETIN

NACELLE - EXHAUST - GUIDE PIN, NO.1 OPEN LATCH INDICATOR, THRUST
REVERSER - REPLACEMENT OF

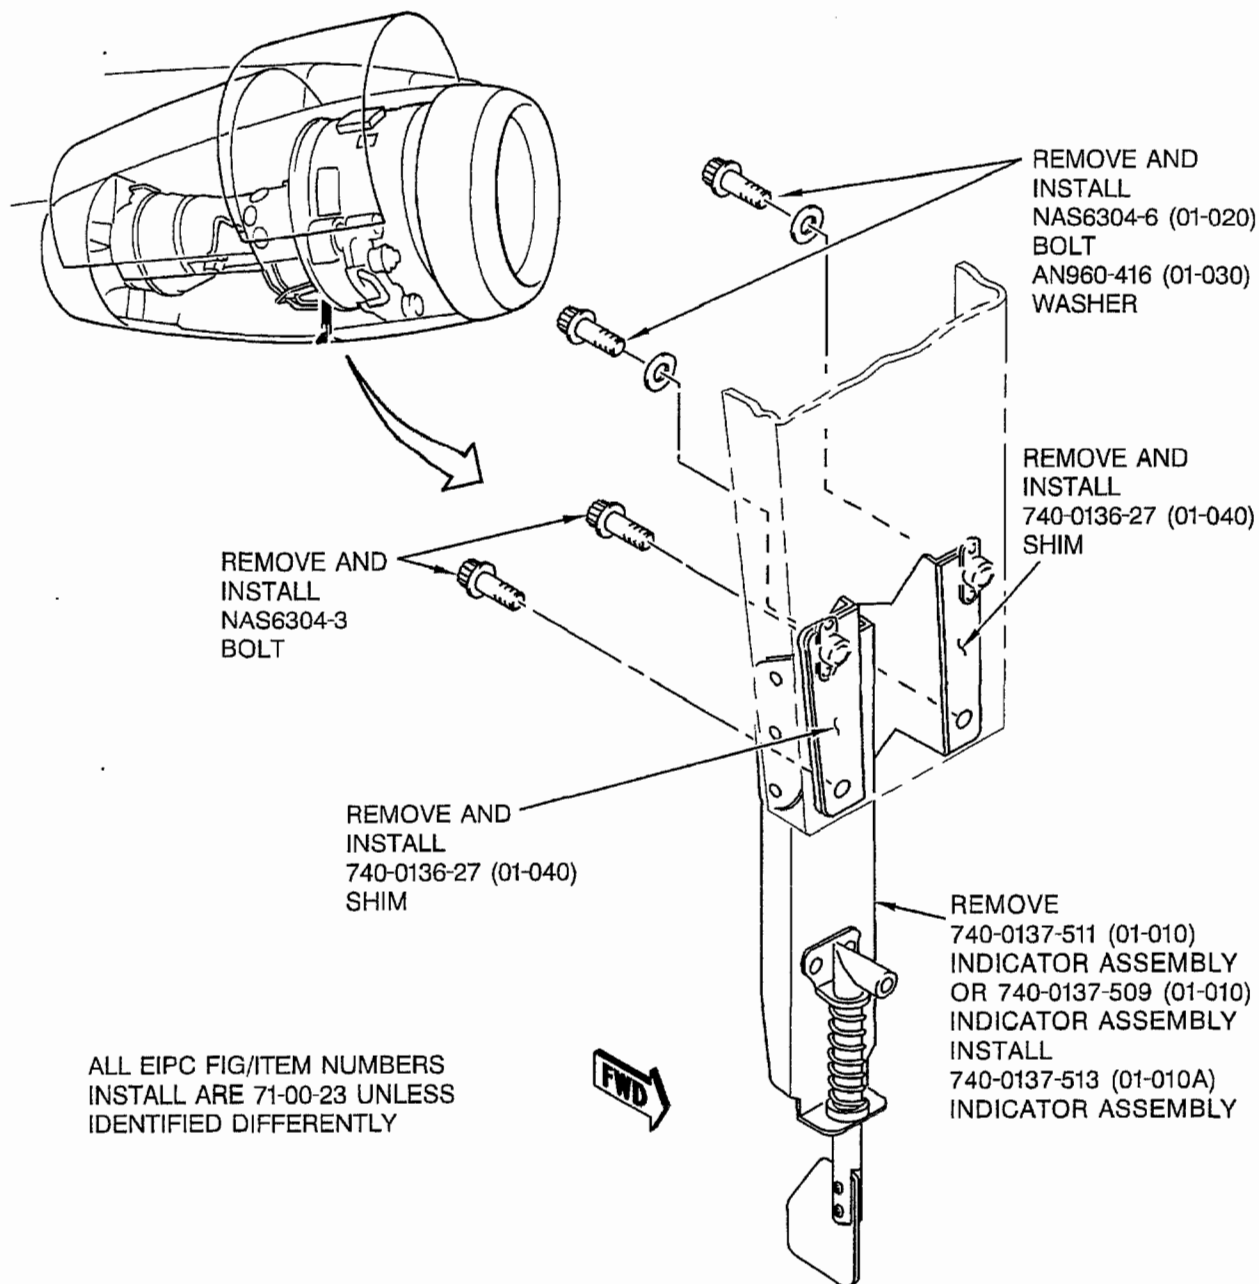
NO. 1 Open Latch Indicator Assembly Removal And Installation
Figure 1

The guide pin in the No. 1 latch indicator guide tube assembly may become loose.

Operators have experienced loose guide pins caused by a too small retainer pin.

- (1) Remove the No. 1 open latch indicator assembly.
 - (a) Remove the two NAS6304-6 bolts and AN960-416 washers, two NAS6304-3 bolts, 740-0137-509 indicator assembly, and the 740-0136-27 shims from the engine. Keep the bolts and shims. Refer to Figure 1.
- (2) Install the No. 1 open latch indicator assembly.
 - (a) Install the 740-0137-513 indicator assembly and 740-0137-27 shims on the engine with the two NAS6304-3 bolts, two NAS6304-6 bolts, and AN960-416 washers. Tighten the NAS6304-3 and NAS6304-6 bolts to a torque of 50-70 in-lbs (5.649-7.909 Nm).

- (1) Remove the No. 1 open latch indicator assembly.
 - (a) Remove the two NAS6304-6 bolts and AN960-416 washers, two NAS6304-3 bolts, 740-0137-511 indicator assembly, and the 740-0136-27 shims from the engine. Keep the bolts and shims. Refer to Figure 1.
- (2) Disassemble the No. 1 open latch indicator assembly.
 - (a) At the top end of the guide tube, drill out the two MS20427M5-5 rivets that attach the guide tube bracket to the indicator assembly with a 0.161-0.165 inch (4.089-4.191 mm) drill. Refer to Figure 2.
 - (b) Remove the guide tube, with the indicator flag and the

- (5) Install the No. 1 latch indicator assembly.
 - (a) Install the 740-0137-513 indicator assembly and 740-0137-27 shims on the engine with the two NAS6304-3 bolts, two NAS6304-6 bolts, and AN960-416 washers. Tighten the NAS6304-3 and NAS6304-6 bolts to a torque of 50-70 in-lbs (5.649-7.909 Nm).
