SERVICE BULLETIN

NACELLE POWER PLANT - FAN COWL DOOR - HOLD-OPEN STRUT BRACKET - REWORK OF - CATEGORY
CODE 4 - MOD.NAC-71-0102

V2500-NAC-71-0102

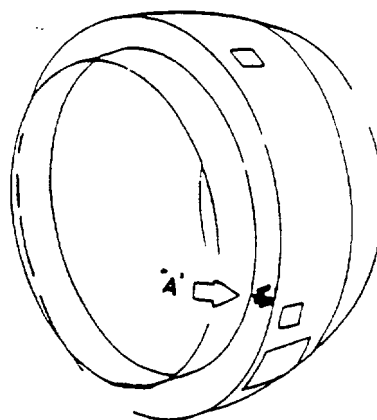
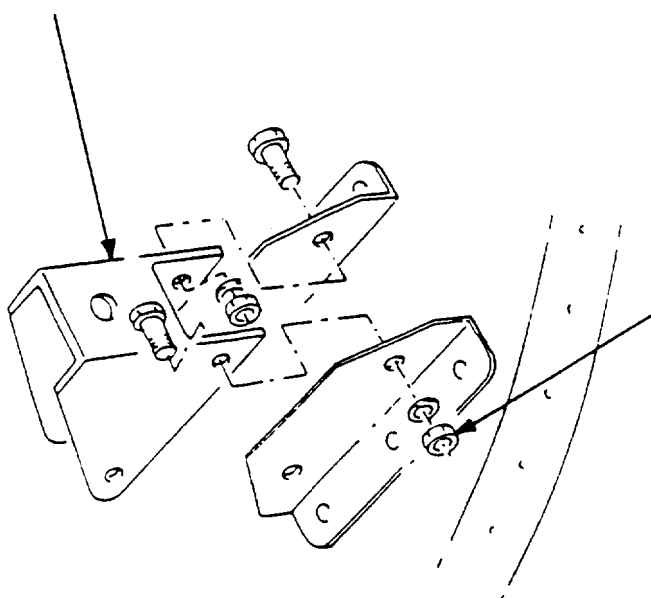
Removal/Installation of Hold-Open Strut Bracket
Fig.2

The bracket for locating the forward hold-open strut-rod on the right fan cowl door may cause a foul with the insulation blanket around the gimbal joint on the TAI air supply pipe.

- (a) The hold-open strut bracket on the rear bulkhead of the inlet cowl is removed. The bracket is modified and reinstalled (ref: Figures 1 AND 2).

- (1) Remove four A104-0-5D bolts, four AN960-C10L washers, and four AS8623-D nuts to release the 740-3086-501 bracket. (Refer to Figure 2.)
- (2) Cut the corner off the 740-3086-501 bracket to form the 740-3086-503 bracket. (Refer to Figure 3.) Remove any burrs from the bracket and identify it to the new part number 740-3086-503 with a vibro-etch engraver.
- (3) Install the 740-3086-503 bracket with the four bolts, four nuts, and four washers kept in paragraph 2.B.(1). Torque the nuts to 40 lb-in. (4.52 N.m). Engage the hold-open strut-rod in the new bracket and examine for a satisfactory clearance.
- (4) Reidentify inlet cowl from 740-3000-585 to 740-3000-593.

REMOVE
740-3086-501 BRACKET
INSTALL
740-3086-503 BRACKET

REMOVE AND INSTALL
A104-0-50 BOLT (4)
AN960-C10L WASHER (4)
AS8623-D NUT (4)
