## SERVICE BULLETIN

POWER PLANT - NACELLE - POWERPLANT - GEARBOX BREATHER OUTLET DUCT - REPLACEMENT OF -  
CATEGORY CODE 5 - MOD.NAC-71-0128

# V2500-NAC-71-0128

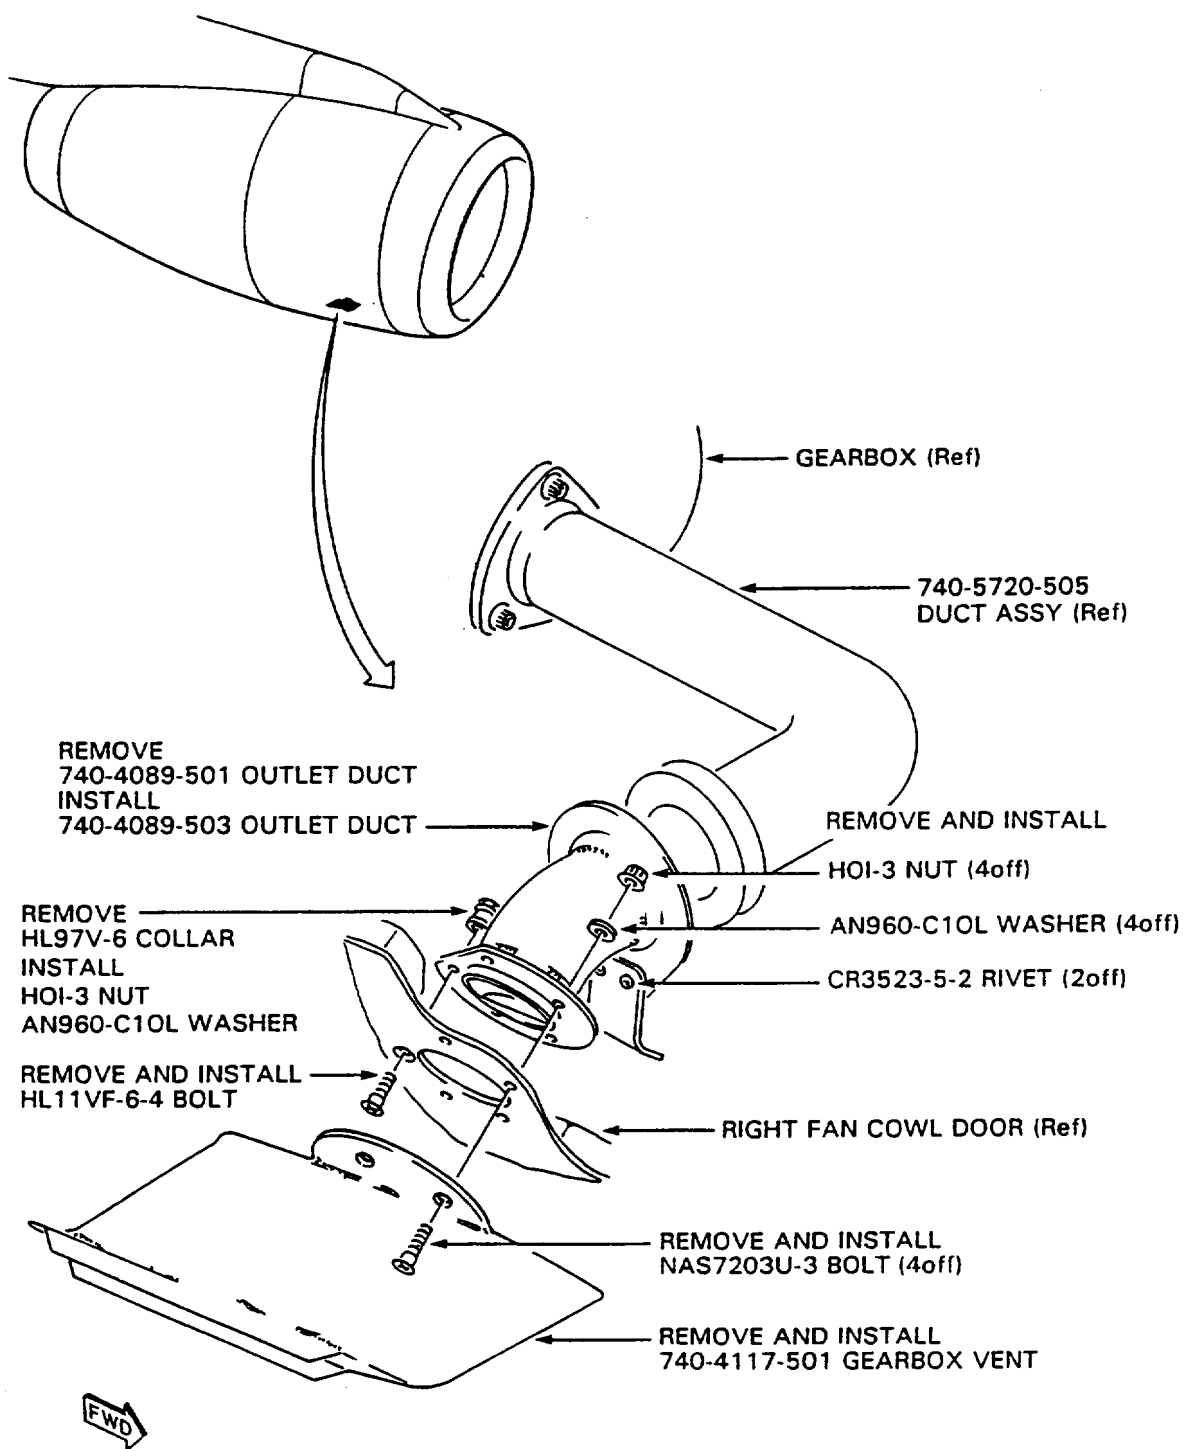
REPLACEMENT OF THE GEARBOX BREATHER OUTLET DUCT  
Fig.1

Introduction of the gearbox breather vent may cause an oil well to form between it and the breather outlet duct. Trapped oil may then leak and cause staining of the fan cowl door.

- (1) Remove and retain four NAS7203U-3 bolts, four AN960-C101 washers and four H01-3 nuts to release the gearbox vent. Retain the gearbox vent also. Refer to figure 1.
- (2) Remove the HL11VF-6-4 Hi-lok bolt and HL97V-6 Hi-lok collar from the outlet duct. Discard the Hi-lok collar.
- (3) Drill out two CR3523-5-2 rivets to release the outlet duct. Remove the outlet duct.

- (4) Clean the mating faces of the outlet duct with trichloroethylene solvent and leave to dry. Apply a liberal coat of PR1422B2 sealant to the mating faces.
- (5) Rivet the new outlet duct in position with two CR3523-5-2 rivets.
- (6) Install the HL11VF-6-4 Hi-lok bolt and safety with an AN960-C10L washer and H01-3 nut. Torque the nut to 40 lbf in.(4.522 Nm).
- (7) Install the gearbox vent back in position with five NAS7203U-3 bolts, four AN960-C10L washers and four H01-3 nuts. Torque bolts to 40 lbf in (4.52Nm).
- (8) Remove any unwanted sealant with a clean rag and leave to cure in accordance with the manufacturers recommendations.
