POWER PLANT - NACELLE - POWERPLANT - GEARBOX BREATHER - OUTLET DUCT - SEALING COMPOUND
- REPLACEMENT OF - CATEGORY CODE 5 - MOD.NAC-71-0133

(1) Airplane: Airbus A320

V2500-NAC-71-0133

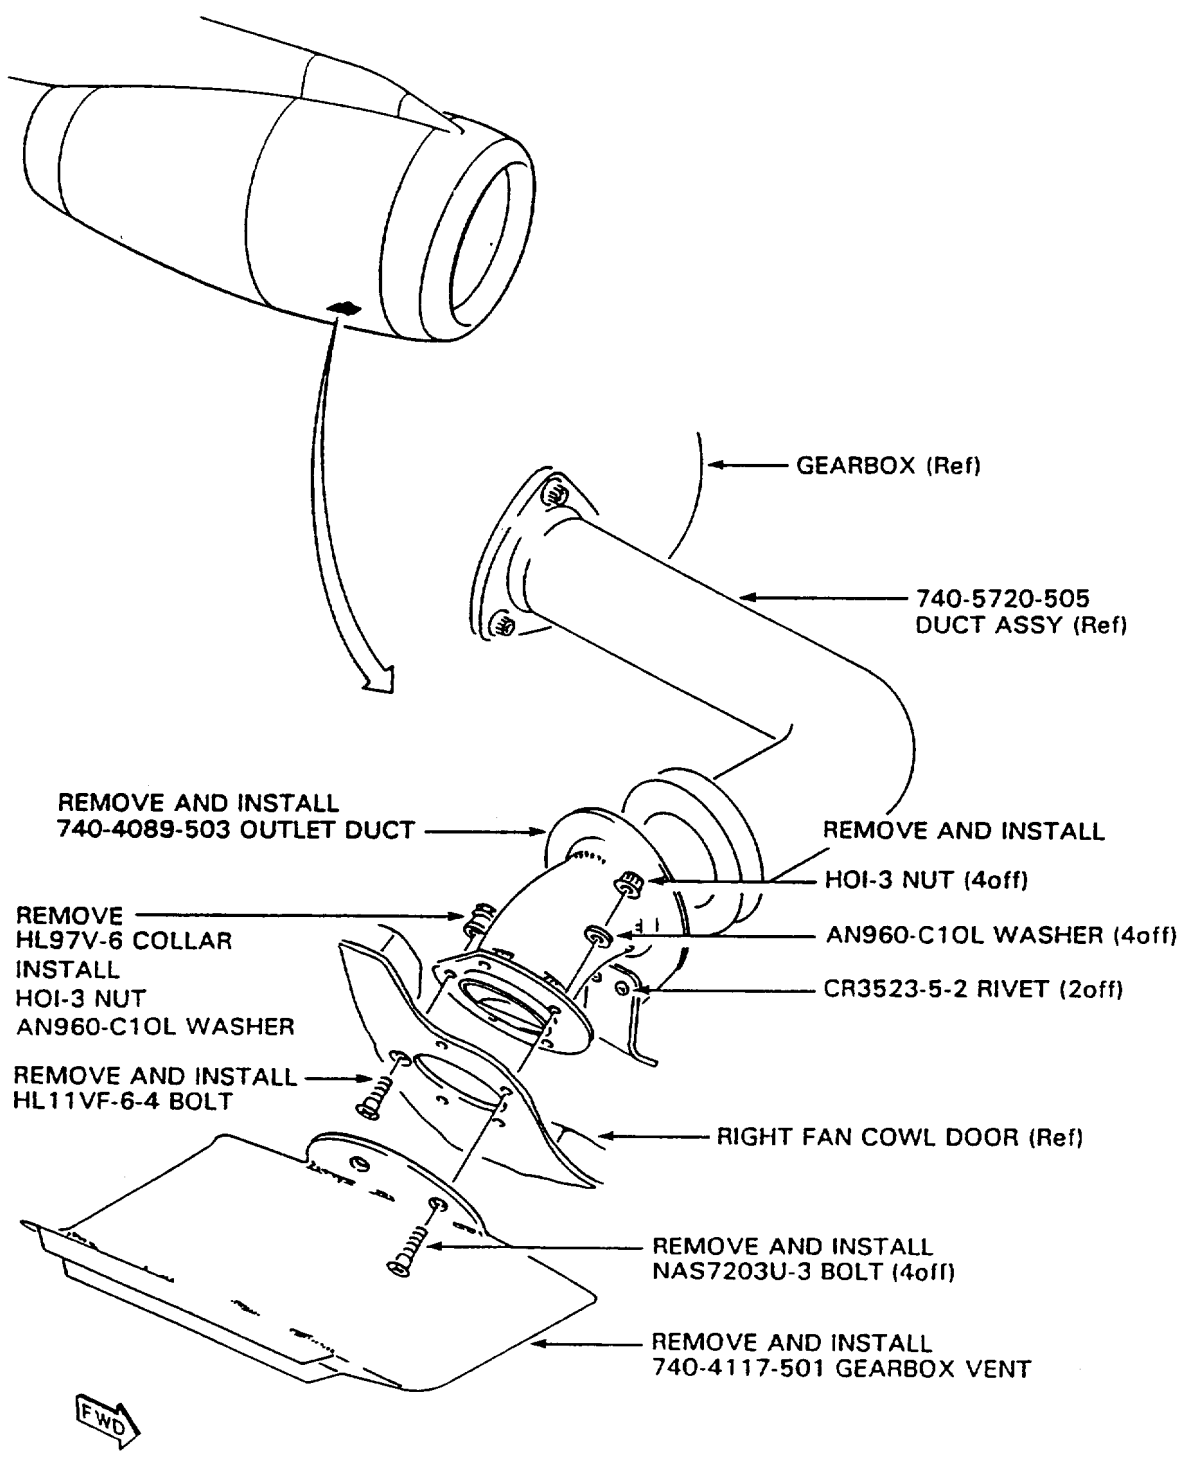
REPLACEMENT OF SEALANT
Fig.1

Oil mist from the gearbox breather pipe is condensing in the gearbox breather outlet duct and collecting in an oil trap between the outlet duct and gearbox vent. The trapped oil is leaking between the outlet duct flange and the fan cowl door inner skin. The oil escapes through a drain hole in the pandown for the outlet duct and causes staining of the F.C.D.

- (1) Open the right hand fan cowl door with instructions in the A320/V2500 Aircraft Maintenance Manual, Task 72-13-00-010-010.
- (2) Find the gearbox breather outlet at the bottom, forward part of the right hand fan cowl door. Refer to figure 1.

- (1) Remove and retain four NAS7203U-3 bolts, four AN960-C101 washers and four H01-3 nuts to release the gearbox vent. Retain the gearbox vent also. Refer to figure 1.
- (2) Remove the HL11VF-6-4 Hi-lok bolt and HL97V-6 Hi-lok collar from the outlet duct. Discard the Hi-lok collar.
- (3) Drill out two CR3523-5-2 rivets to release the outlet duct. Remove the outlet duct.

(4) Clean the mating faces of the outlet duct with trichloroethylene solvent and leave to dry. Apply a liberal coat of PR1422B2 sealant to the mating faces.

(5) Rivet the outlet duct back in position with two CR3523-5-2 rivets.

(6) Install the HL11VF-6-4 Hi-lok bolt and safety with an AN960-C10L washer and H01-3 nut. Torque nut to 40 lbf in. (4.52NM).

(7) Install the gearbox vent back in position with four NAS7203U-3 bolts, four AN960-C10L washers and four H01-3 nuts. Torque nuts to 40 lbf in (4.52 Nm).

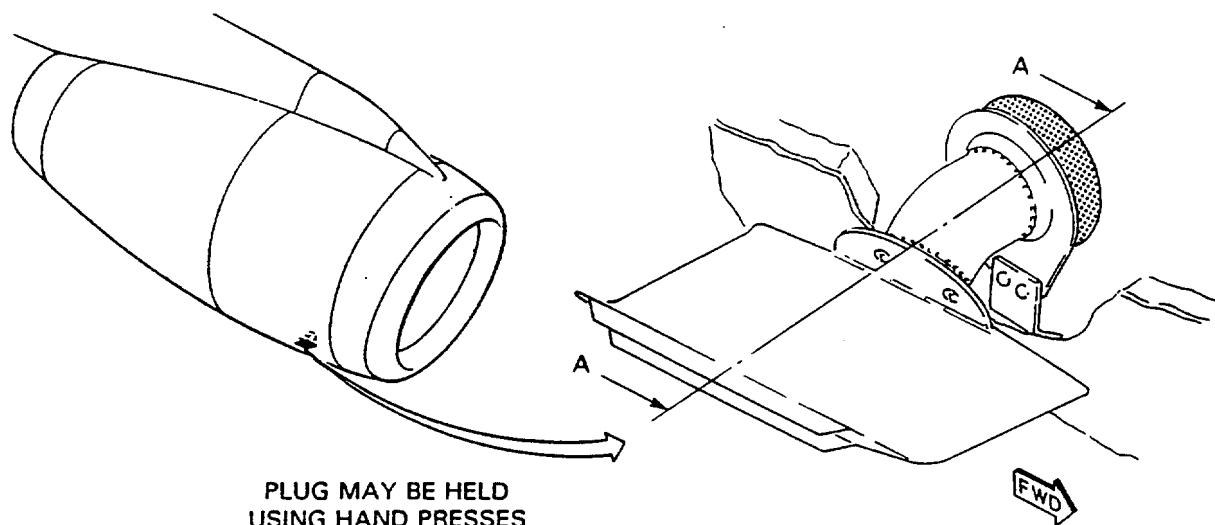
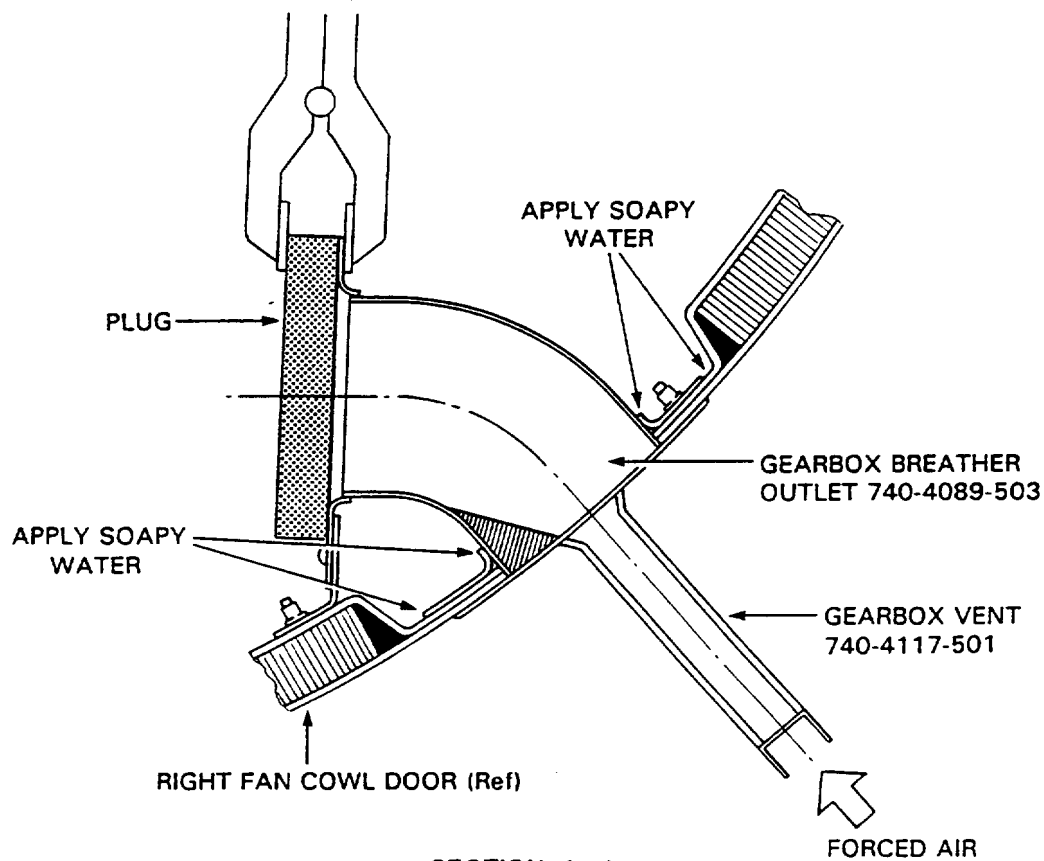
LEAK TEST
Fig.2

PLUG MAY BE HELD
USING HAND PRESSES

- (1) Do a pressure test of the gearbox breather outlet duct as follows (Refer to Figure 2):
 - (a) Make a plug equal to the diameter of the outlet duct from 0.25 in.(6mm) thick (approximate) silicone rubber sheet.

- (b) Put the plug on the end of the gearbox breather outlet duct (GBOD) as shown. Use hand presses as necessary to provide an effective seal.
 - (c) Put soapy water around the sealed edge of the GBOD as shown.
 - (d) Blow forced air through the gearbox vent and examine for leaks around the sealed edge of the GBOD.
 - (e) If air leaks are found, remove the GBOD and apply sealant again with instructions in step 2.B.
- (2) Close the right fan cowl door with instructions in the A320/V2500 Aircraft Maintenance Manual, Task 71-13-00-410-010.
