International
Aero Engines

SERVICE BULLETIN

**NACELLE - POWER PLANT - FORWARD MOUNT INCREASED CLEARANCE MONOBALL STOP
AND INCREASED STRENGTH BOLT UPGRADE**

V2500-NAC-71-0135
Page 1 of 23

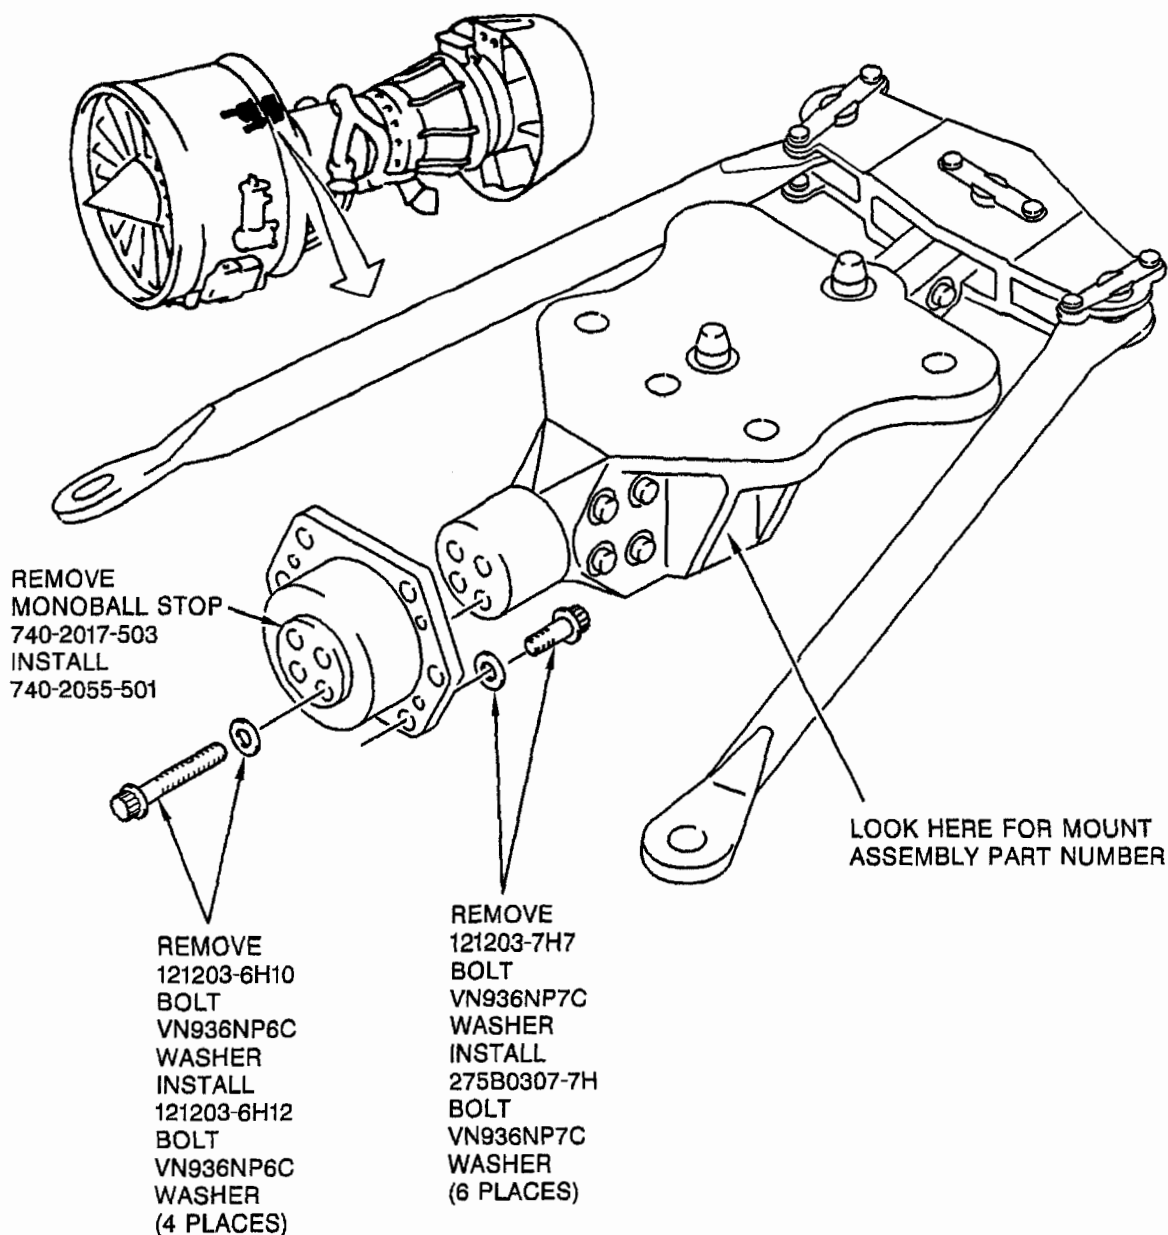
Replacement of Engine Mount Bolts and Monoball Stop
Figure 1

Part 1 - The V2500-A1 forward engine mount assembly secondary load path does not meet the thrust load specification requirements of the V2500-A5 engine models.

Part 1 - Removes the forward engine mount monoball stop and associated hardware, and installs a new monoball stop with improved clearances, longer monoball stop-to-engine mount attach bolts installed with engine oil to increased torques, and new high strength monoball stop-to-engine attach bolts.

- (1) Remove the forward engine mount from the engine. Refer to the A320/V2500-A1/A320/A321/V2500-A5 Engine Manual, Task 71-00-32-350-001. Discard the six 121203-7H7 bolts. Keep the washers.
- (2) Remove the lockwire, four bolts 121203-6H10, four washers VN936NP6C and the monoball stop. Discard the bolts and monoball stop. Keep the washers. Refer to Figure 1.

- (4) Install the monoball stop 740-2055-501 with four bolts 121203-6H12 and washers VN936NP6C. Lubricate the bolts with CoMat 10-077 engine oil. Torque the bolts to 520-630 lb-in. (58.7-71.2 N.m).
- (5) Safety the bolts with lockwire (CoMat 02-147).
- (6) Re-identify the forward engine mount assembly as instructed in Part 3 of this service bulletin.
- (7) A record of accomplishment is required. Note in the aircraft log that Service Bulletin V2500-NAC-71-0135, Part 1 has been incorporated.

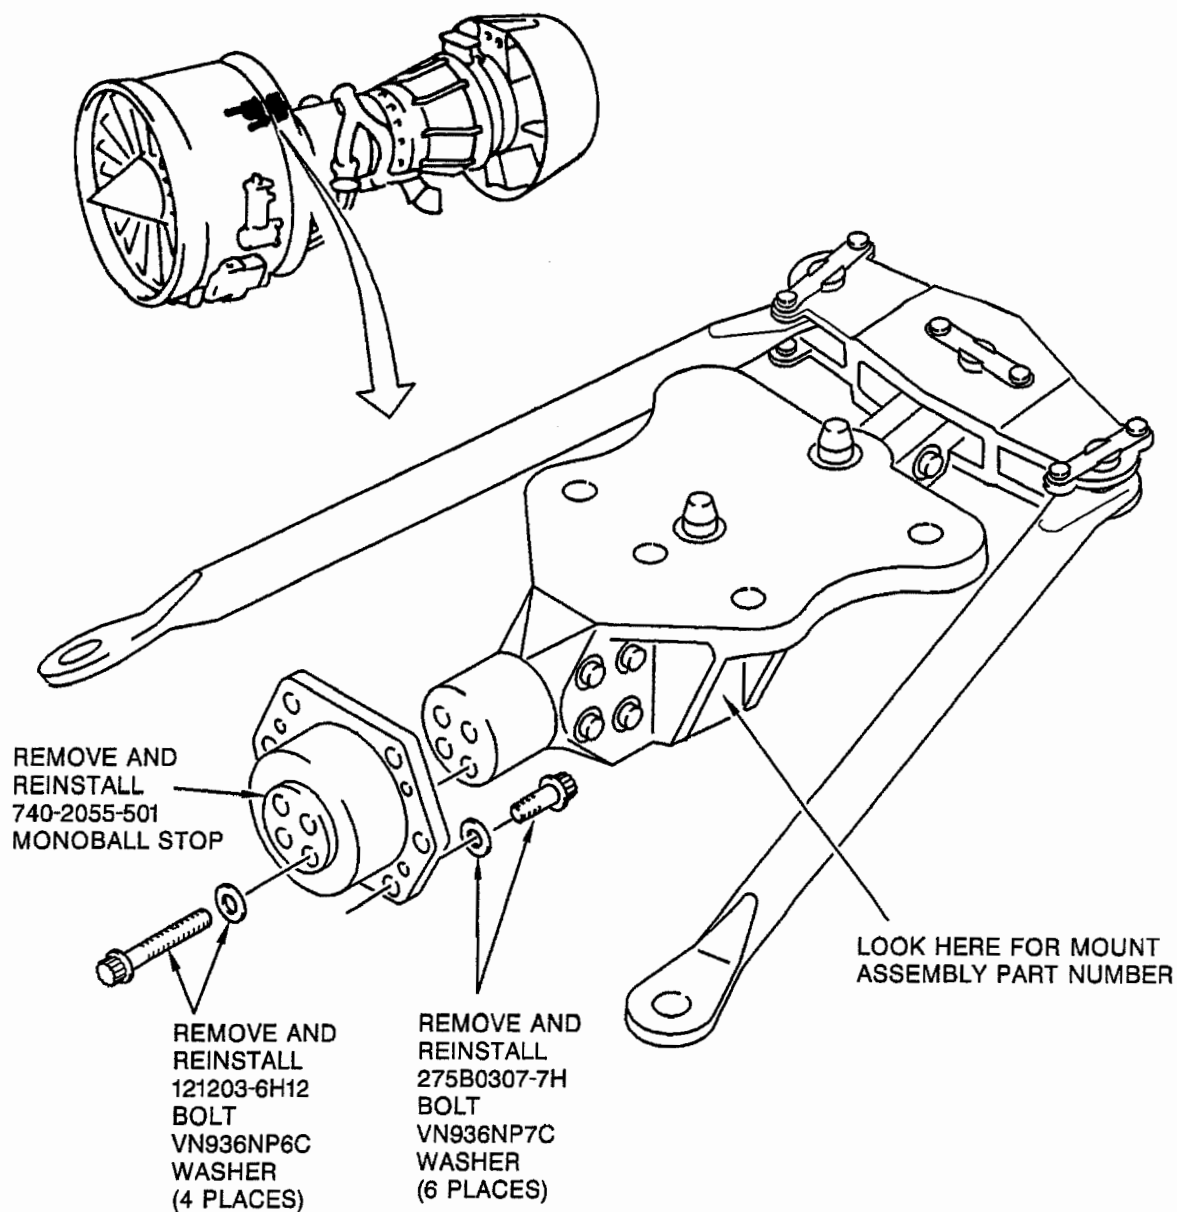
Engine Mount Bolts Intallation and Re-Torque
Figure 2

Part 2 - The torque specification on some forward engine mount assembly monoball stop bolts, 121203-6H12, was not to the latest standard. The torque of the monoball stop bolts must be correct to ensure the secondary load path meets the thrust load specifications of the V2500-A5 engine models.

Part 2 - Removes the monoball stop bolts and monoball stop and reinstalls the same bolts lubricated with engine oil and tightened to increased torques.

- (1) Remove the forward engine mount from the engine. Refer to the A320/V2500-A1/A320/A321/V2500-A5 Engine Manual, Task 71-00-32-350-001. Keep the bolts and washers.
- (2) Remove the lockwire, four bolts 121203-6H12, four washers VN936NP6C and the monoball stop. Keep the bolts, the washers and the monoball stop. Refer to Figure 2.

- (4) Install the monoball stop 740-2055-501 with the bolts 121203-6H12 and washers VN936NP6C. Lubricate the bolts with CoMat 10-077 engine oil. Torque the bolts to 520-630 lb-in. (58.7-71.2 N.m).
- (5) Safety the bolts with lockwire (CoMat 02-147).
- (6) Re-identify the forward engine mount assembly as instructed in Part 3 of this service bulletin.
- (7) A record of accomplishment is required. Note in the aircraft log that Service Bulletin V2500-NAC-71-0135, Part 2 has been incorporated.

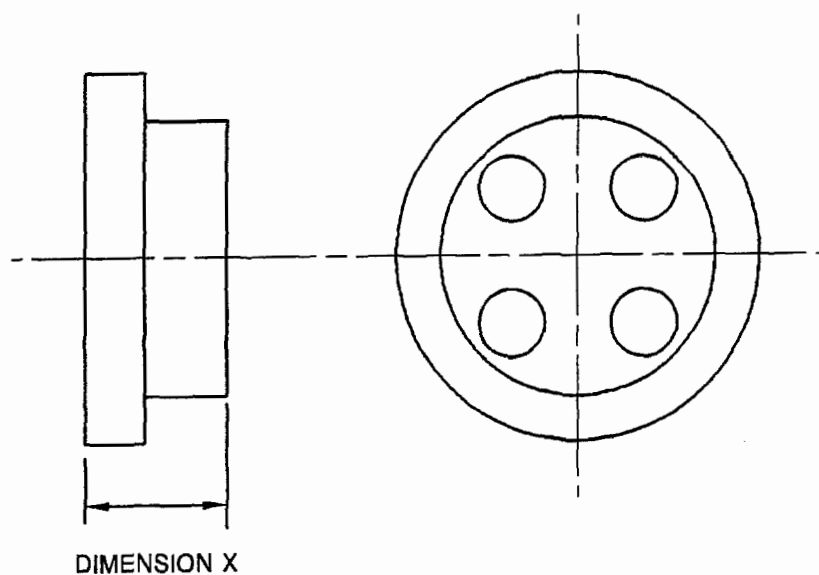
Monoball Stop Dimension Check
Figure 3

(c) If you cannot find a monoball stop part number, measure the monoball stop as shown in Figure 3.

1 If the monoball stop dimension X measurement is 0.836 inch (21.23 mm), re-install the monoball stop as instructed in Part 2 of this service bulletin and re-identify the mount as instructed in Part 3.

2 If the monoball stop dimension X measurement is 0.730 inch (18.54 mm), replace with the 740-2055-501 monoball stop as instructed in Part 1 of this service bulletin and re-identify the mount as instructed in Part 3.

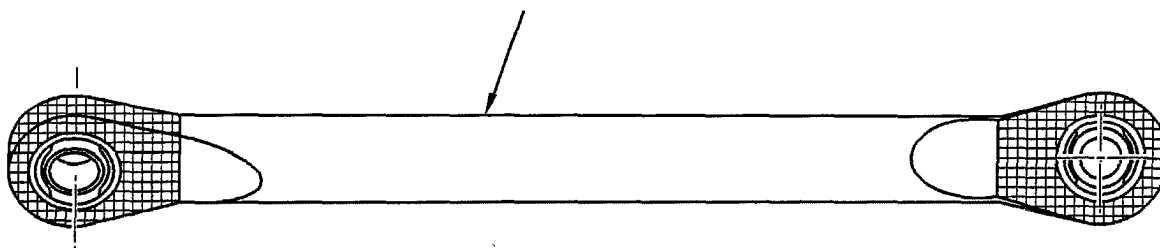
Visual Inspection of the Forward Engine Mount Link
Figure 4

- (3) Visually inspect the forward engine mount links, 740-2018-501 and 740-2018-502 for cracks or failure. Use a mirror to inspect all sides of the links in the areas indicated in Figure 4. Do not remove the links to do this inspection.

INSPECT FOR CRACKS OR FAILURE
IN THESE AREAS OF THE LINKS
(LINK SHOWN REMOVED FOR CLARITY)

- (a) If any link is bad, and the engine mount part number is 740-2010-513 but without the letter "N" or a revision of "N" or later, you must replace the bad link(s) (Refer to the Engine Manual TASKs 71-21-12-030-001 and 71-21-12-430-001) and do Parts 2 and 3 of this service bulletin.

- (b) If any link is bad, and the engine mount part number is other than 740-2010-513, you must replace the bad link(s) (Refer to the Engine Manual TASKs 71-21-12-030-001 and 71-21-12-430-001) and do Parts 1 and 3 of this service bulletin.
- (c) If any link is bad, and you cannot find a part number on the forward engine mount assembly, you must replace the bad link(s) (Refer to the Engine Manual TASKs 71-21-12-030-001 and 71-21-12-430-001) and do the procedures in paragraph 2.B.(4).
