International Aero Engines

SERVICE BULLETIN

<u>POWER PLANT - NACELLE - EXHAUST - STAINLESS STEEL GUIDE PADS, NO. 1 OPEN LATCH INDICATOR, THRUST REVERSER - ADDITION OF - CATEGORY CODE 8 - MOD.NAC-71-0137</u>

V2500-NAC-71-0137

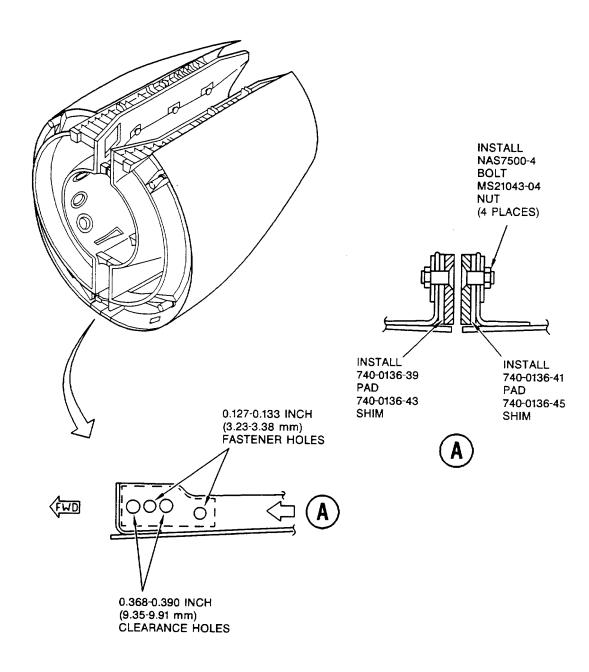
No. 1 Latch Open Indicator Guide Pad Installation Fig.1

The No. 1 open latch indicator has excessive lateral movement and can jam.

Present open latch indicator installation can give false open indication.

- (c) Put the shims and pads into position on the thrust reverser lower track and backdrill two 0.156-0.163 inch (3.96-4.14 mm) holes through the lower track. Refer to Figure 1.

- (d) Temporarily install the pads and shims on the thrust reverser halves with NAS7500-04 screws and MS21043-04 nuts.
 - (e) Adjust the clearance between the latch open indicator and the pads when the thrust reverser and engine are installed on the aircraft. Refer to A320 Aircraft Maintenance Manual, Chapter 78-32-01 and 78-32-03.
