POWER PLANT - NACELLE - POWERPLANT - CORE SERVICES HARNESS - REROUTE OF - CATEGORY
CODE 8 - MOD.NAC-71-0138

V2500-NAC-71-0138

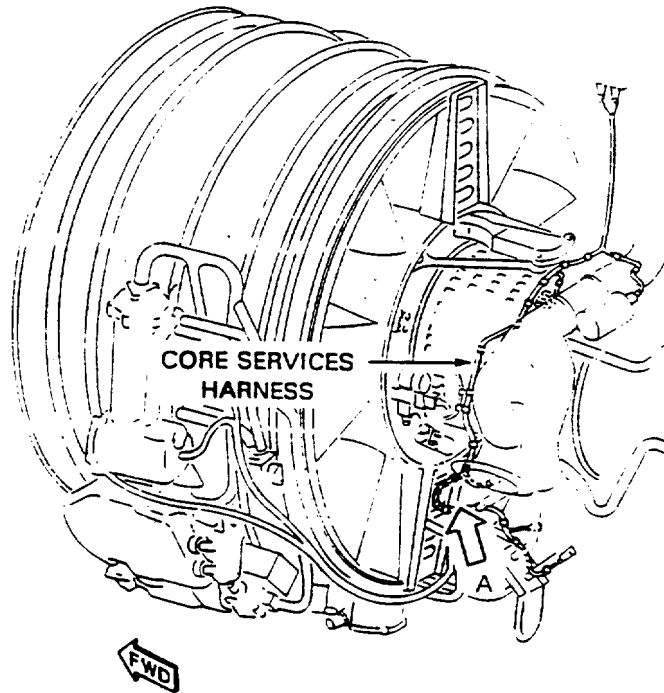
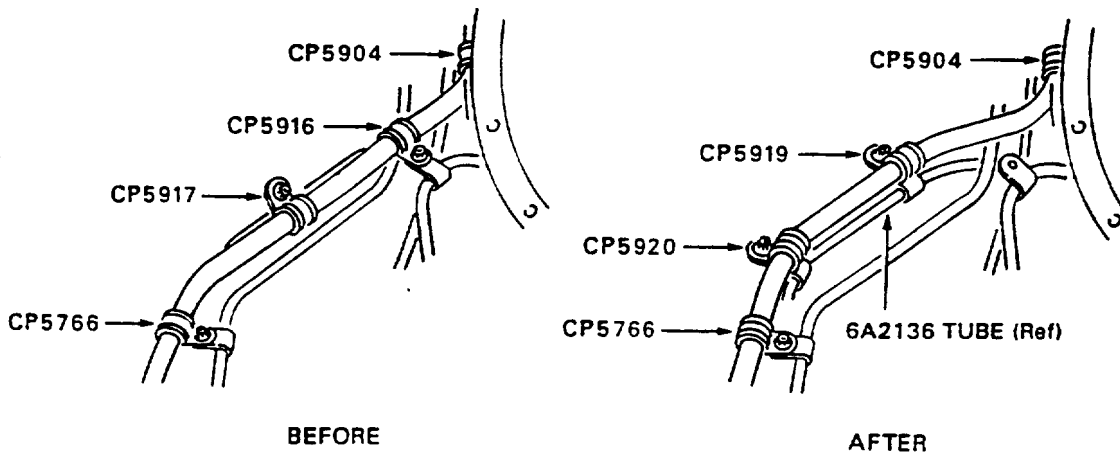
LOCATION OF CLIPPING POINT CHANGES
Fig.1

The thrust reverser deflector may touch and damage the core services harness.

- (a) Clipping points CP5916 and CP5917 on the core services harness are deleted. Two new clipping points replace them: CP5919 and CP5920. The new clipping points are attached to a pneumatic tube local to the old clipping points.

- (1) Find clipping points CP5916 and CP5917 at the bottom of the engine core. See Figure 1.
- (2) Remove the AS21407 bolt, TA025074-03 clamp, AS20624 nut, and SP154D washer from clipping point CP5916. Retain hardware for reinstallation. See Figure 2.
