International
Aero Engines

V2500 Propulsion System — Nacelle

NACELLE — POWERPLANT — RIGHT FAN COWL DOOR — INTRODUCTION OF A DRAIN HOLE

V2500-NAC-71-0142

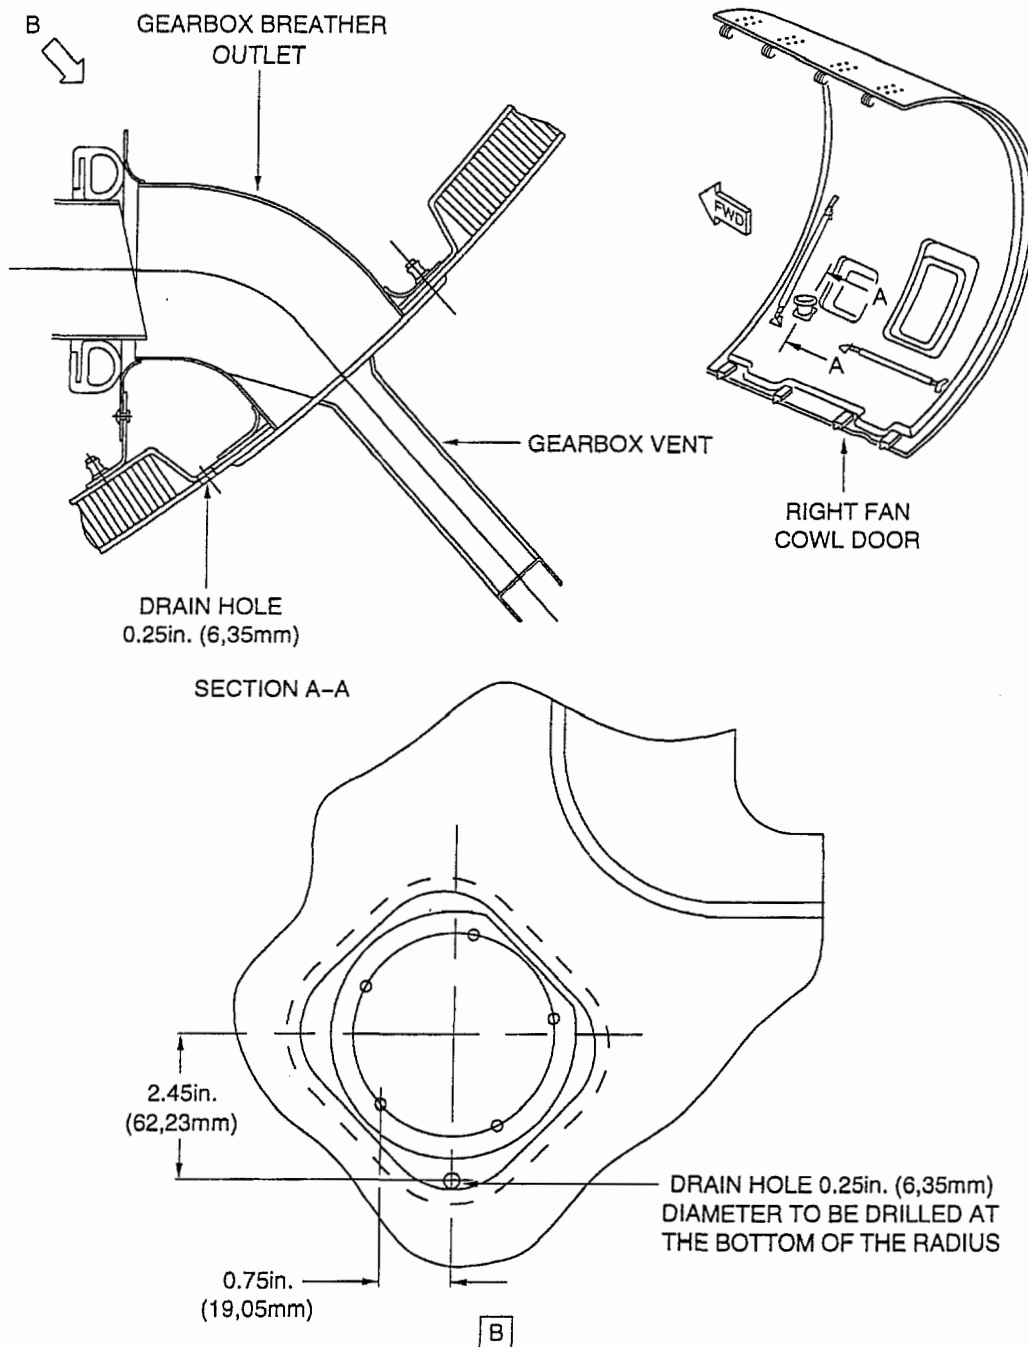
Location of Drain Hole In Right Fan Cowl Door
Figure 1

The right Fan Cowl Door may retain fluid in the pan down area at the gearbox breather outlet duct.

(Breather duct assy not shown for clarity)

- (1) Drill a 0.098 inch (2.50 mm) diameter hole into the right Fan Cowl Door where shown. Drill from the inner face of the fan cowl door. Refer to Figure 1.
- (2) Increase the hole size to 0.25 inch (6.35 mm) diameter. Remove any burrs from the hole.

(5) Apply finish to the cut edges of the drain hole.
