POWER PLANT - NACELLE - POWERPLANT - REPLACEMENT OF THE TAI VALVE - CATEGORY CODE 7 -
MOD.NAC-71-0166

V2500-NAC-71-0166

SERVICE BULLETIN

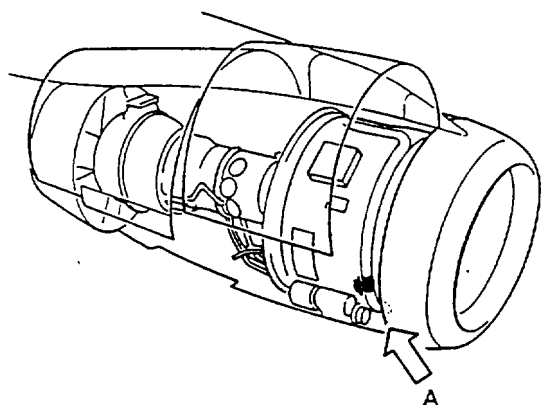
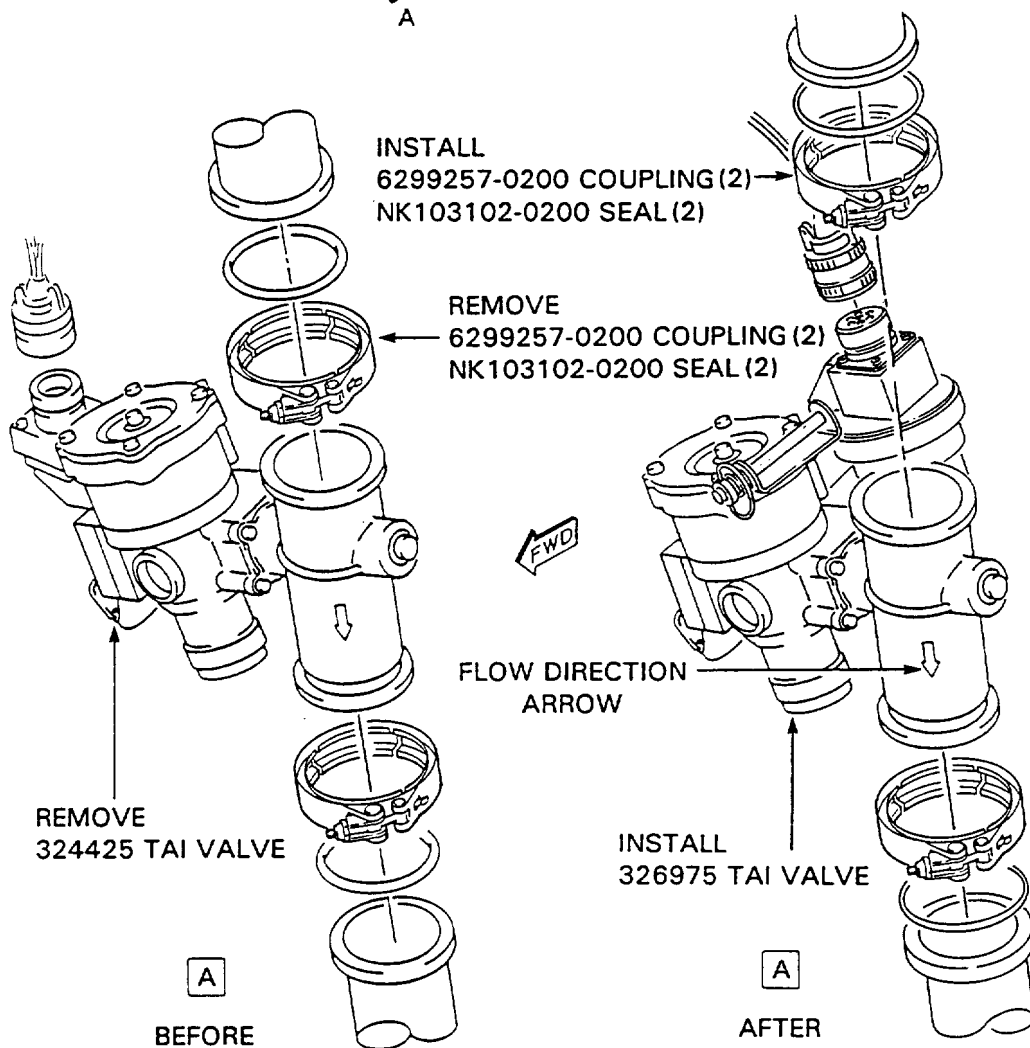
REPLACEMENT OF T.A.I. VALVE
FIG.1

The TAI valve may be slow to open when the engine is at idle speed.

- (a) The TAI valve is removed and replaced with a new valve. An existing bracket is made redundant and a new one is introduced to accommodate the routing change of the cable harness to the new TAI valve.

- (1) Disassemble clipping point CP0828 (Refer to Figures 1 and 2.)
- (2) Remove the two NAS1291C4M nuts and SP155E washers to release the 740-5421-501 bracket, 740-5923-501 packing piece and 740-5420-501 bracket from the 'A' flange of the fan case. Do not remove the bolts from the flange.
- (3) Install the 740-5420-501 bracket and 740-5923-501 packing piece back to 'A' flange with the two NAS1291C4M nuts and SP154D washers. Torque the nuts 85 to 105 lbfin (10 to 12 Nm).
- (4) Install the 740-5420-501 bracket and 740-5923-501 packing piece to 'A' flange as shown with the two NAS7204U6 bolts, two SP155E washers and two NAS1291C4M nuts. Torque the nuts 85 to 105 lbfin (10 to 12 Nm).
- (5) Assemble clipping point CP1206 to bracket 740-5420-501 as shown with the 4W0103 bolt, TA025074-04 clamp, SP154D washer and AS41104 clip nut. Hand tighten bolt at this stage.
