International Aero Engines

<u>POWER PLANT - NACELLE - POWERPLANT - REPLACEMENT OF FCD LATCH HOUSING FASTENERS - CATEGORY CODE 7 - MOD.NAC-71-0170</u>

V2500-NAC-71-0170

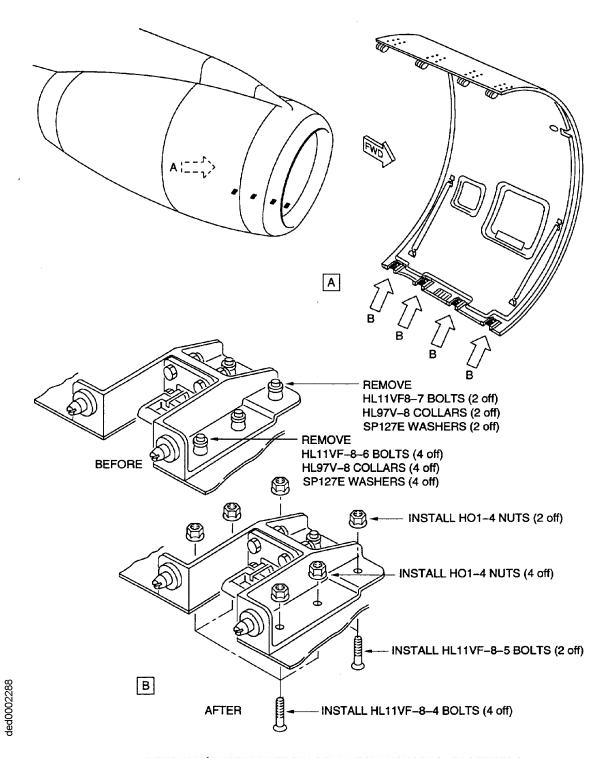
REMOVAL/INSTALLATION OF LATCH HOUSING FASTENERS FIG.1

Minimum clearance has been observed between the fasteners on the left Fan Cowl Door latch assemblies and the Fan Cowl Door locating pins when the door is in the closed position.

- A. Pre-requisite Instructions
 - (1) None.
- B. Modification Instructions
 - (1) Remove two HL11VF8-7 bolts, two SP127E washers and two HL97V-8 collars, as shown, from the left Fan Cowl Door latch housing (Refer to Figure 1)
 - (2) Install two HL11VF8-5 bolts and two HO1-4 nuts to the left Fan Cowl Door latch housing as shown.
 - (3) Remove four HL11VF8-6 bolts, four and four HL97V-8 collars from the left Fan Cowl Door latch housing
 - (4) Install four HL11VF8-4 bolts and four HO1-4 nuts to the left Fan Cowl Door latch housing as shown.
 - (5) Torque the six HO1-4 nuts to 100 lbfin (11.3 Nm)
 - (6) Do steps 2.B.(1) thru 2.B.(5) at the three remaining latch housing positions.
 - (7) Restore the exterior paint finish on the left Fan Cowl Door.
- C. Post-requisite Instructions
