POWER PLANT - NACELLE - POWERPLANT - REPLACEMENT OF FASTENERS ON THE FCD LOCATOR -
CATEGORY CODE 7 - MOD.NAC-71-0171

V2500-NAC-71-0171

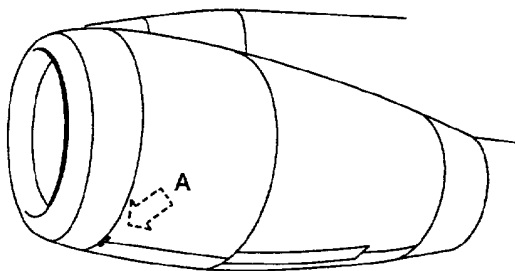
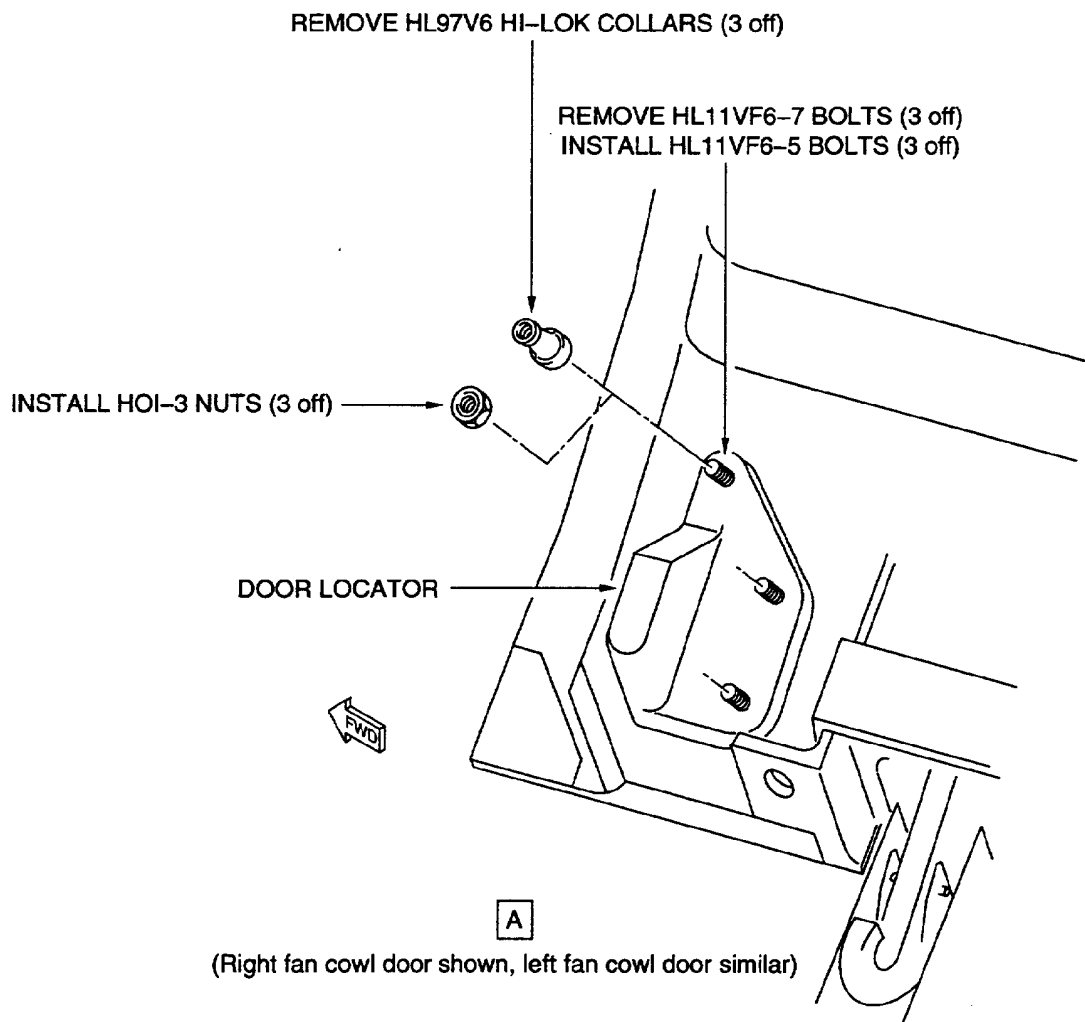
REPLACEMENT OF DOOR LOCATOR FASTENERS
FIG.1

When the fan cowl doors are in the closed position the fasteners that secure the right and left FCD locators to the doors may contact the nose cowl guide bar.

- (1) Remove an HL97V6 Hi-lok collar and an HL11VF6-7 Hi-lok bolt from the left fan cowl door. (Refer to Figure 1).
- (2) Install an HL11VF6-5 bolt and an H01-3 Kaynar nut to the left Fan Cowl Door in place of the bolt and nut removed in step B.(1).
- (3) Replace the two remaining Hi-Lok bolts and collars on the left Fan Cowl Door as instructed in steps B.(1) and B.(2).
- (4) Torque the Kaynar Nuts to 40lb in (4.52 Nm).
- (5) Restore the paint finish to the left Fan Cowl Door.
- (6) Do steps B. (1) thru B.(5) for the right Fan Cowl Door.
