**International  
Aero Engines**

V2500 Propulsion System — Nacelle

NACELLE - POWERPLANT - COWL, AIR INTAKE - ADAPTER RING ATTACHING RIVETS -  
INSPECTION/REPLACEMENT OF

**V2500-NAC-71-0186**

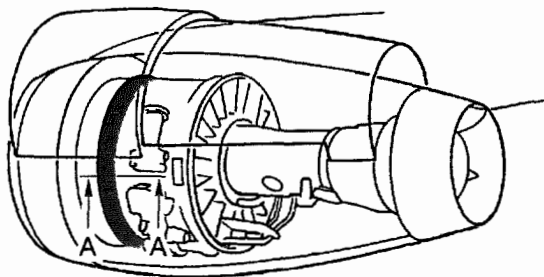
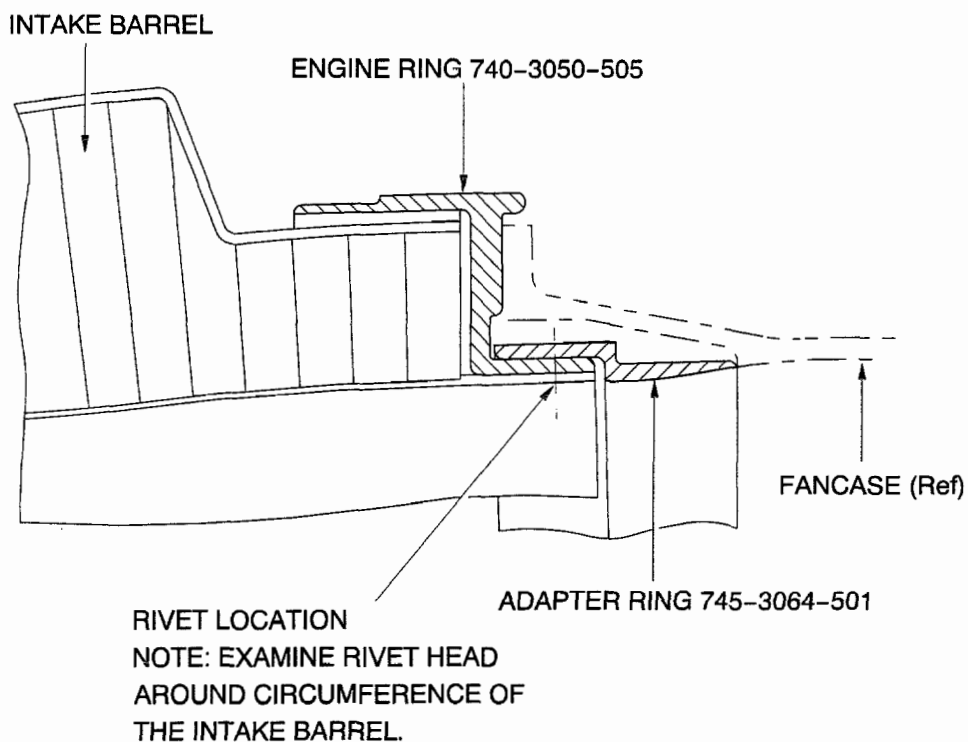
INSPECTION/REPLACEMENT OF AIR INTAKE COWL RIVETS  
FIGURE 1

- (2) Clean the Adapter ring on the Air Intake Cowl with a clean lint-free cloth(CoMat 02-099)made moist with solvent (COMAT 01-076) or (COMAT 01-457). Wipe the area dry before the solvent evaporates.
- (3) Examine the Adapter ring assembly for CSR922-6-7R rivets as shown. Refer to Figures 1 and 2. Proceed with Step 2.B.(4) if any CSR922-6-7R rivets are found, otherwise proceed to Paragraph 2.C.

RIVET LOCATION  
NOTE: EXAMINE RIVET HEAD  
AROUND CIRCUMFERENCE OF  
THE INTAKE BARREL.

- (4) Replace the CSR922-6-7R rivets with CSR902B6-10 rivets as follows:
  - (a) Carefully drill out the CSR922-6-7R rivets making sure you do not elongate the holes. Do not remove more than ten rivets at one time.
  - (b) Measure the rivet holes to ensure they are between 0,191 in.(4,85mm) and 0,195 in.(4,95mm) diameter.
  - (c) Install the CSR902B6-10 rivets in place of the CSR922-6-7R rivets. Refer to the IAE V2500 Standard Practices/Processes Manual(SPP-V2500-11A)Chapter/Section 70-39-03,Installation of rivets.
  - (d) Remove any unwanted material and metal particles from the Air Intake Cowl.
  - (e) Do steps 4(a) thru 4(d) until all the CSR922-6-7R rivets are replaced.

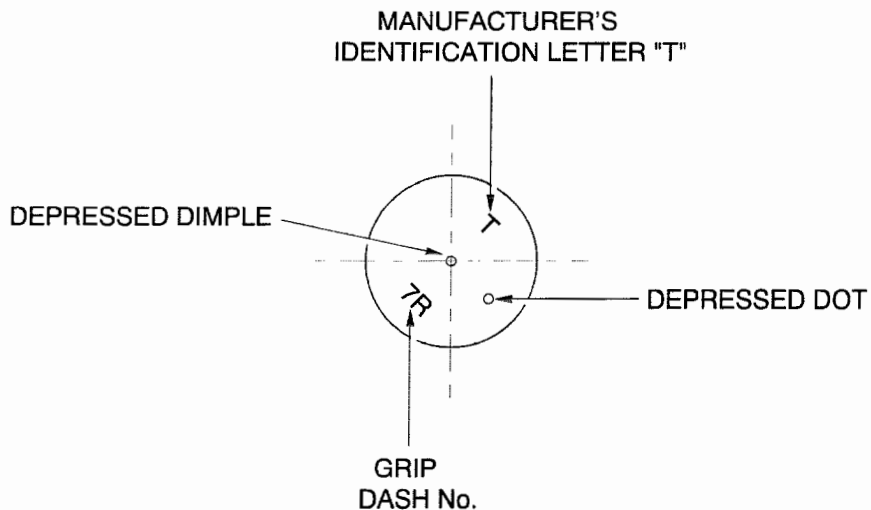
RIVET IDENTIFICATION MARKINGS  
FIGURE 2

MARKINGS FOR CHERRY BUCK RIVET CSR922-6-7R (CSK HEAD)

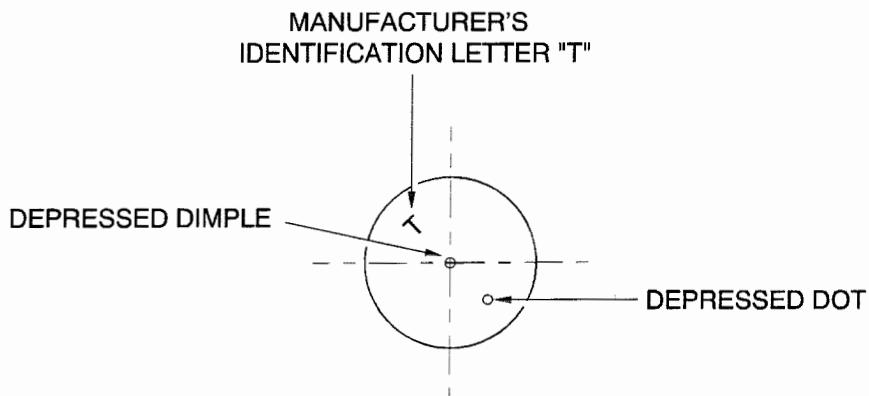
MARKINGS FOR CHERRY E-Z BUCK RIVET CSR902B6-10 (CSK HEAD)
