**International
Aero Engines**

SERVICE BULLETIN

**NACELLE - NOSE COWL - FORWARD BULKHEAD ANTI-ICE DUCT CONNECTION -
ADDITION OF POSITIVE RETENTION FEATURE**

V2500-NAC-71-0193

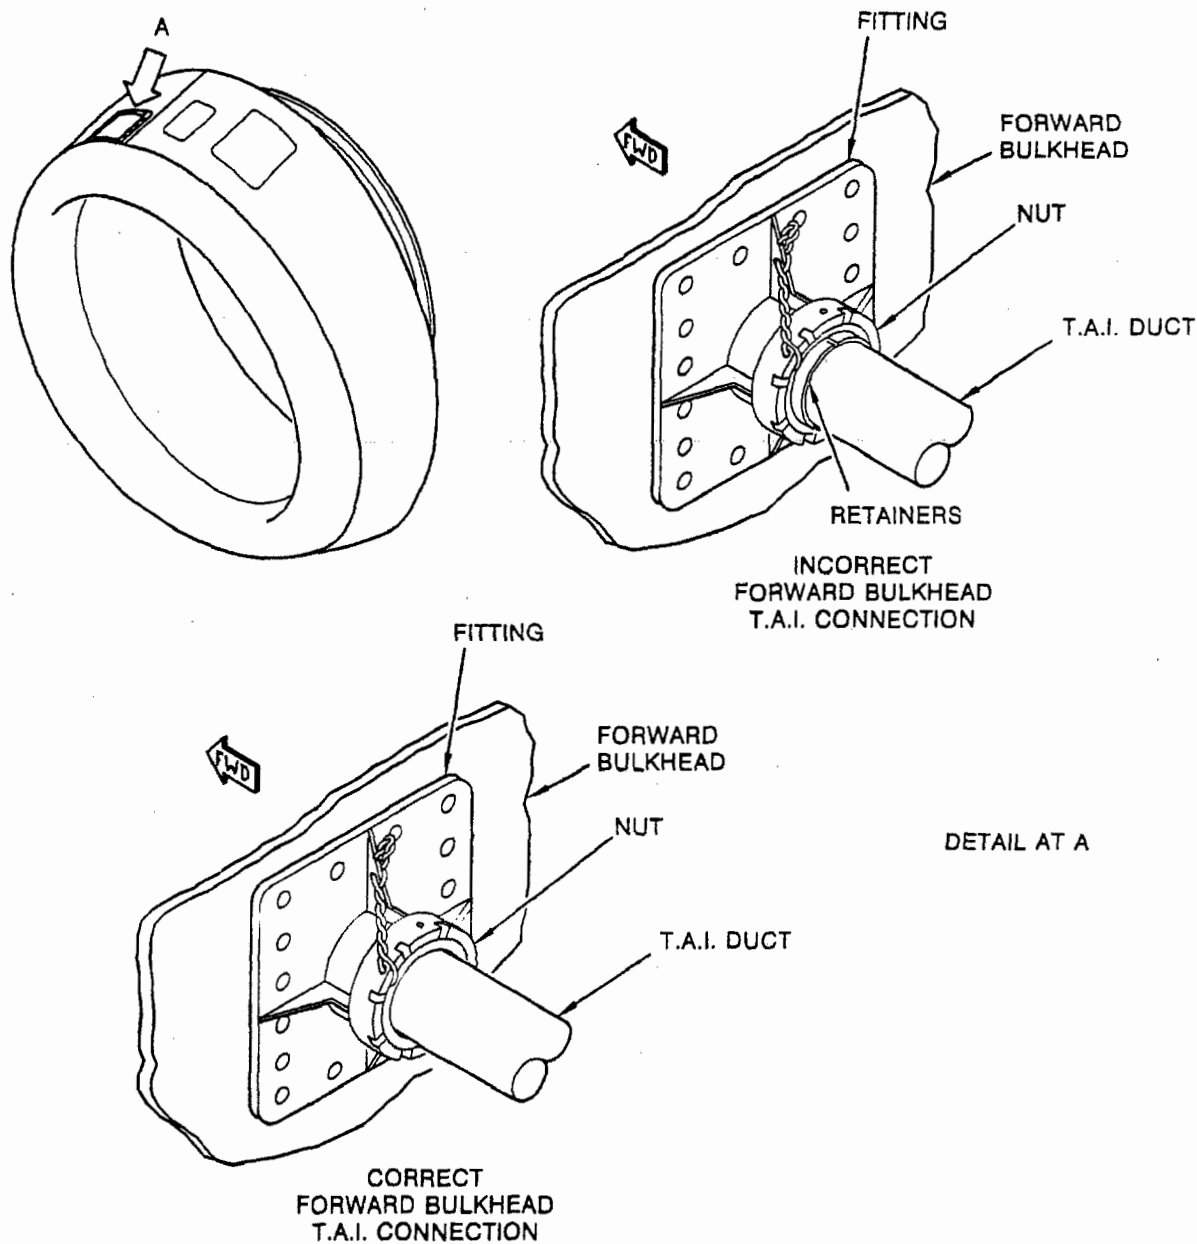
Nose Cowl T.A.I Duct-to-Forward Bulkhead Connection Inspection
Figure 2

- (1) If you can see the retainers behind the T.A.I. duct nut, the installation is incorrect, and you must do Part 3 of this Service Bulletin. Refer to Figure 2.
- (2) If you cannot see the retainers behind the T.A.I. duct nut, the installation is correct, and you must do Part 2 of this Service Bulletin. Refer to Figure 2.
