IAE Propulsion System NON-MODIFICATION SERVICE BULLETIN

Subject: Transmittal of Revision 2 to Service Bulletin Number V2500-NAC-71-0208

NACELLE – POWERPLANT – SEAL, PYLON APRON, FORWARD UPPER AND LOWER –
REPLACEMENT OF

V2500-NAC-71-0208

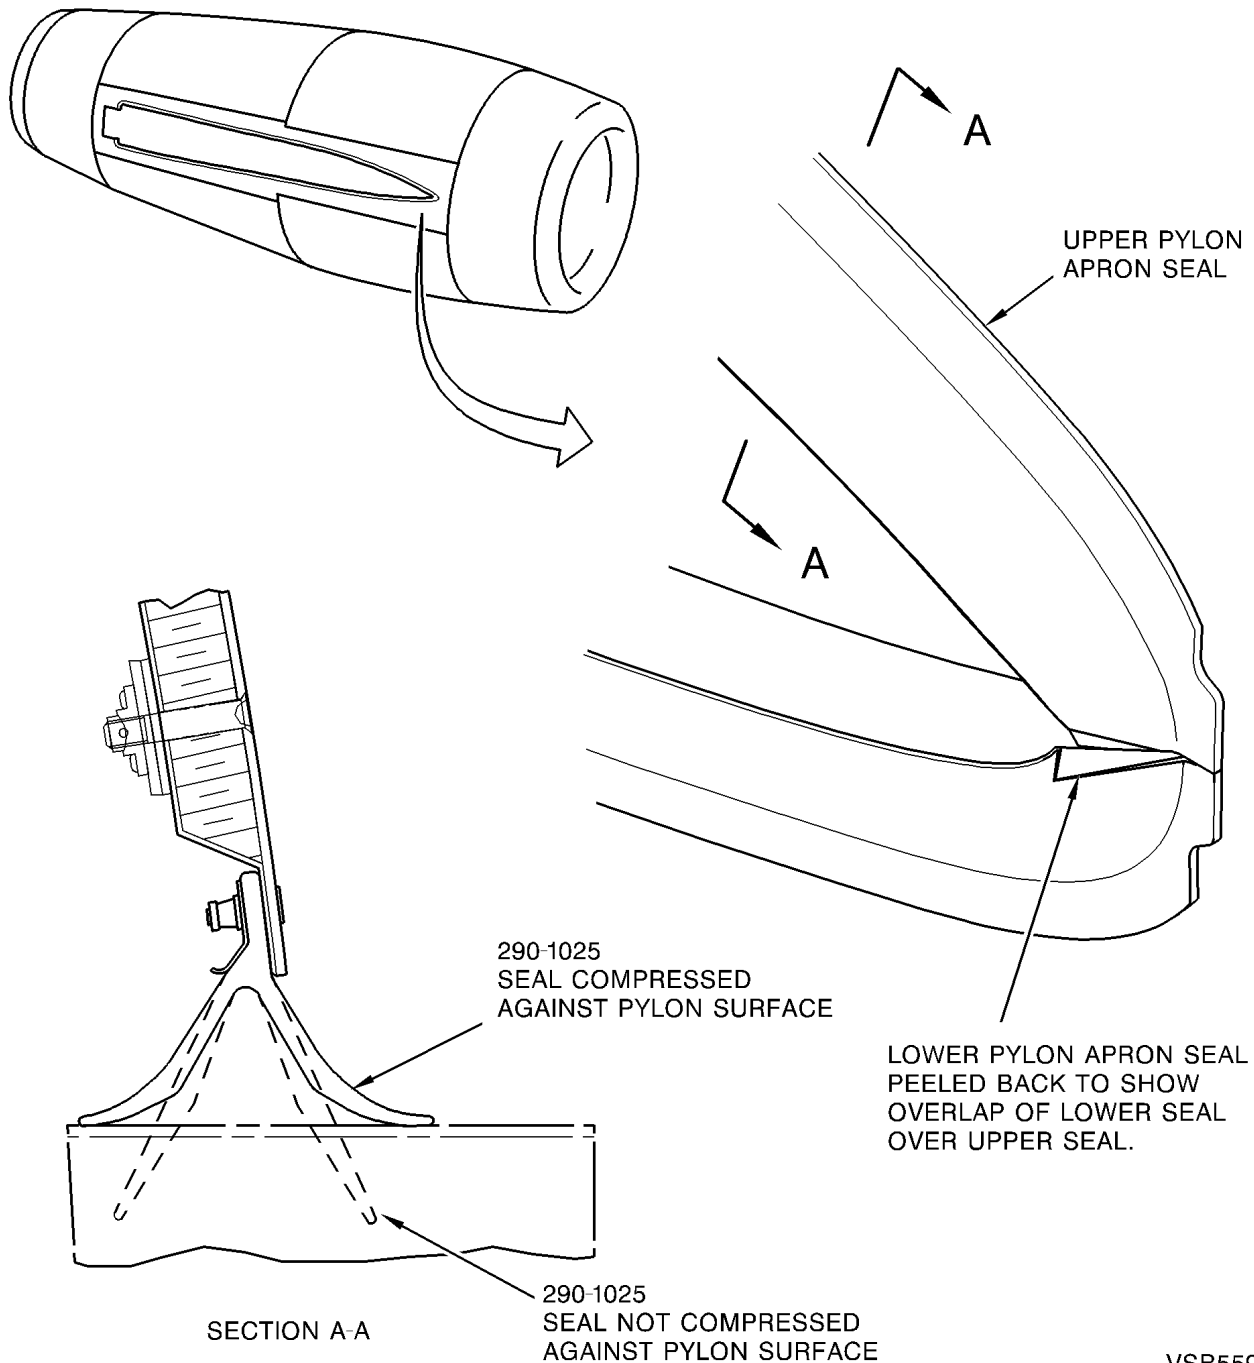
Install the Upper and Lower Forward Pylon Aprons
Figure 2

CAUTION: MAKE SURE THE SEALS ARE SPREAD AGAINST THE PYLON. MAKE SURE THE LOWER SEAL IS OVER THE UPPER SEAL WHERE THE SEALS COME TOGETHER AT THE FORWARD END OF THE PYLON. IF YOU DO NOT DO THIS, THE SEALS CAN GET DAMAGED AND ALLOW TOO MUCH AIR INTO THE FAN COWLS.

- (1) Install the upper and lower forward pylon aprons. Refer to the MD-90 Aircraft Maintenance Manual, Chapter 71-14-01, page block 401. Make sure the seals are spread against the pylon. Make sure the seals of the lower pylon aprons are over the seals of the upper aprons where they come together at the forward end of the pylon. Refer to Figure 2.
