International  
Aero Engines

V2500 Propulsion System — Nacelle

NACELLE — POWERPLANT — BOLTS, PYLON APRON, — REPLACEMENT OF

V2500-NAC-71-0209

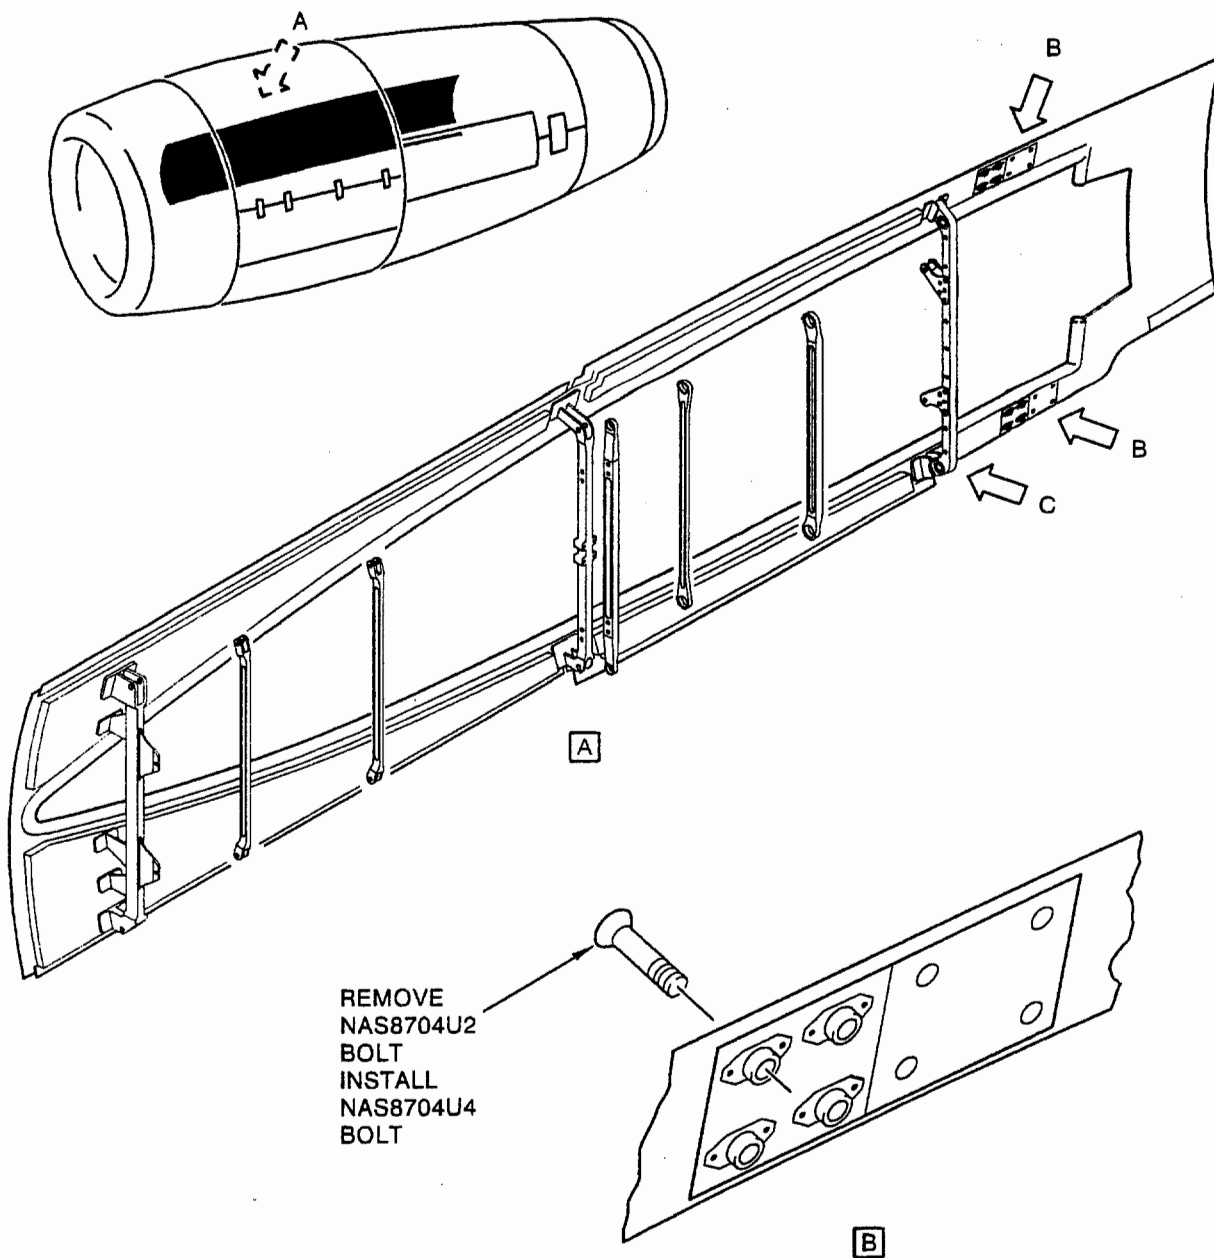
Replace the Pylon Apron Bolts - Left Nacelle  
Figure 1 (sheet 1)

Some of the pylon apron bolts may not have sufficient thread engagement.

Insufficient thread engagement of some pylon apron bolts was observed at the airframer during installation of the pylon aprons.

(1) Remove the NAS8704U2 bolts. Refer to Figures 1 and 2.

(2) Install the NAS8704U4 bolts. Torque the bolts to 63 to 70 lbfin (7.1 to 7.9 Nm). Refer to Figures 1 and 2.
