Subject: Transmittal of Revision 1 to Service Bulletin Number V2500-NAC-71-0210

# International Aero Engines SERVICE BULLETIN

NACELLE - POWER PLANT - LINKS, FORWARD ENGINE MOUNT - REPLACEMENT OF

V2500-NAC-71-0210 Page 1 of 17

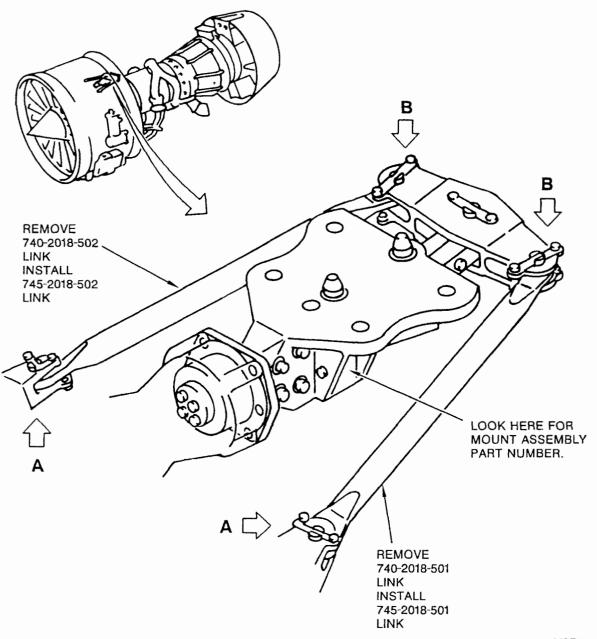
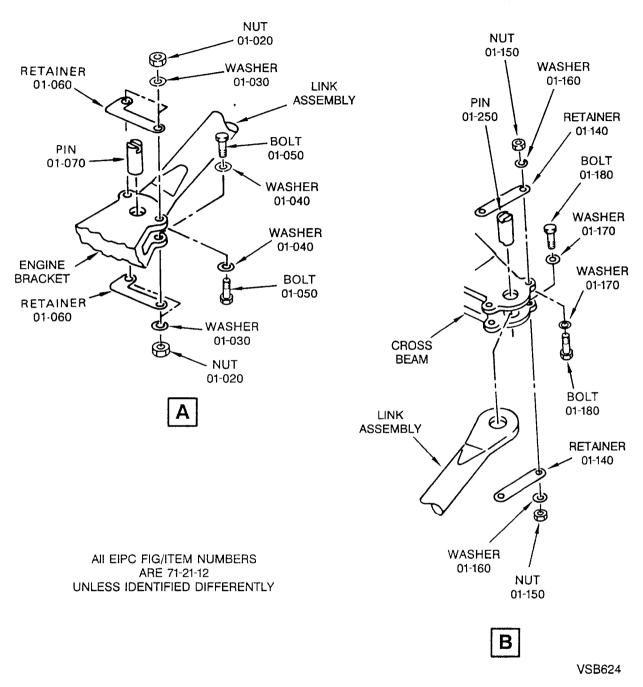
Replacement of Engine Mount Links Figure 2 (Sheet 1)

A V2500 forward engine mount assembly link demonstrated insufficient life during testing under V2500-A5 load specifications.

Certification tests and analysis have proven the V2500 forward engine mount link (part numbers 740-2018-501 and 740-2018-502) does not meet the full aircraft life requirements for the V2500-A5 engine models (64,000 flight cycles).

- (2) For engine mounts that are installed on the engine, remove the nuts (01-020), bolts (01-050), washers (01-030 and 01-040), and retainers (01-060) from the engine bracket. Remove the pin (01-070) from the engine bracket. Refer to Figure 2.

- (3) Remove the nuts (01-150), bolts (01-180), washers (01-160 and 01-170), and retainers (01-140) from the cross beam. Remove the pin (01-250) from the cross beam. Refer to Figure 2.

- (4) Remove the 740-2018-501 (740-2018-502) link. Destroy the link. Refer to Figure 2.
- (5) Put the 745-2018-501 (745-2018-502) link in the cross beam and the engine bracket. Refer to Figure 2.

- (6) Attach the link to the cross beam with the pin (01-250), retainers (01-140), washers (01-160 and 01-170), bolts (01-180), and nuts (01-150). Torque the nuts (01-150)to 20-25 lbin (2,26-2,82 Nm). Refer to Figure 2.

- (7) For engine mounts that are installed on the engine, attach the link to the engine bracket with the pin (01-070), retainers (01-060), washers (01-030 and 01-040), bolts (01-050), and nuts (01-020). Torque the nuts (01-020)to 20-25 lbin (2,26-2,82 Nm). Refer to Figure 2.
